NJDOT CHALLENGES ON COMPOSITE PAVEMENT

**2018 NORTH EASTERN STATES
MATERIALS ENGINEERS' ASSOCIATION**

NUSRAT S MORSHED, P.E.

PAVEMENT DESIGN

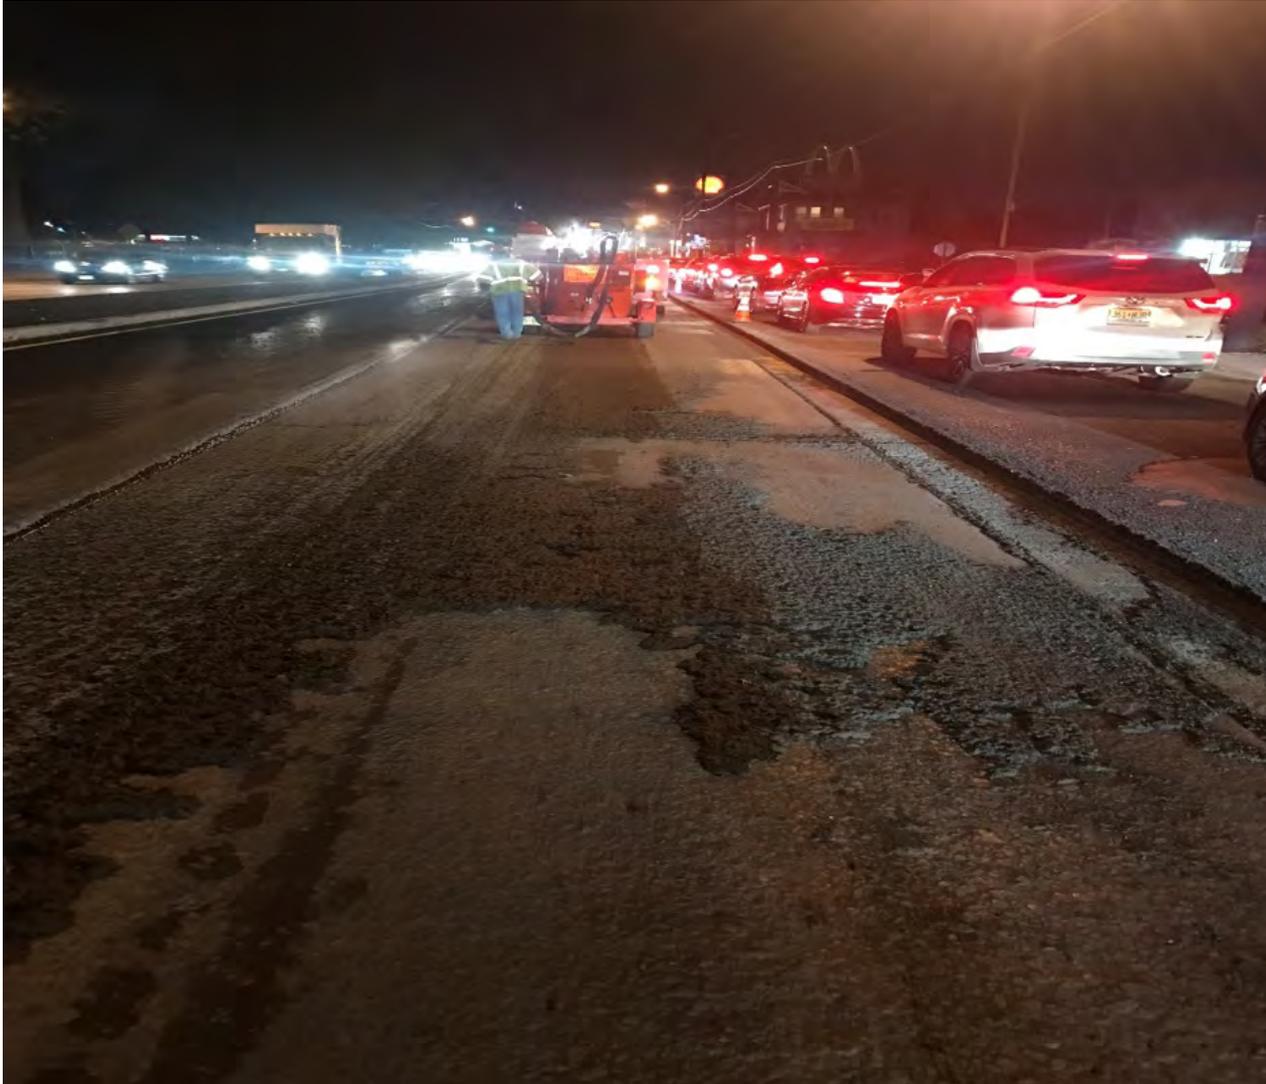
Challenges of Removing HMA Overlay:

Pavement Recommendation:

Mill 3" and Pave with 3" SMA
12.5 MM Surface Course

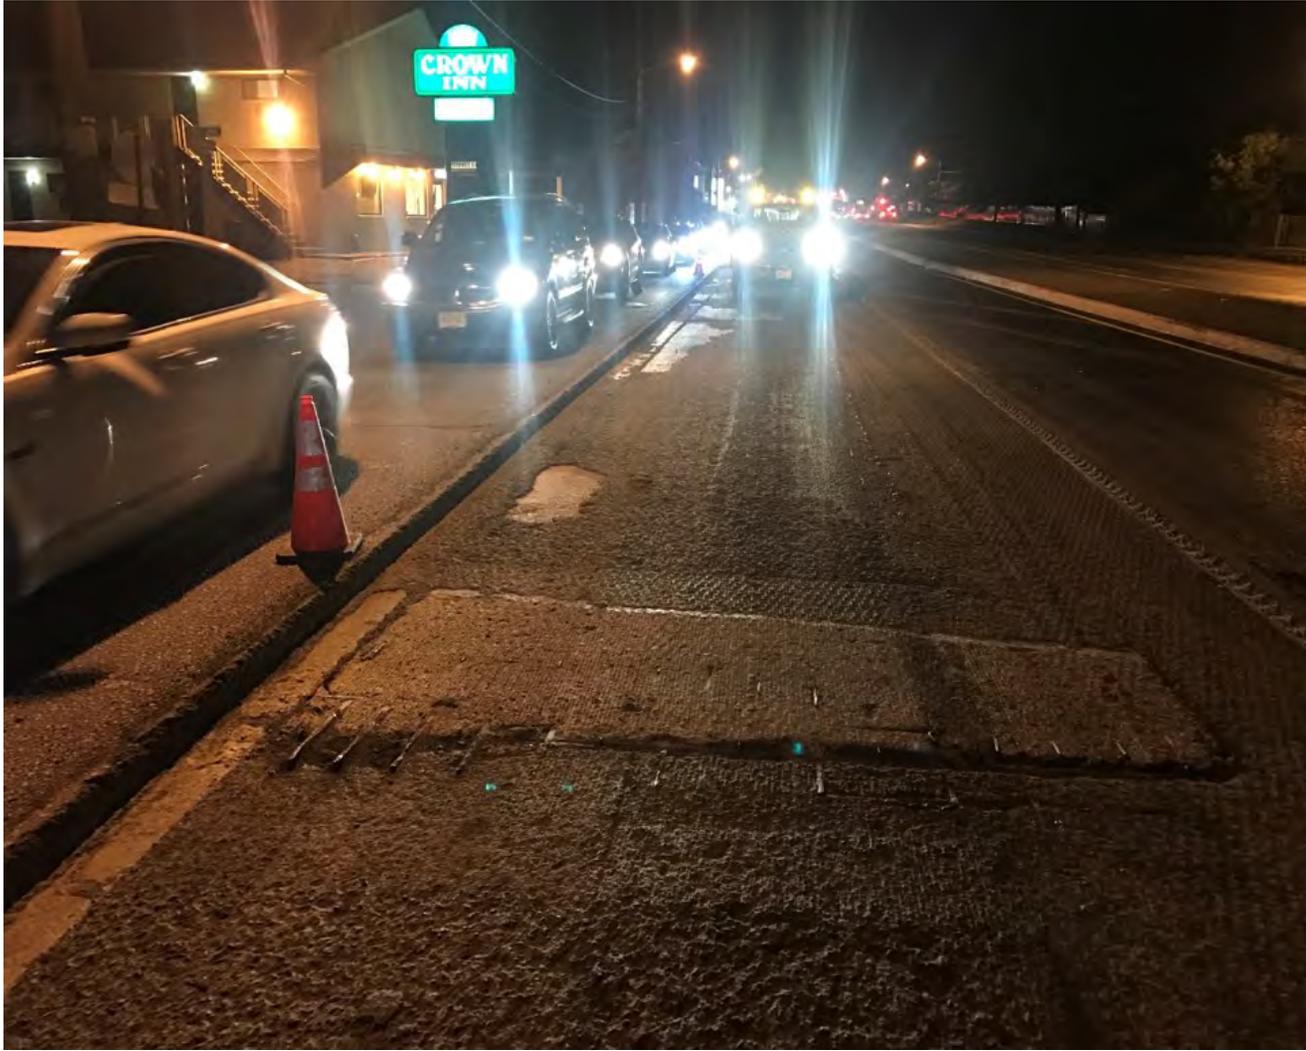
Challenges of Removing HMA Overlay:

Core Information:

Lane 1 Core information was 5.25" to 7.75" HMA over PCC.

Lane 2 Core information was not available during design.

Lane 3 Core information was 3.5" to 19.5" HMA over PCC.

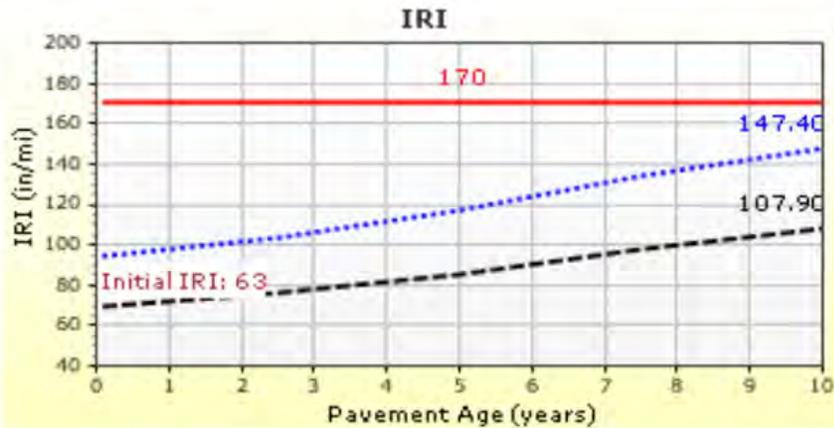
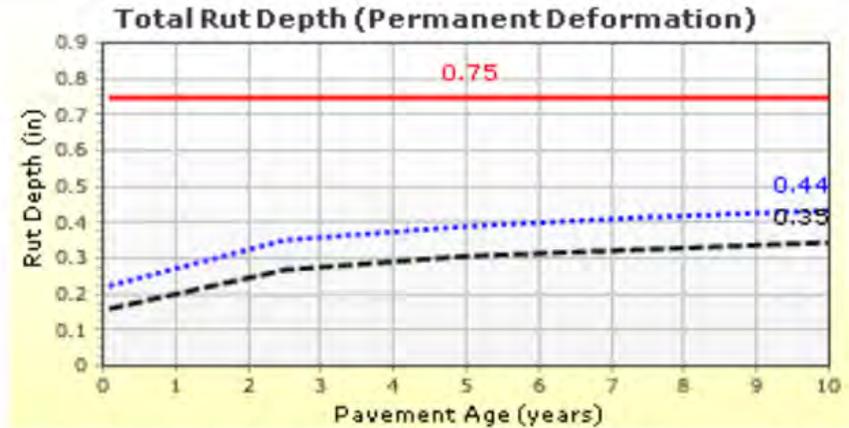
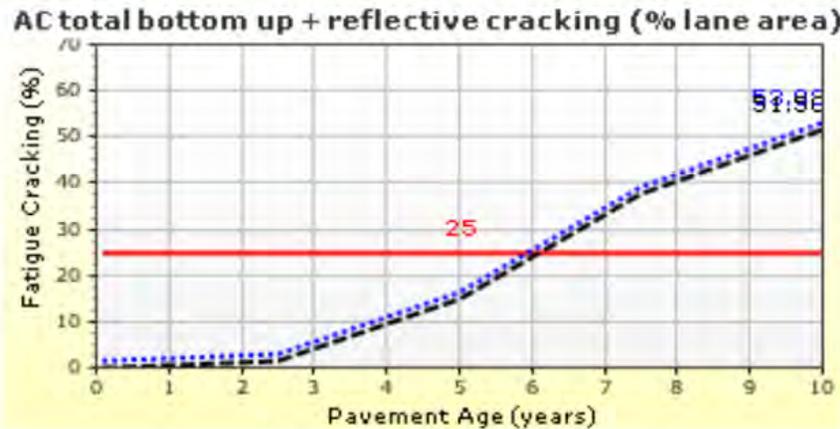
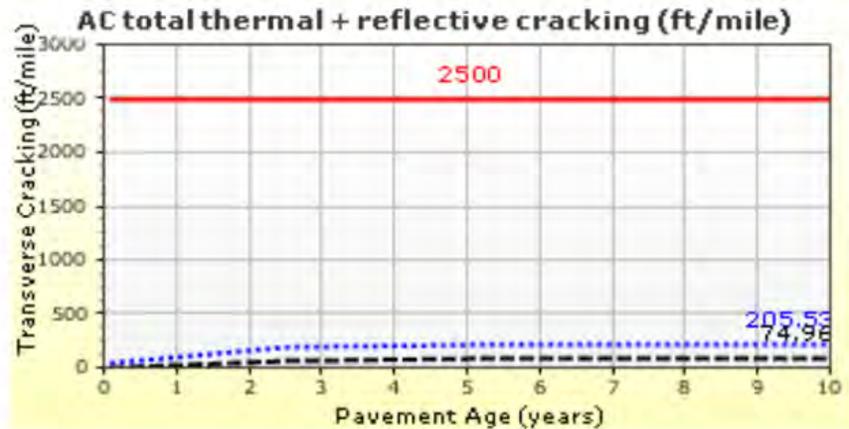
Distress Charts

Distress Prediction Summary

Distress Type	Distress @ Specified Reliability		Reliability (%)		Criterion Satisfied?
	Target	Predicted	Target	Achieved	
Terminal IRI (in/mile)	170.00	147.44	90.00	97.79	Pass
Permanent deformation - total pavement (in)	0.75	0.44	90.00	100.00	Pass
AC total fatigue cracking: bottom up + reflective (% lane area)	25.00	53.08	90.00	0.00	Fail
AC total transverse cracking: thermal + reflective (ft/mile)	2500.00	205.53	90.00	100.00	Pass
AC bottom-up fatigue cracking (% lane area)	25.00	0.00	50.00	100.00	Pass
AC thermal cracking (ft/mile)	1000.00	1.00	50.00	100.00	Pass
AC top-down fatigue cracking (ft/mile)	2000.00	320.08	90.00	100.00	Pass
Permanent deformation - AC only (in)	0.25	0.13	90.00	100.00	Pass

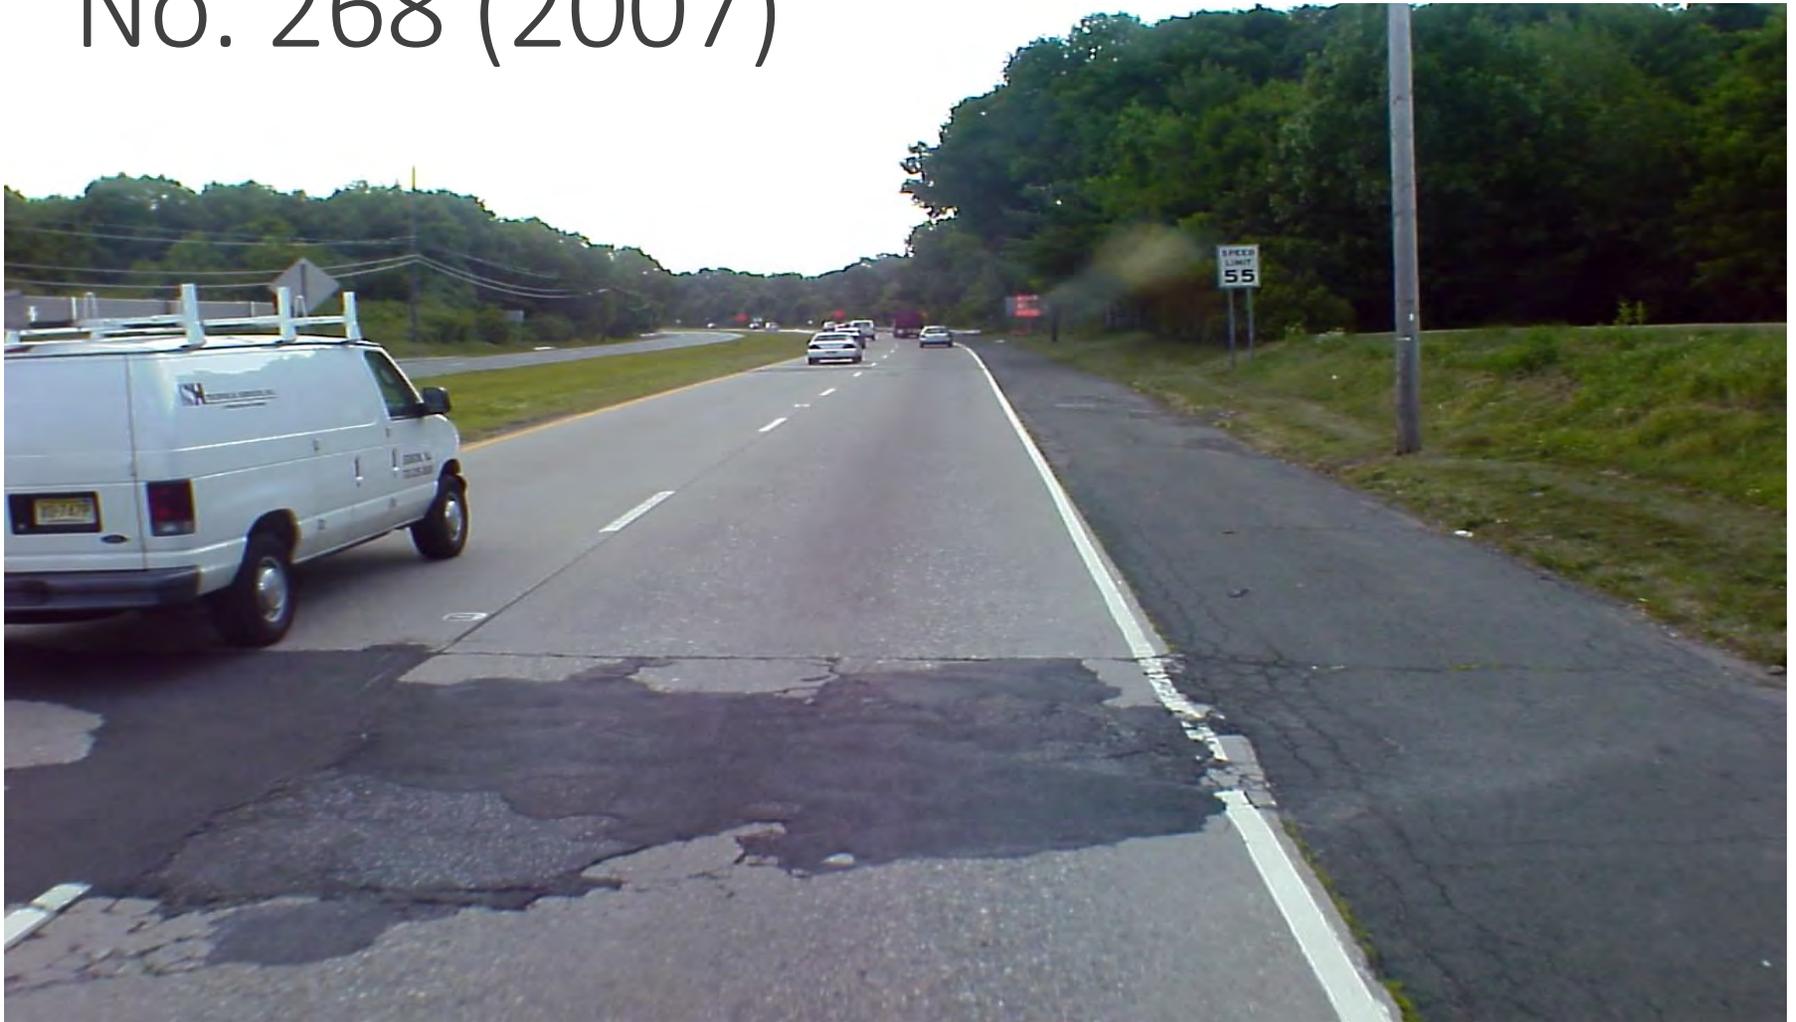
Rt.202 SB (MP 13.4-17.03) – Maintenance Resurfacing Contract No. 268 (2007)

Visual Survey of JRC Pavement

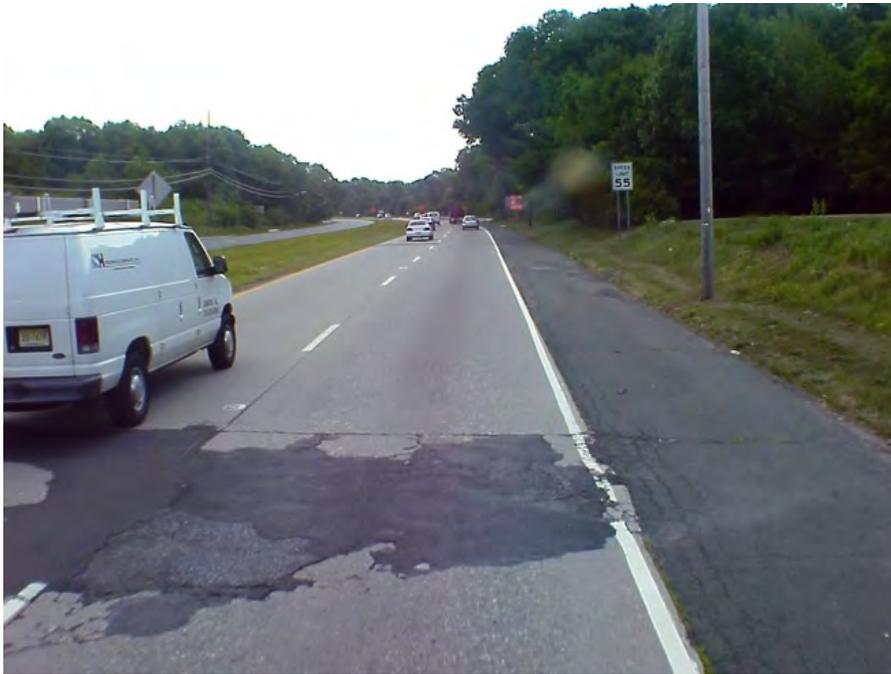
BEFORE REHAB

SDI = 2.07

Ride Quality

- MP 13.4-14.75, IRI=197.2
- MP 14.75-15.25, IRI=154.7
- MP 15.25-15.75, IRI=143.8
- MP 15.75-17.03, IRI=151.5
- Ride Quality for the project, IRI=168.6

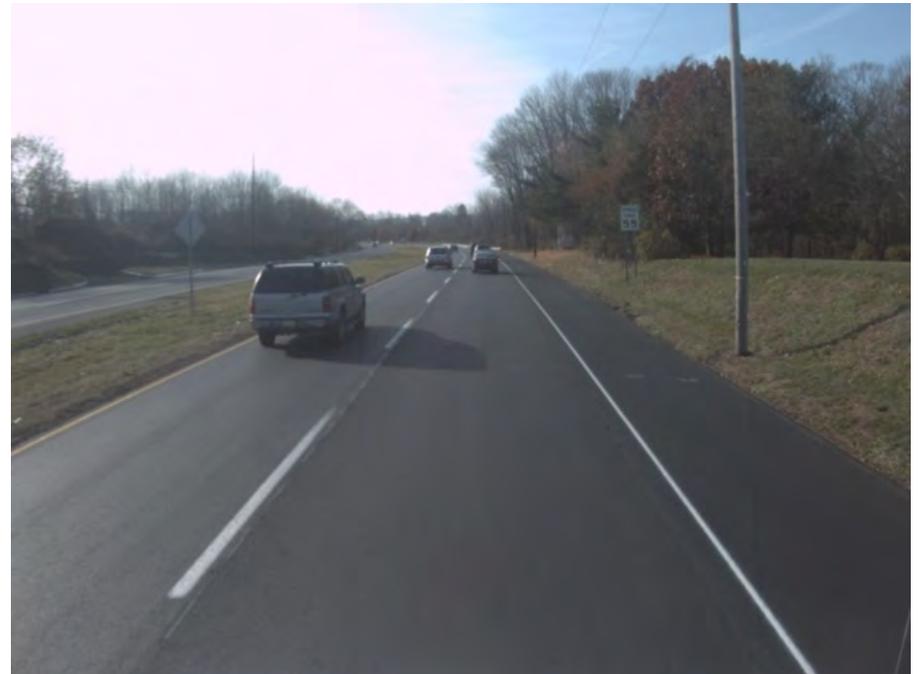
AFTER REHAB

SDI = 5.0

Ride Quality

- MP 13.4-14.75, IRI=88.3
- MP 14.75-15.25, IRI=78.0
- MP 15.25-15.75, IRI=77.7
- MP 15.75-17.03, IRI=75.0

Ride Quality for the project,
IRI=80.4

Rehab. Design of Asphalt Outside Shoulder

- Roadway Excavation
- Pave with 3" min. & var. HMA 25M64 Base Course
- Pave with 4" (2 lifts) of high quality HMA

Full Depth Concrete Repairs with Very Early Strength Concrete

Overlay Design with 4" (2 lifts) of high quality HMA

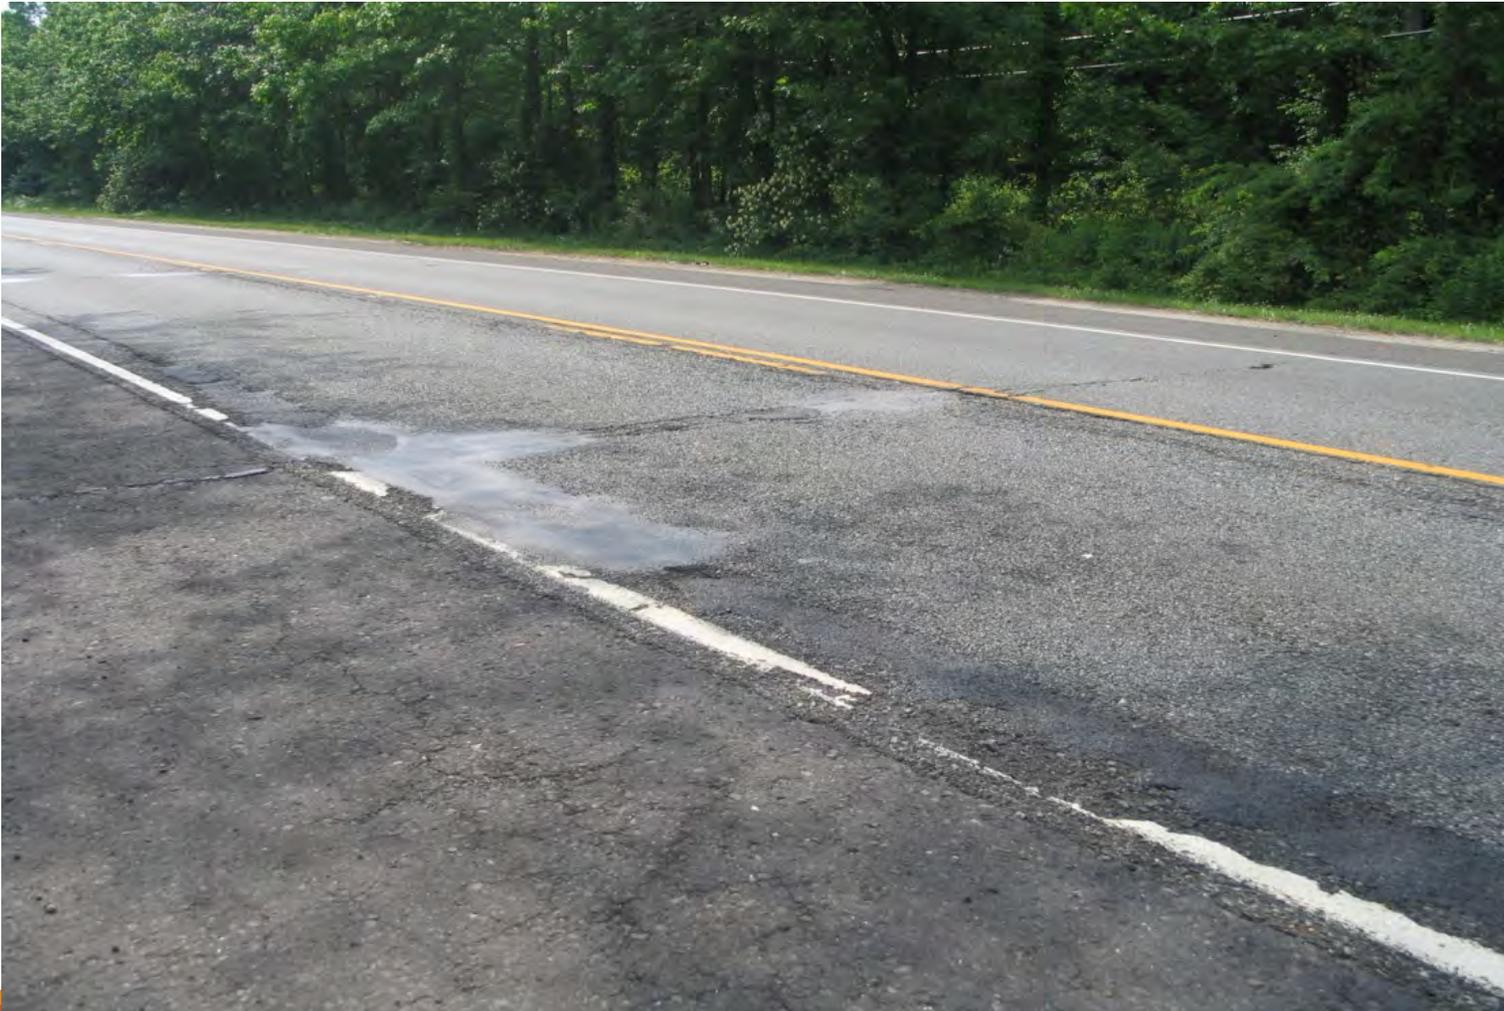
Rt.70 (MP8.61-12.06)- Maintenance Roadway Repair Contract No. 327 (2007)

Located high deflection joints (> 15 mils deflection) with FWD during construction

Failed joints were successfully (reduced deflection < 10 mils) grouted with HDP by Uretek

Full Depth Repairs with HMA were performed on high severity joints/areas

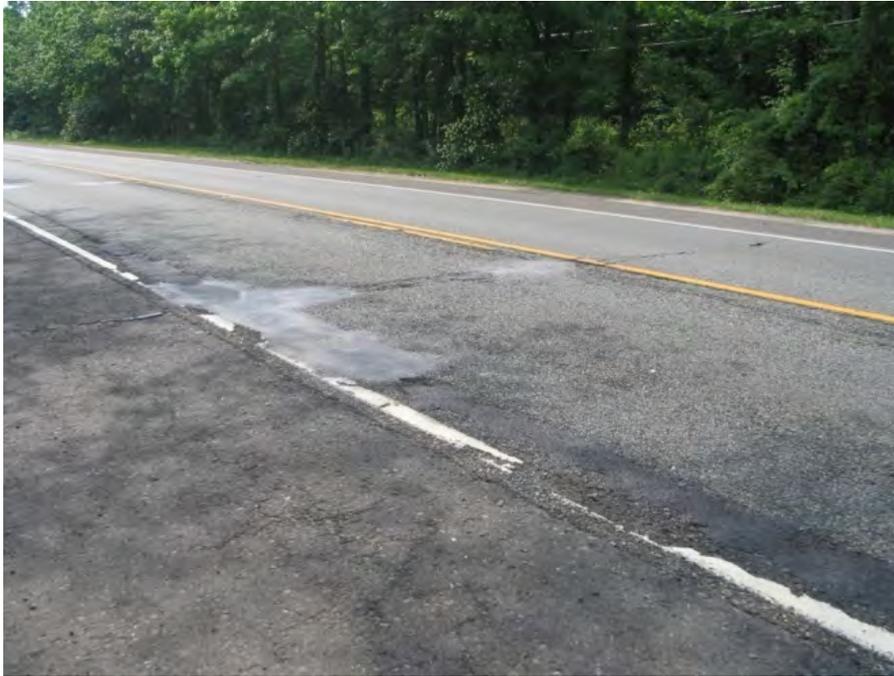
BEFORE REHAB

SDI = 1.56

Ride Quality IRI = 157

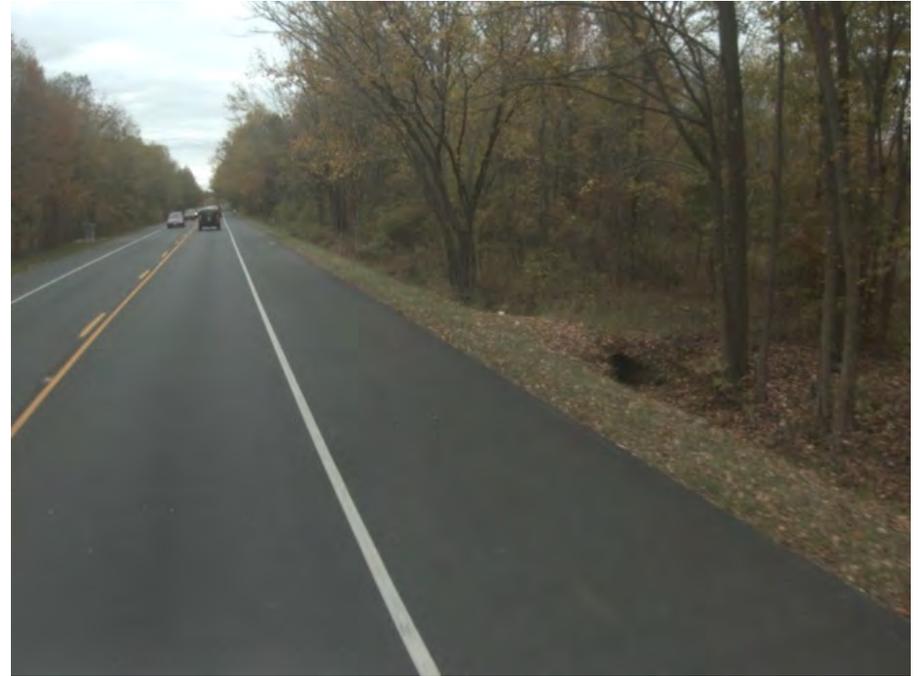
AFTER REHAB

SDI = 5

Ride Quality IRI = 94
