ASTM A588 Weathering Steel Guardrail

Routine Maintenance Turns Up Problems in 1993

Condition Survey 1995/1996

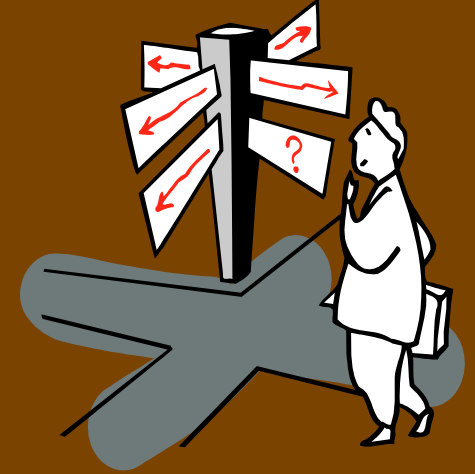
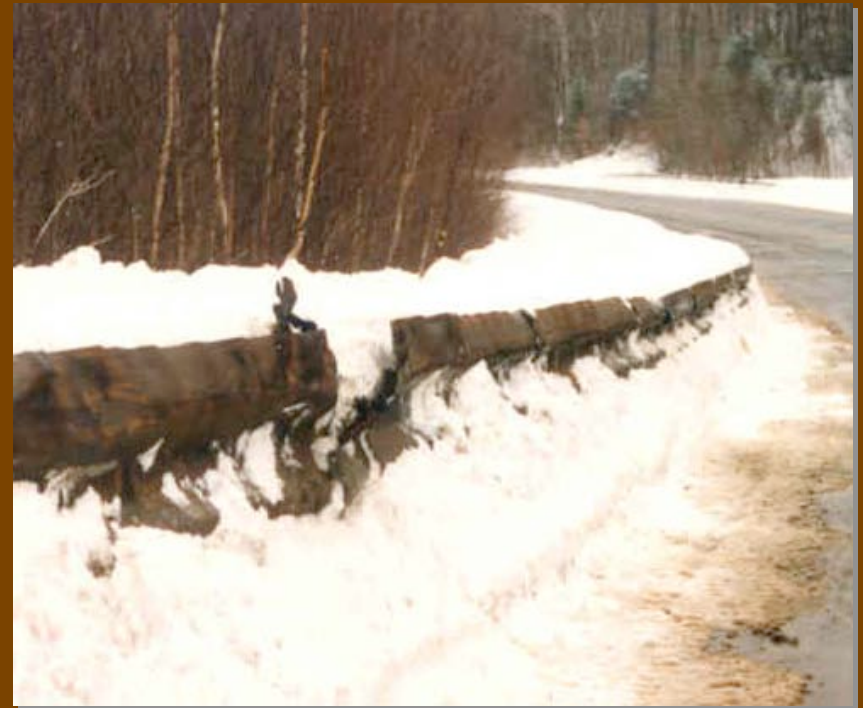
- Advanced Deterioration was discovered
- Beam Guardrail had rusted through at the point of overlaps along the Kancamagus Highway
- Preliminary Investigation showed:
 - Virtually all areas containing A588 Steel are within National Forest Lands
 - All showed some degree of failure

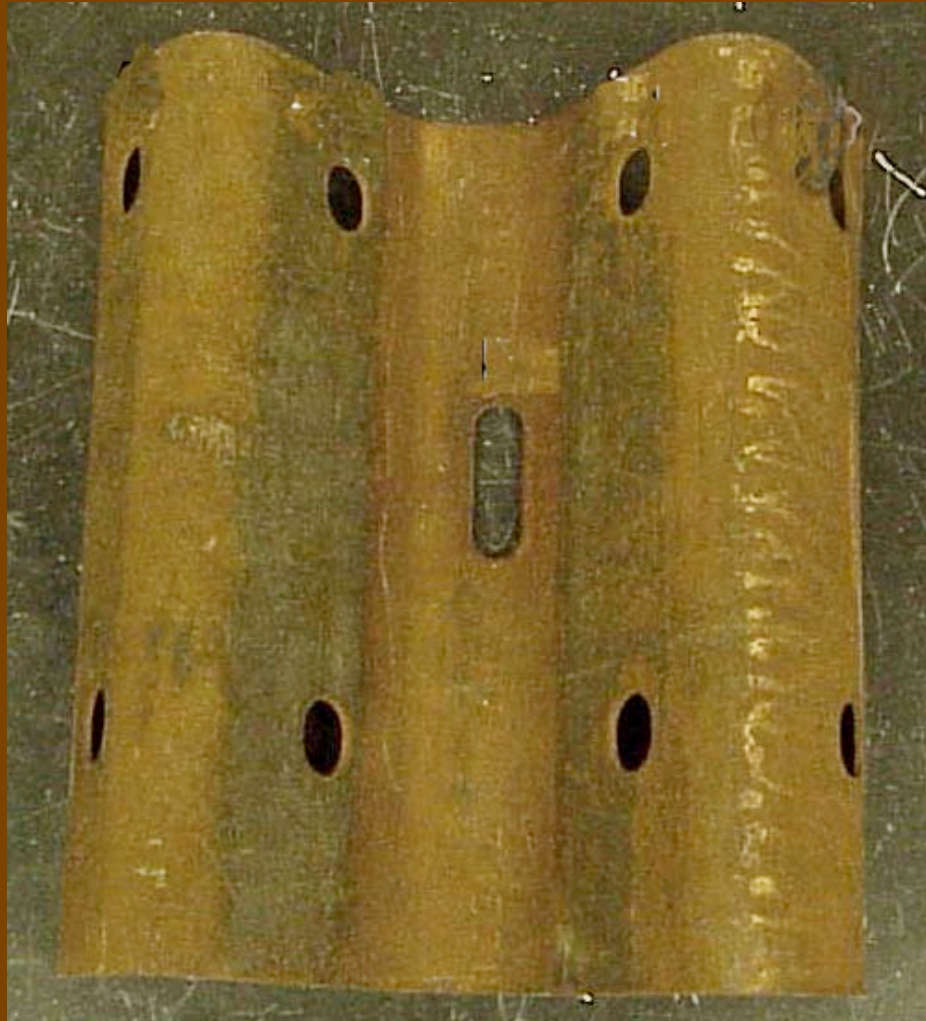
The Salt-fog samples left
looking like this...

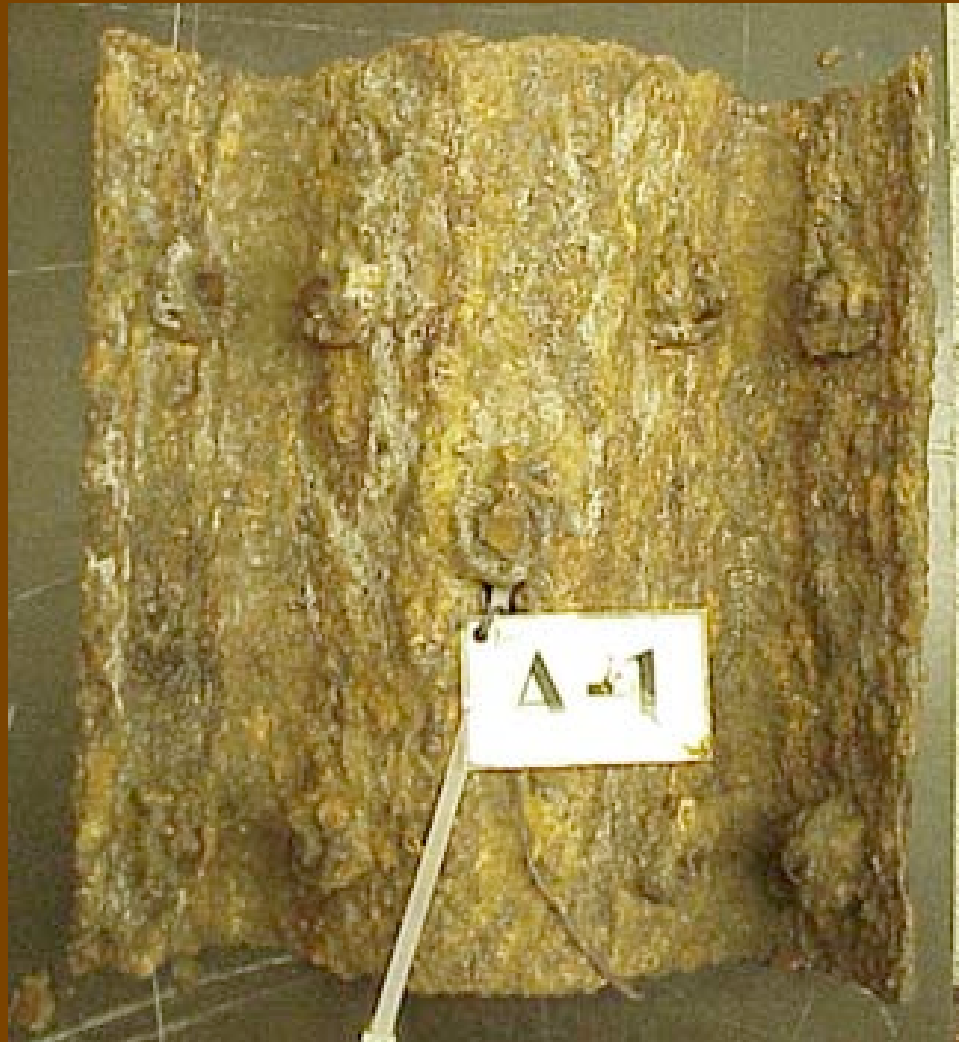
And Came Back Like This!

What a mess!

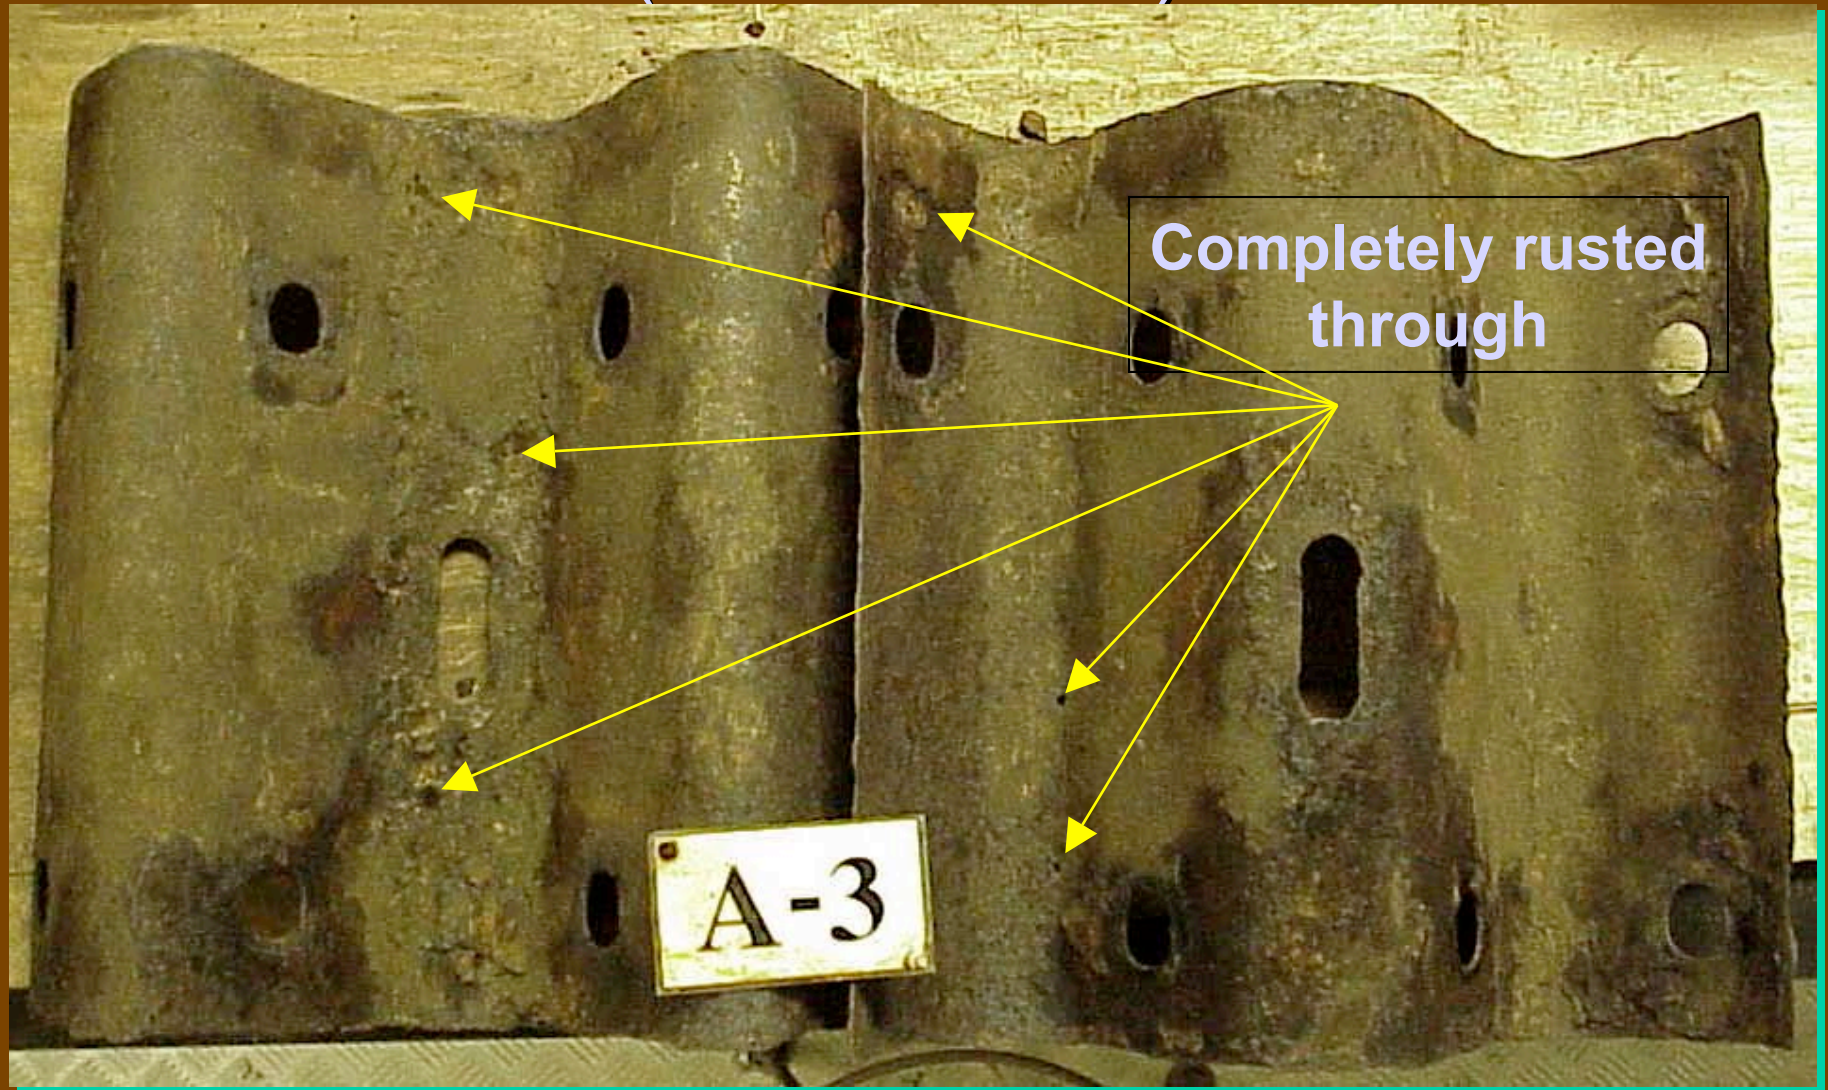
Control sample – post salt fog (Inside shown)

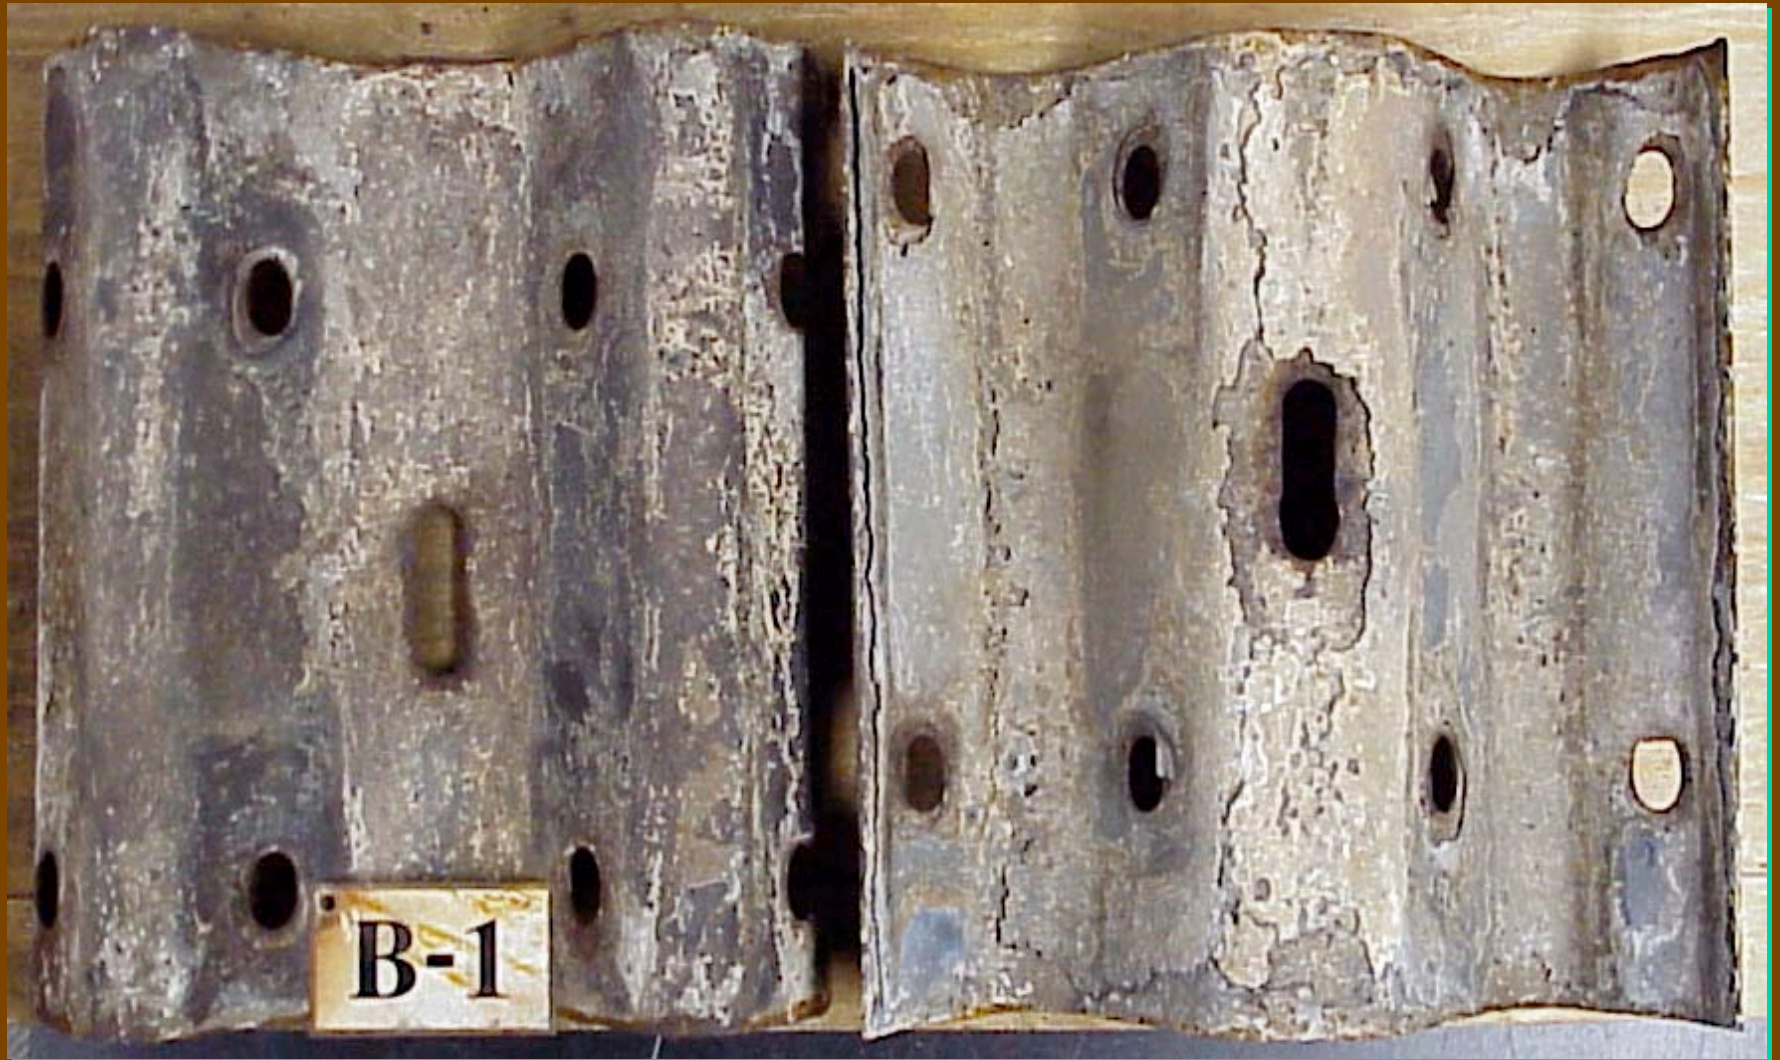
Zinc Insert – Post Salt Fog

- All coatings provided some level of protection to the side they were applied to
- The zinc inserts gave full protection to both sides
- The zinc inserts are the easiest, fastest and cleanest option
- With Zinc, the joints will no longer be the failure point

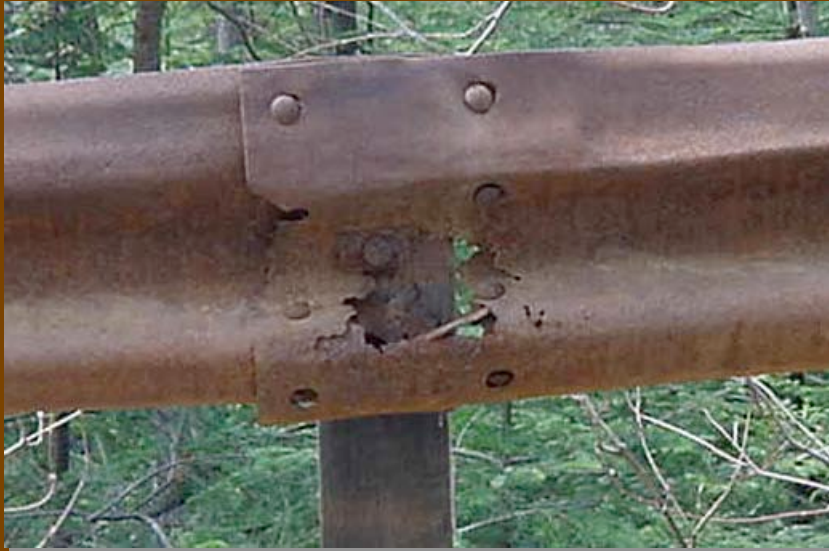
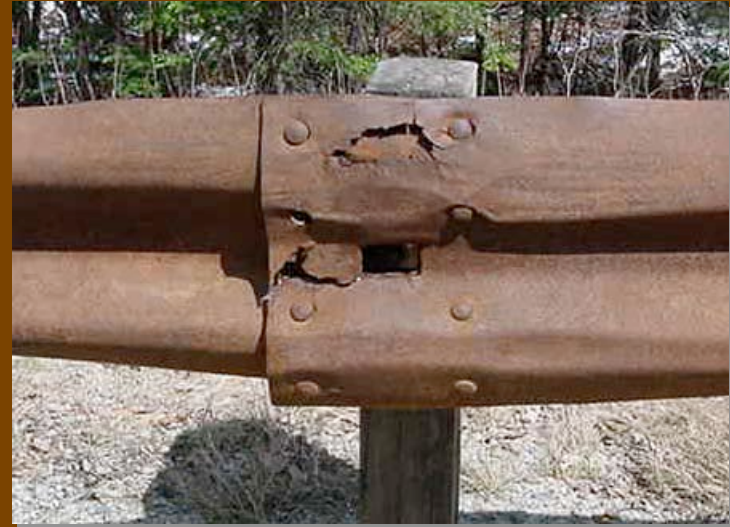
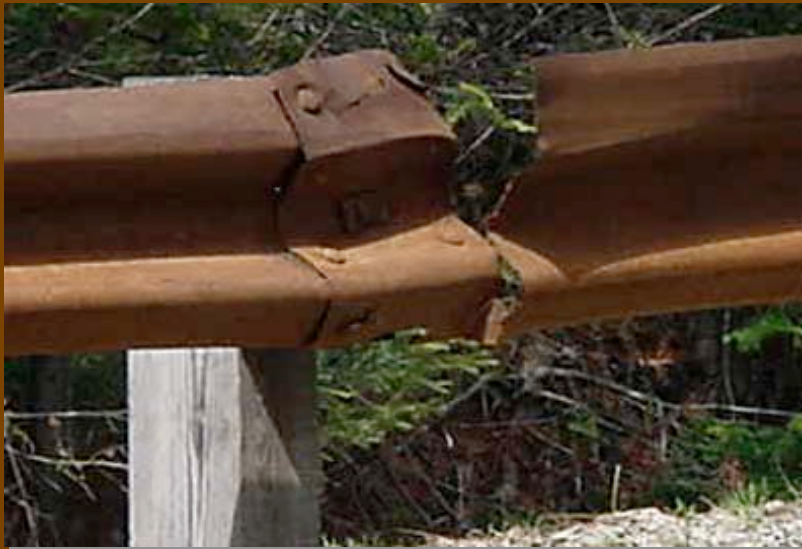
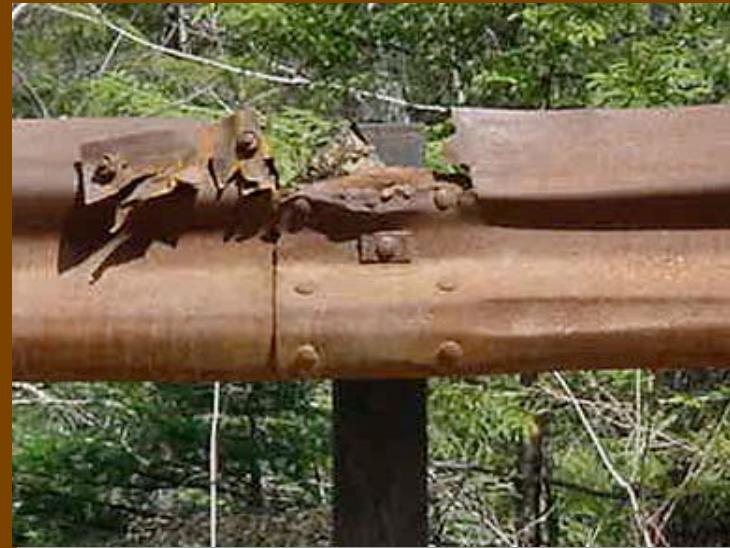
Recent Photos From Rte 112 – Lincoln

- Weathering Steel is not suited for use in corrosive environments
- In 1997 we had the support of the USFS to discontinue the use of Weathering Steel Guardrail
- Current condition of some rail is a inadequate

- **Discontinue use of Weathering Steel Guardrail**
- **If we are going to continue using Weathering Steel Guardrail...**
 - We should start using zinc inserts
 - Revisit mid-span locations to verify 10% or greater section loss is remaining constant
 - Continue to monitor long term performance of zinc
