85th NESMEA Conference
October 6, 2009
South Portland, Maine

Accelerated Concrete Pavement Rubblization and HMA Overlay

Joyce Taylor
MaineDOT

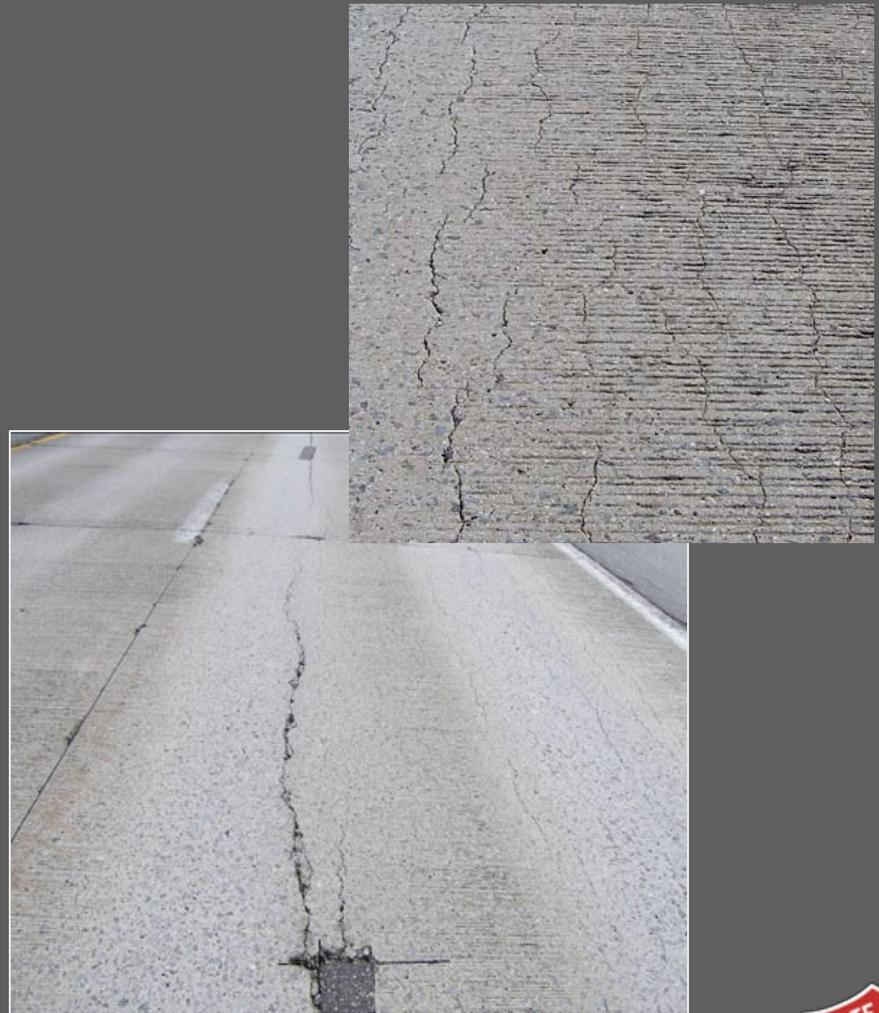
Existing Pavement

- Constructed in 1970's
 - 9" Jointed Plain Concrete Pavement
 - Individual slabs 12' wide, 20' long
 - Slabs placed over 29" of good quality gravel daylighted to inslope
- Visible signs of distress, blow-ups and structural issues associated with Alkali-Silica Reactivity
- Positive test results for ASR (done by UNH)

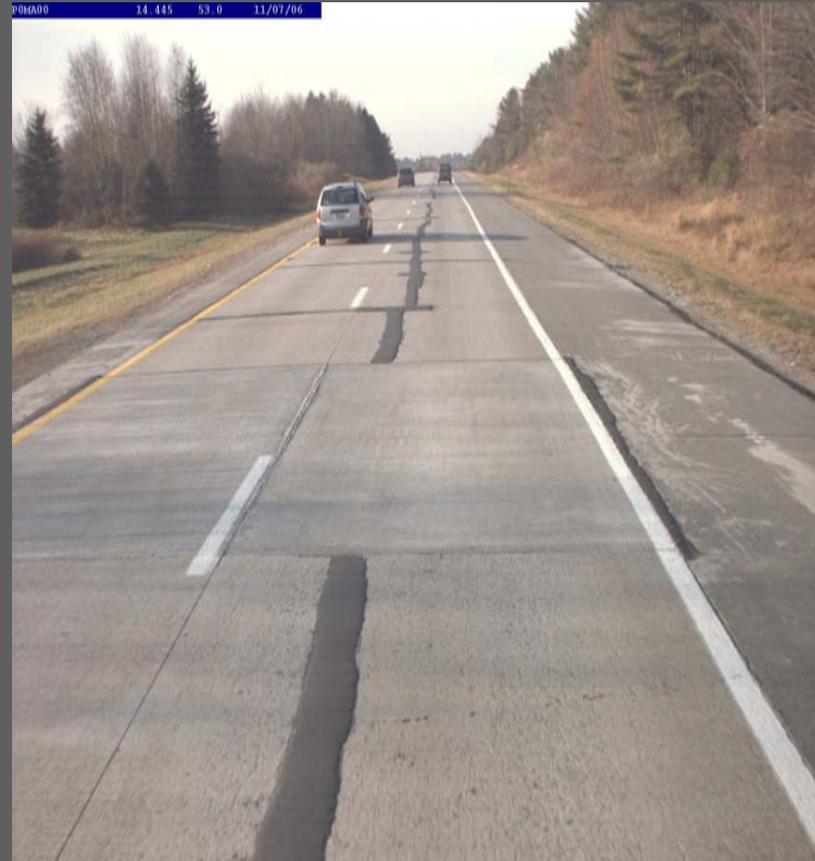
- Many repair methods were used to address the deteriorating conditions of the pavement:
 - Thin overlay (NovaChip)
 - Slab replacement
 - Expansion Joints
 - Joint seal
 - Patching
 - Partial Depth Crack Repair
- These repairs were done in preparation for a 4 " overlay

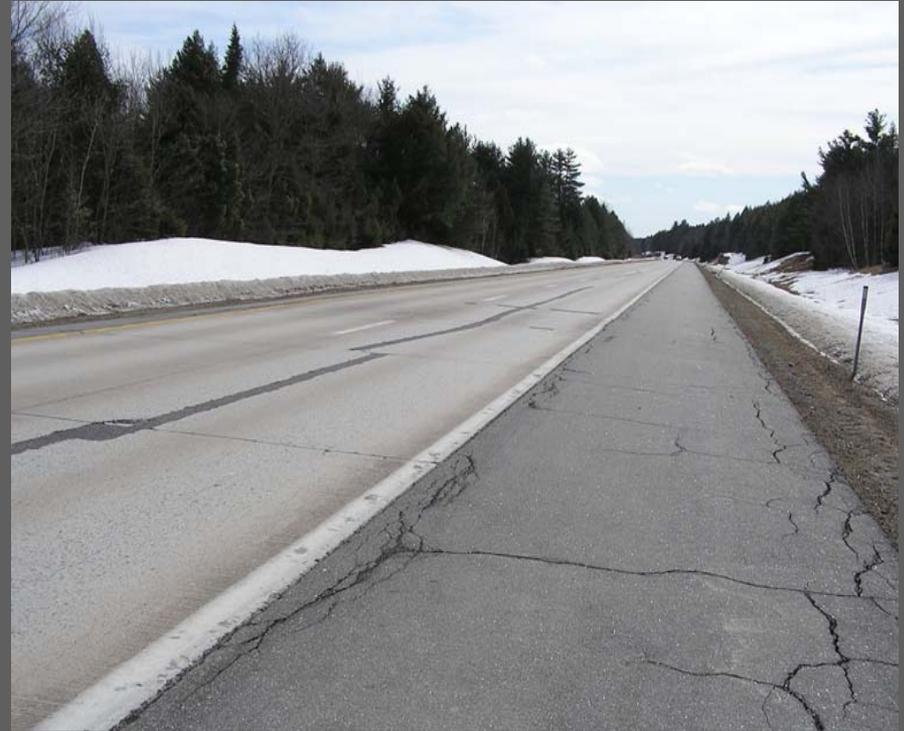
- Funds for rehabilitation became available in November 2007
- A multi-disciplined VE team was assigned to analyze alternatives and make recommendations

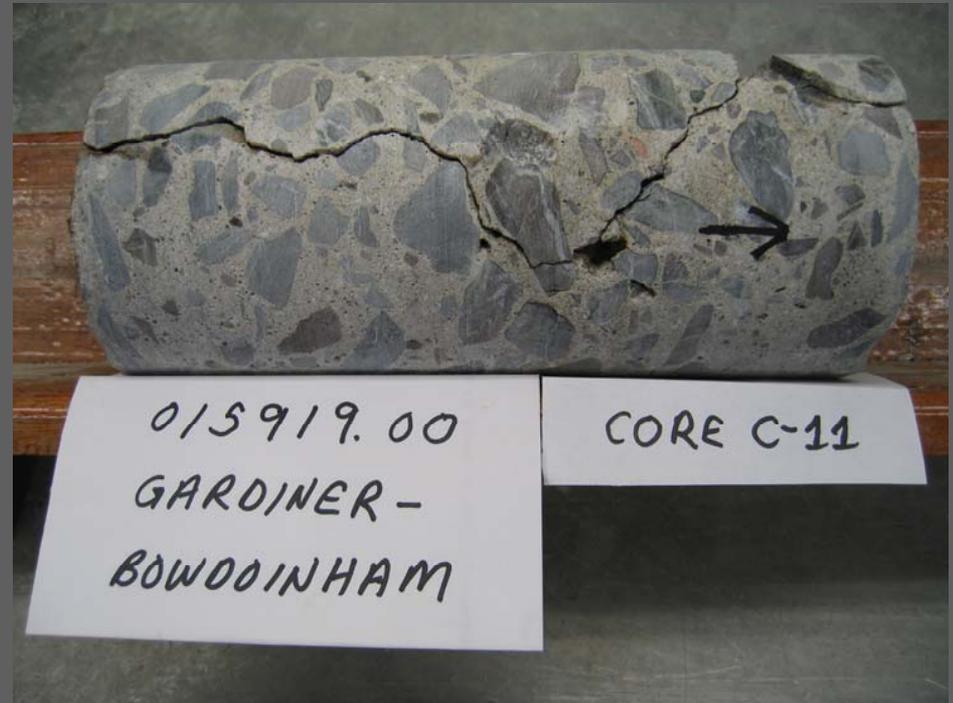
Repairs

- Cores cut on longitudinal cracks
- Found that the cracks seen on the surface went through the entire depth of the slab
- Broken slabs → structural failure

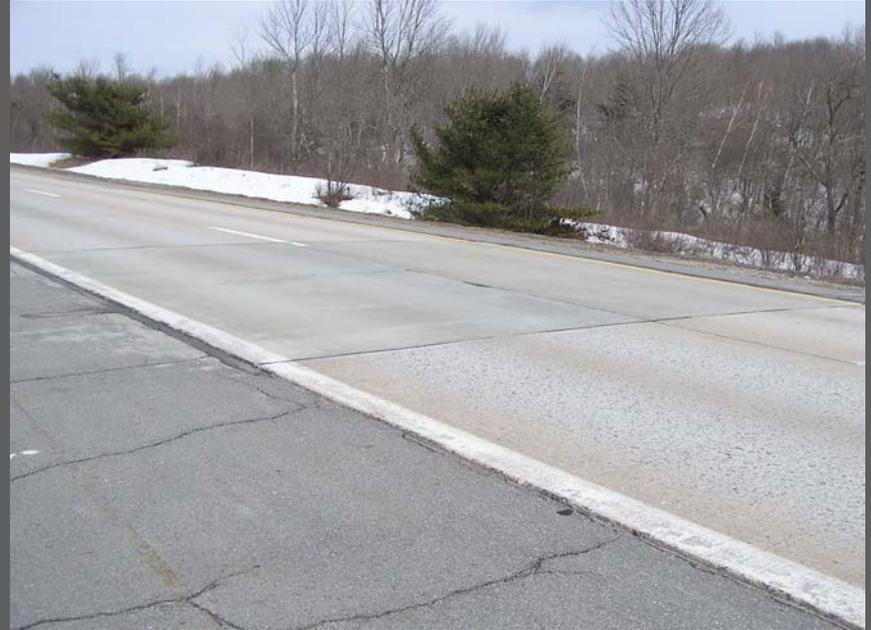
- Overlay was not a good option since 11,220 slabs would need to be replaced prior to overlay (\$\$\$)
 - Overlay also did not address ASR
 - Pavement functional/service life unknown

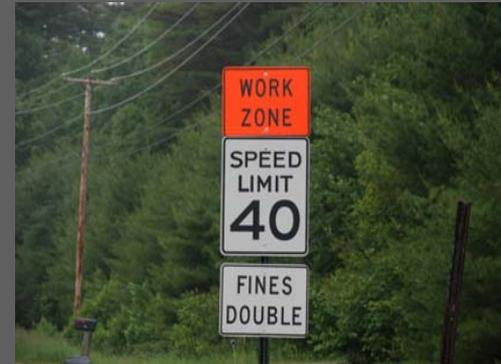
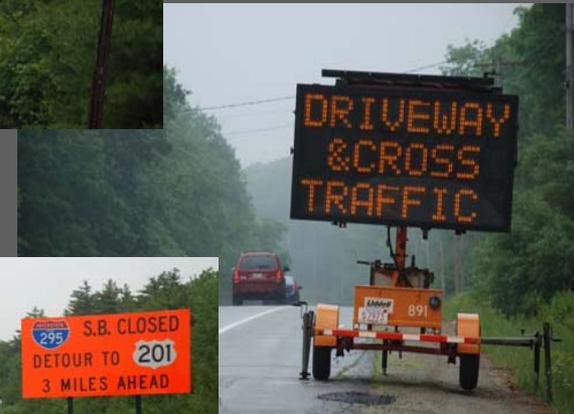
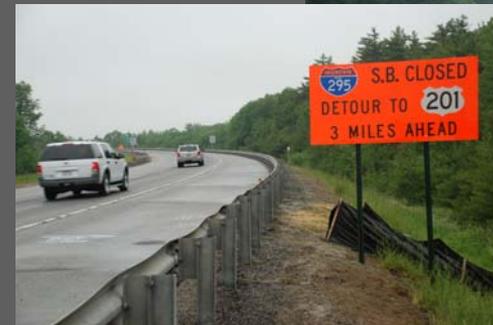
Route 201 Traffic Plan

- MaineDOT “patrol” will assist motorists with vehicle problems and report “hot spots”
- Make Route 201 look and feel like a work zone
 - Improvements made to Route 197 Intersection
 - Installing flashing lights at the intersections of Route 125 and at Route 138
 - Street lighting at major intersections
 - Work zone speed limits – fines doubled
 - Install radar speed signs
 - Temporary ramp constructed in Topsham

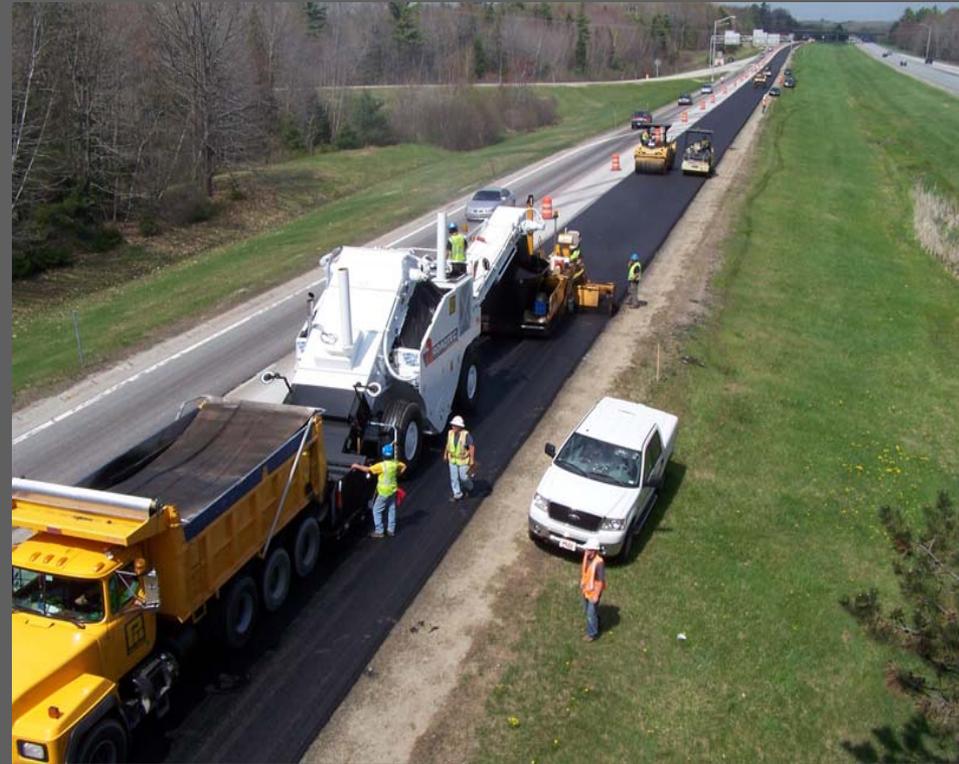
- Prior to full closure:
 - Overlay of section between Brunswick and Topsham
 - Rehabilitated 2 bridges
 - Construct a temporary on-ramp
 - Completion deadline - June 15, 2008

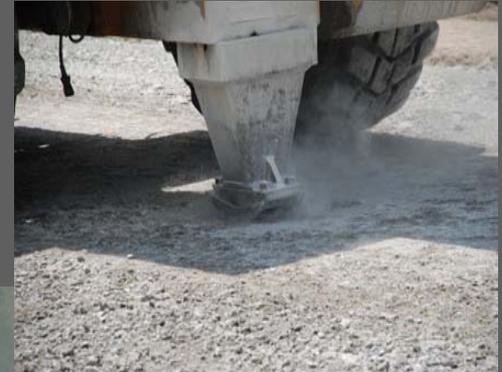
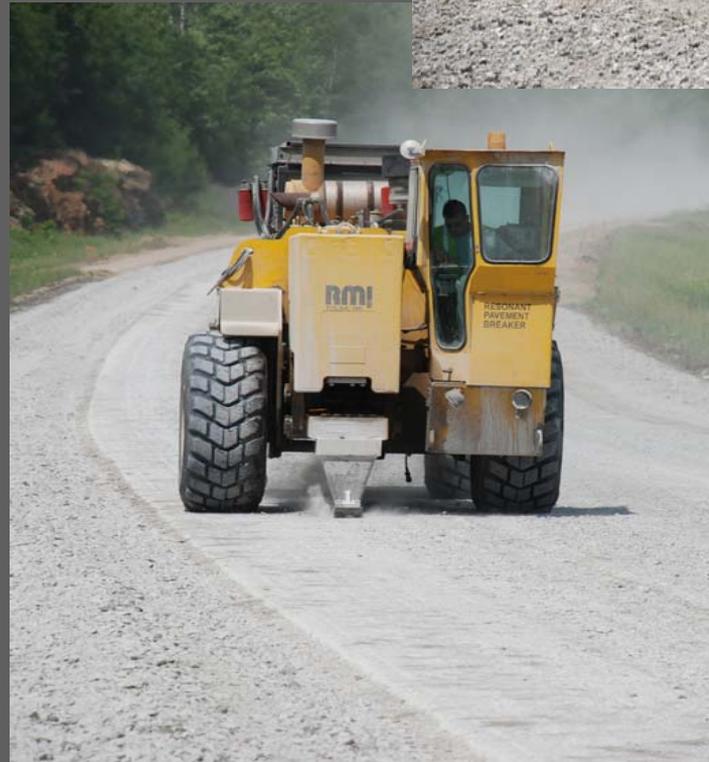
Construction - Rubblization

- Resonant Breaker Rubblizer specified
 - Specification included criteria for
 - Particle size
 - 6" minus for bottom layer
 - 2" minus at surface
 - Grading
 - Compaction
 - Surface tolerance
 - Steel – must be debonded, exposed removed
 - Crack sealant removal
 - Patch removal

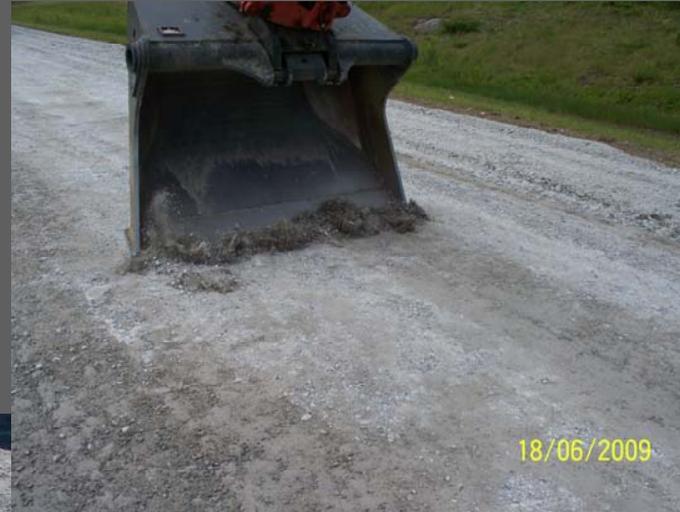
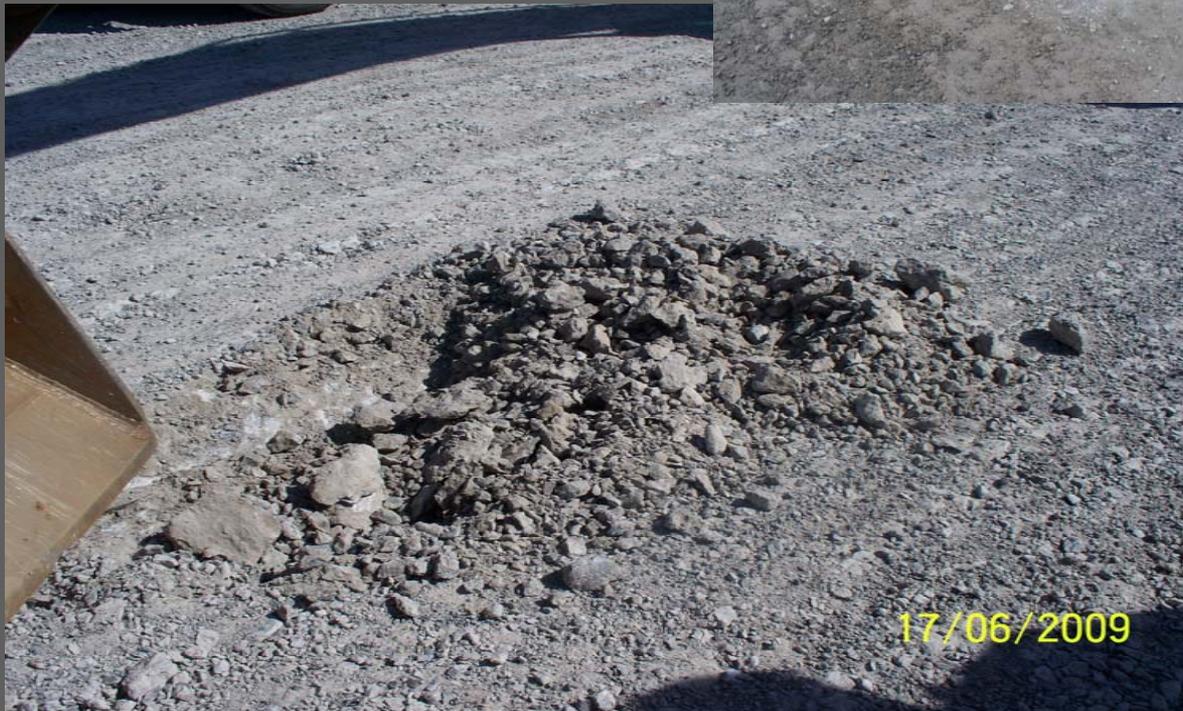
Construction - Rubblization

■ Test pits

- Gradation check
- De-bonding check
- Every 2500' per lane

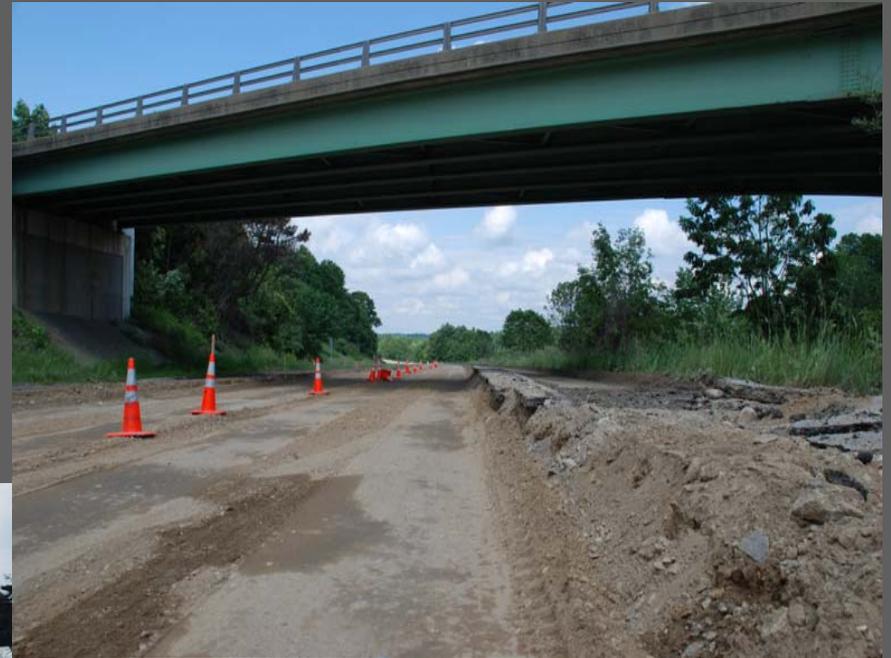
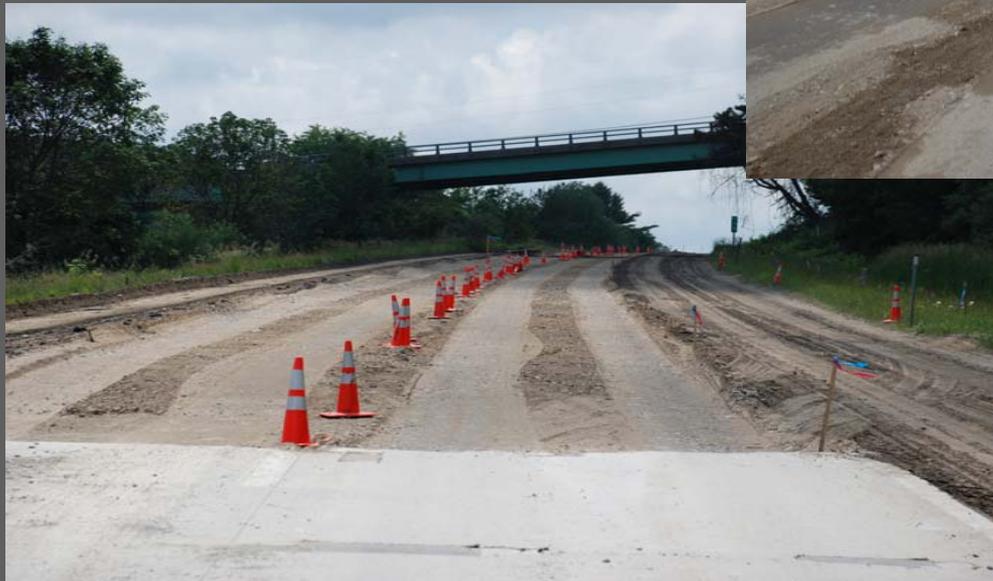
Construction - Slab Removal

- Some slabs were removed because of:
 - Pavement deterioration
 - Clearance requirements under overpasses
 - Used 9" HMA in these areas

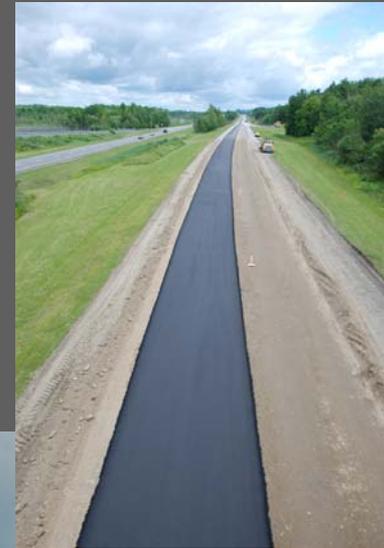
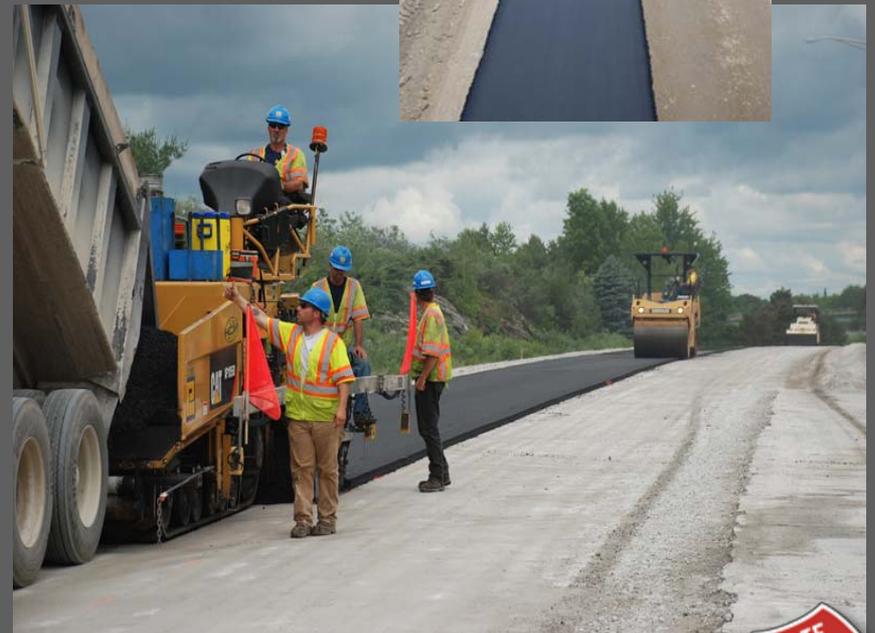
Construction – HMA –Asphalt Rich Base

- Used to reduce reflective cracking potential from stiff rubblized concrete
 - 19.0 mm mix
 - 2 ½ " thick
 - PGAB 64-28
 - PGAB target - 5.5%
 - Air Void target - 2.5%
 - 50 gyrations

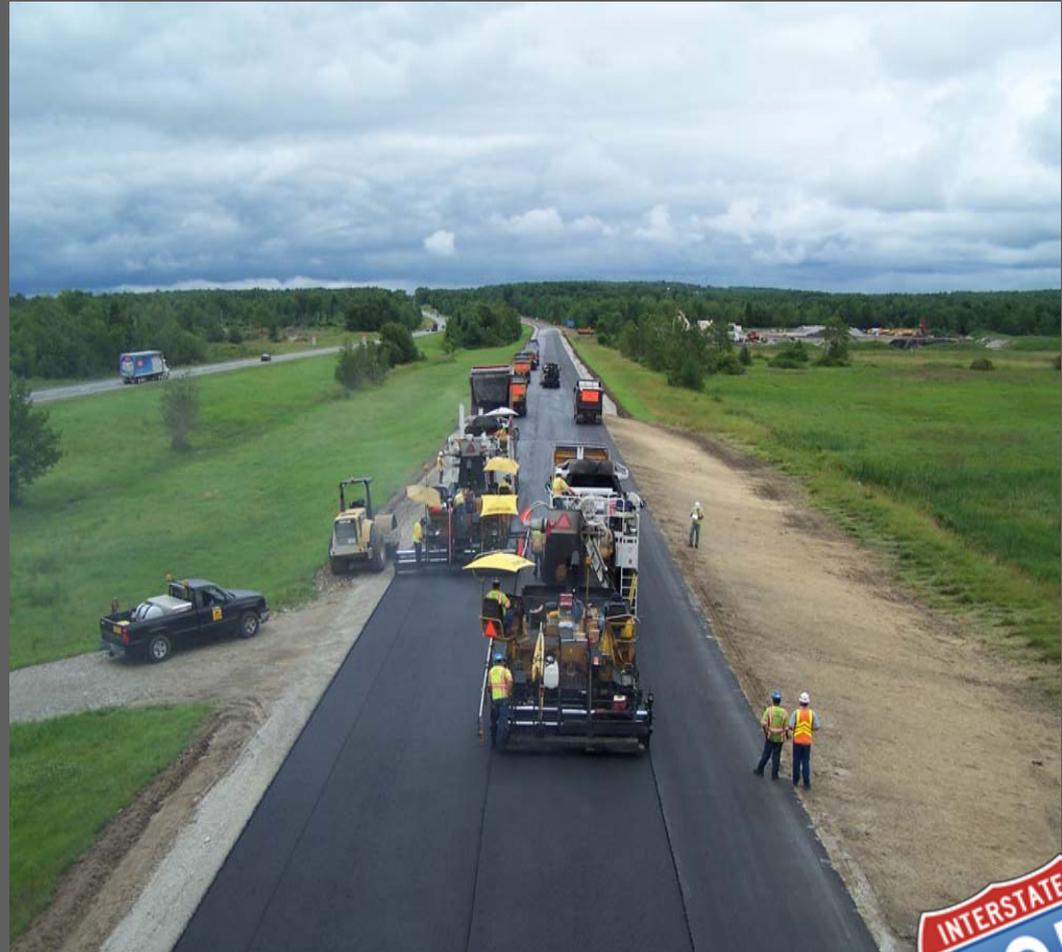
Construction – HMA Base Course

- 19.0 mm mix
- 2 ½ " thick
- PGAB 64-28
- 75 gyrations

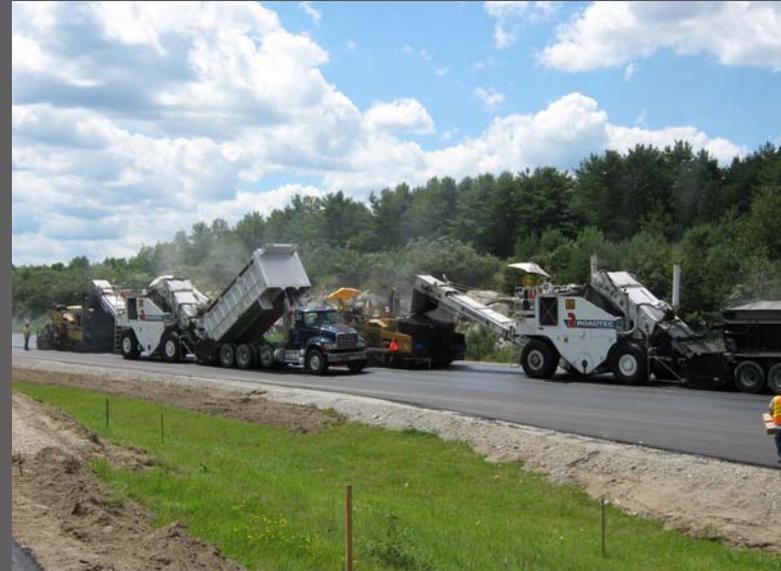
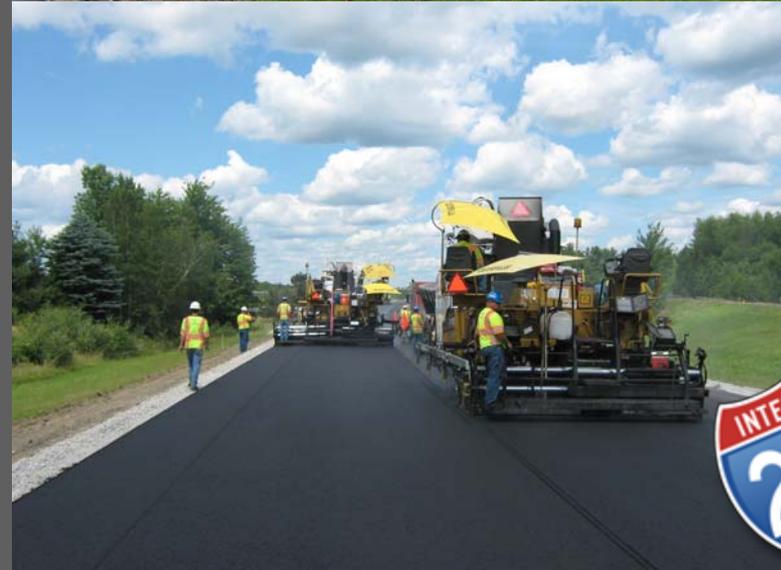
Construction - HMA Surface and Intermediate Course

- Polymer Modified
 - 1 ½ " lift - surface
 - 1 ½ " lift - intermediate
 - 12.5 mm mix
 - PGAB 70-28
 - 75 gyrations
- RAP not permitted in mix
- Material transfer vehicle specified

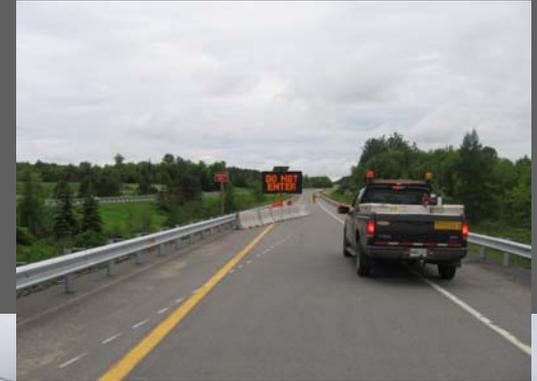
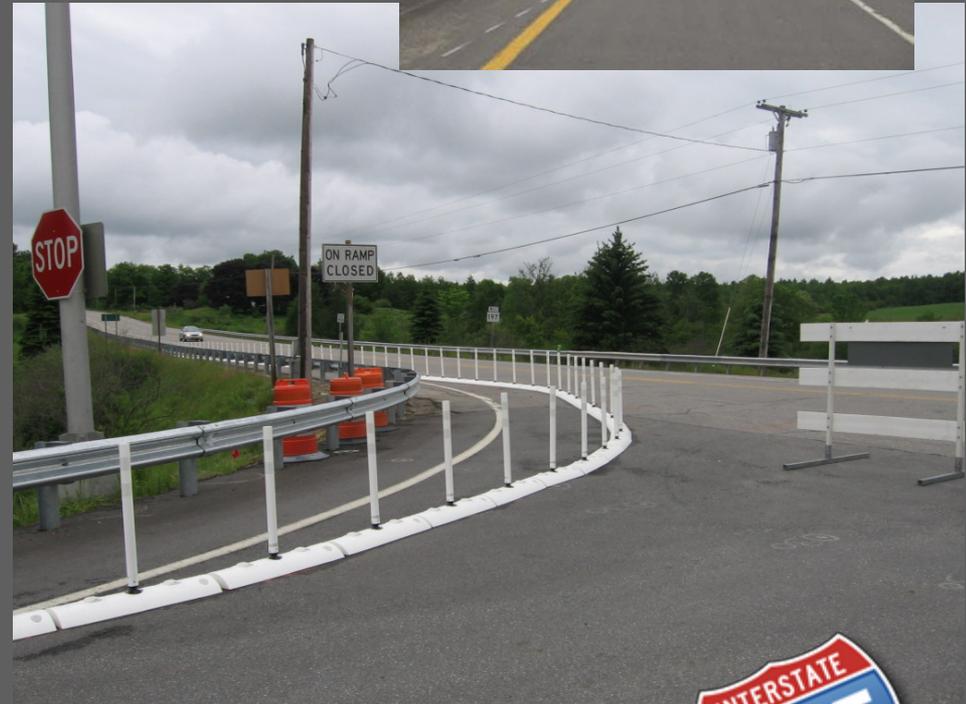
- Prior to full closure:
 - Overlay of section between Brunswick and Topsham
 - 2 bridges rehabs
 - Construct 2 temporary crossovers
 - Modifications to 2 ramps
 - Completion deadline - June 15, 2008

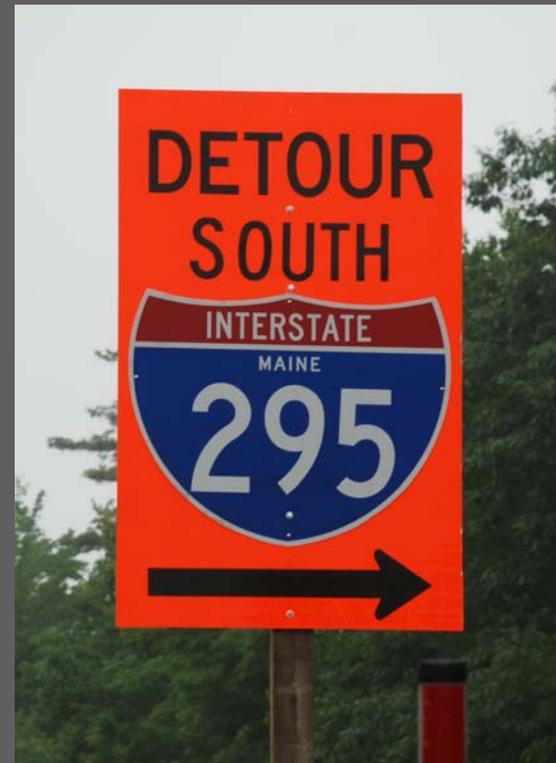
- Full Closure – began June 16, 2009
- 17 mile section between Topsham and Gardiner
- Scope includes:
 - Milling
 - Slab removal (under overpasses)
 - Rubblization
 - HMA paving
 - Fill a “Richmond settlement” area
 - In-slope work
 - 5 bridge deck rehabs
 - Guardrail installation
 - Rumble strips
 - Striping

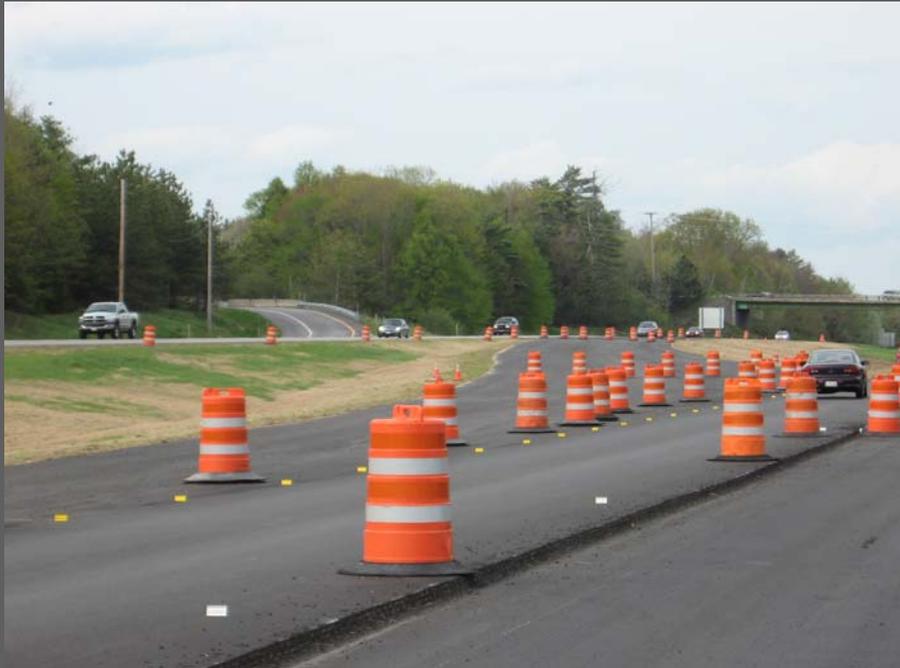
Topsham

Construction - Crossovers

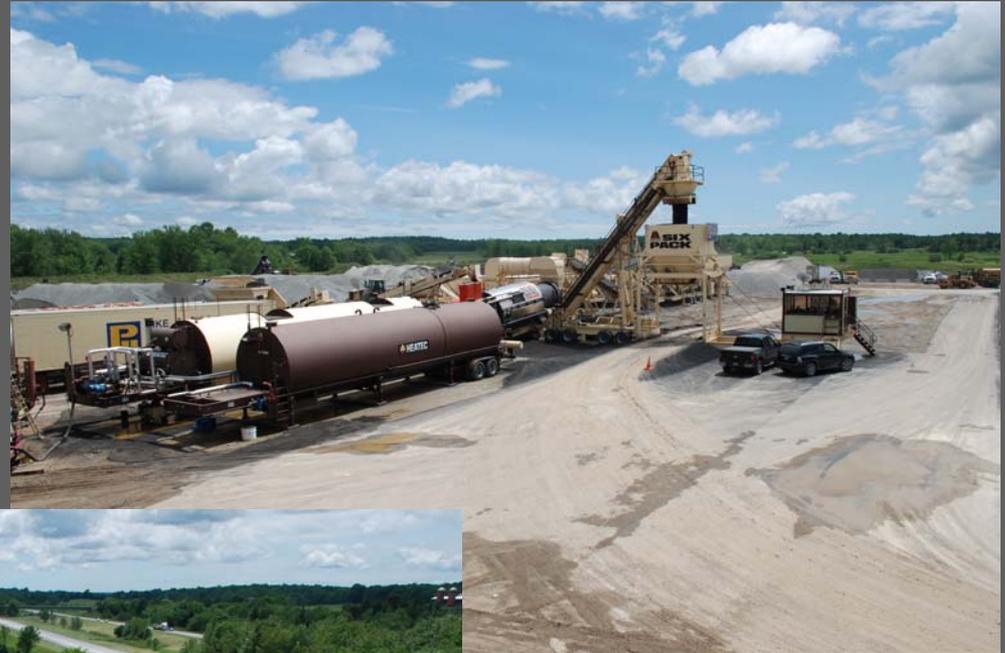
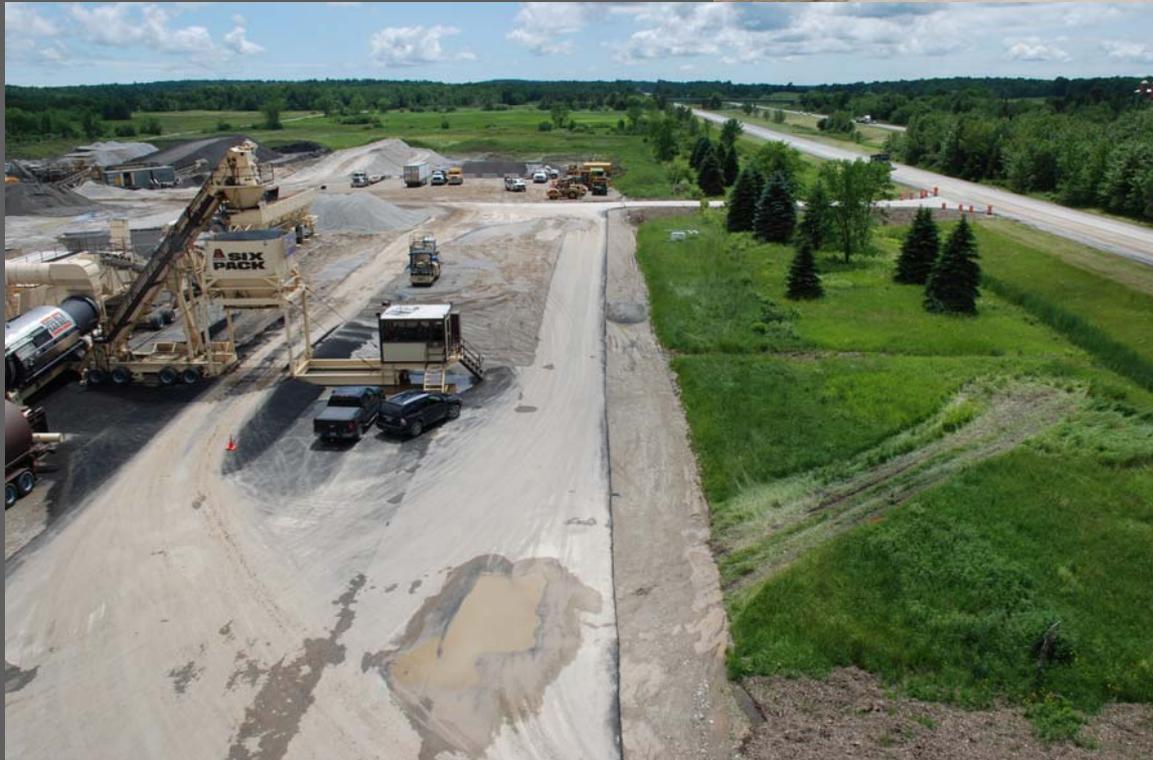
Construction

- Portable Plant
 - Significantly reduced hauling

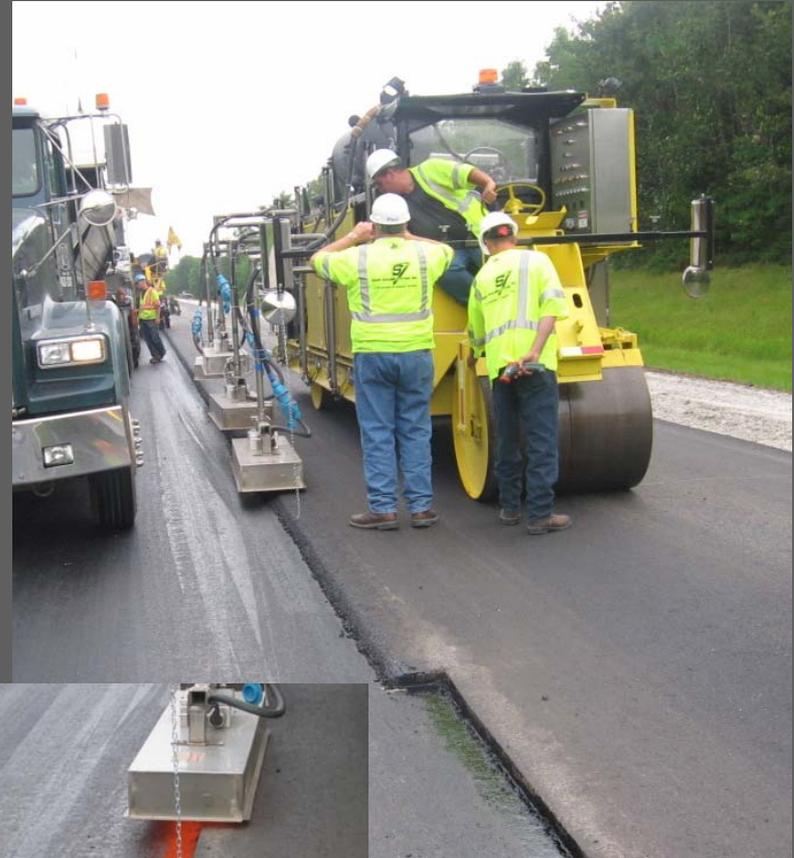
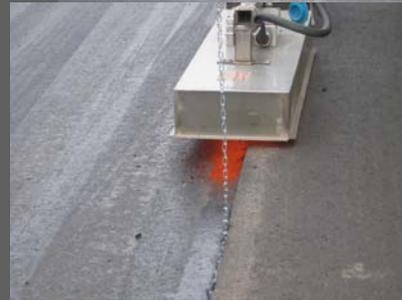
Construction - Longitudinal Joint

- Asphalt rubber joint sealer specified to adhere adjoining HMA materials together
- Used in the 12.5 mm polymer modified intermediate and surface course if not paved in echelon
- Infrared technology used to heat previously placed HMA prior to placement of adjoining HMA
