Aggregates Containing Pyrrhotite

James Mahoney

Connecticut Transportation Institute

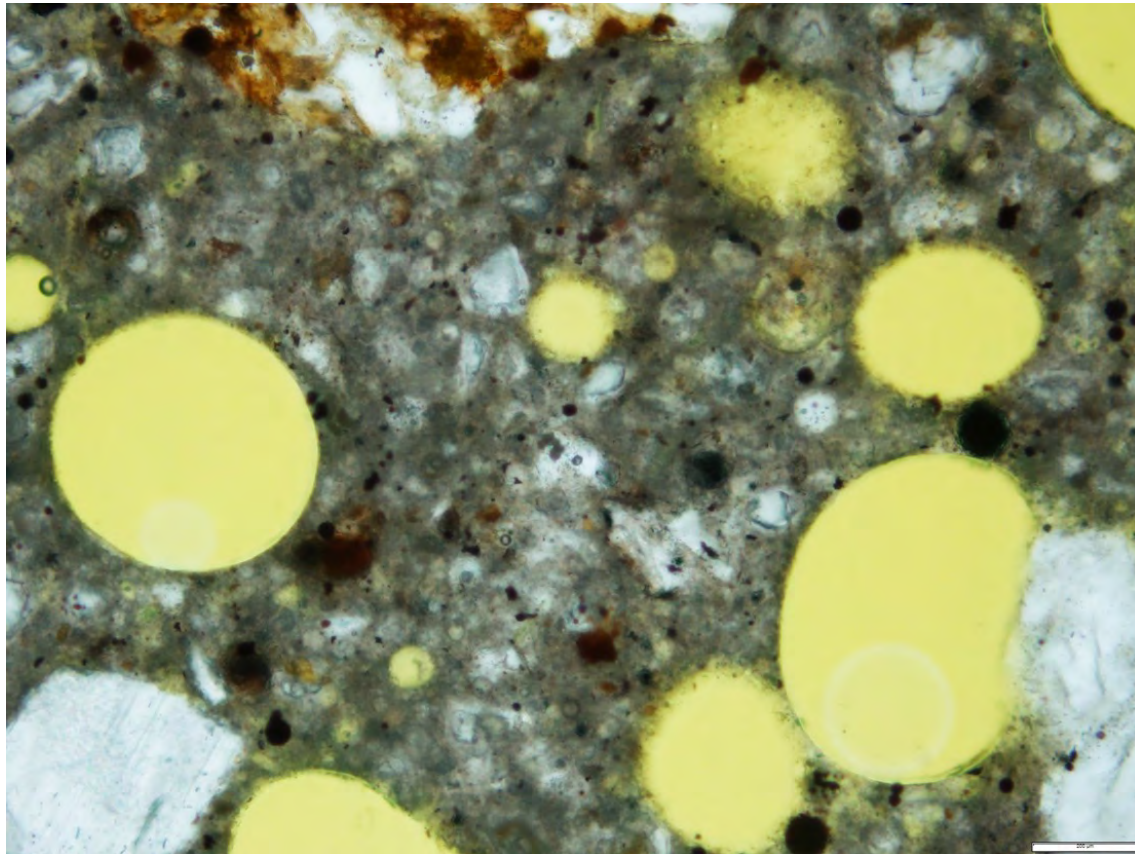
Concrete Without Ettringite Deposits or Cracking

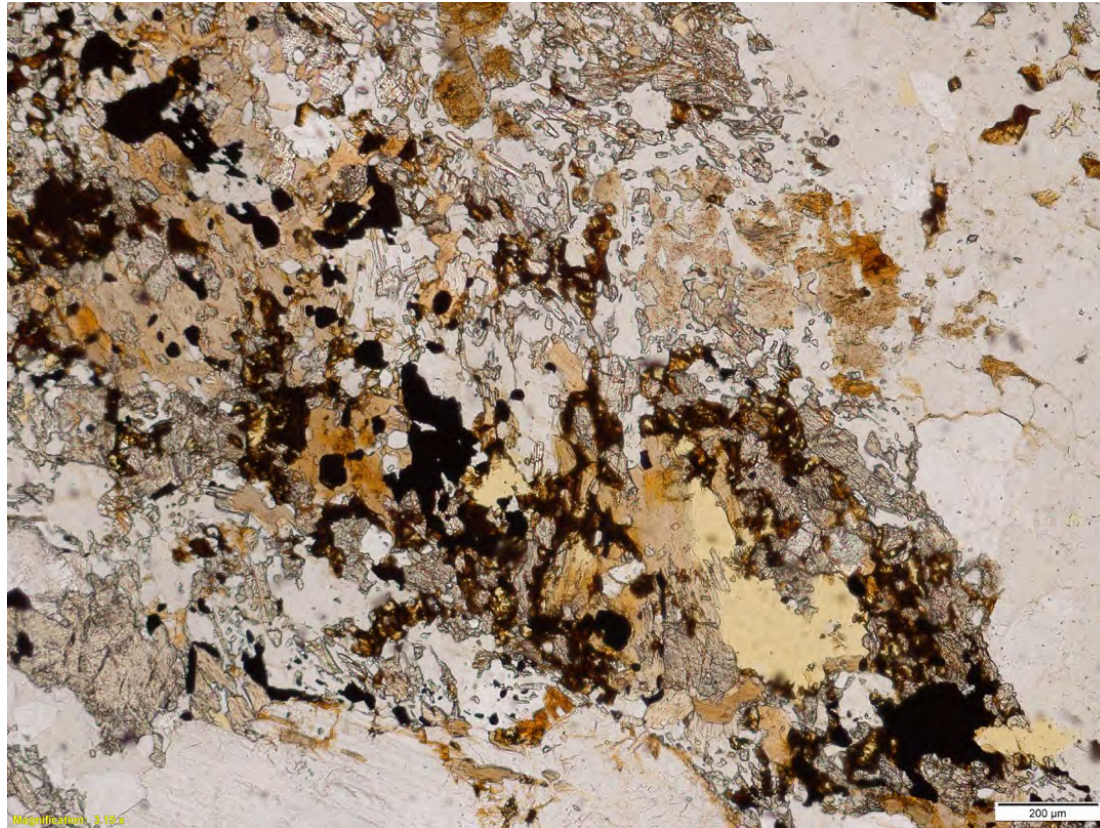
Microscopic View of Pyrrhotite in Concrete

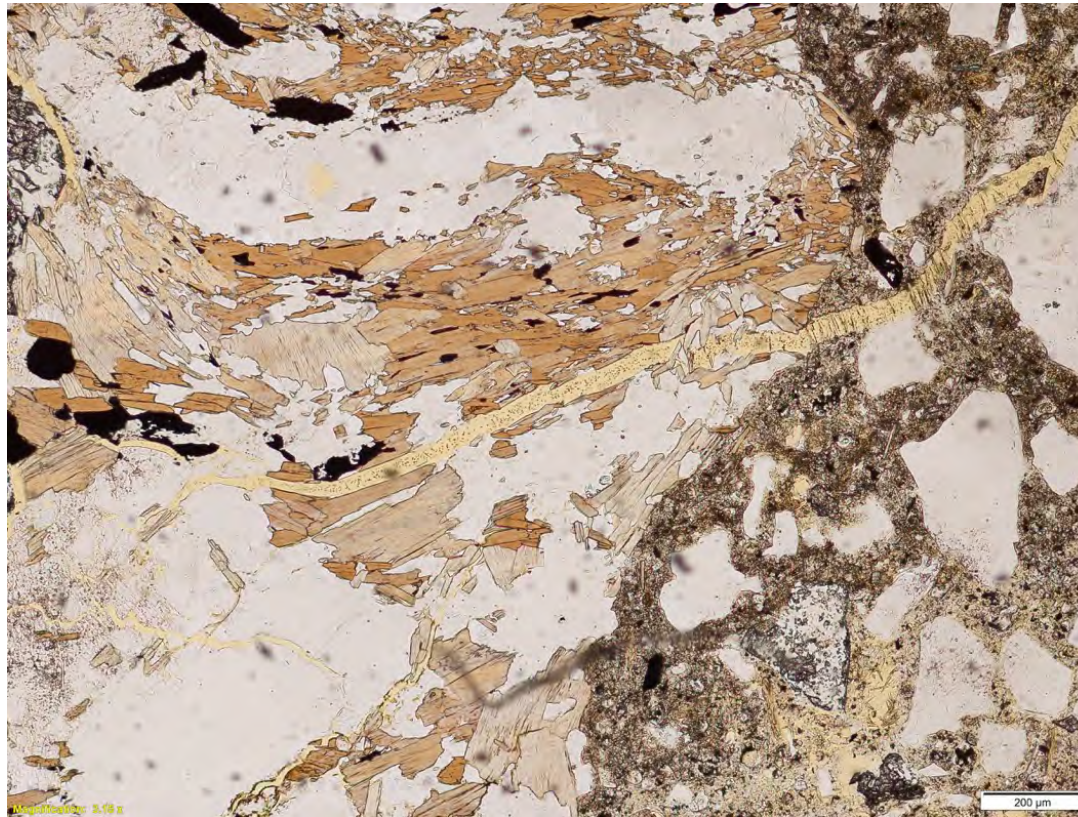
Microscopic Damage from Pyrrhotite in Concrete

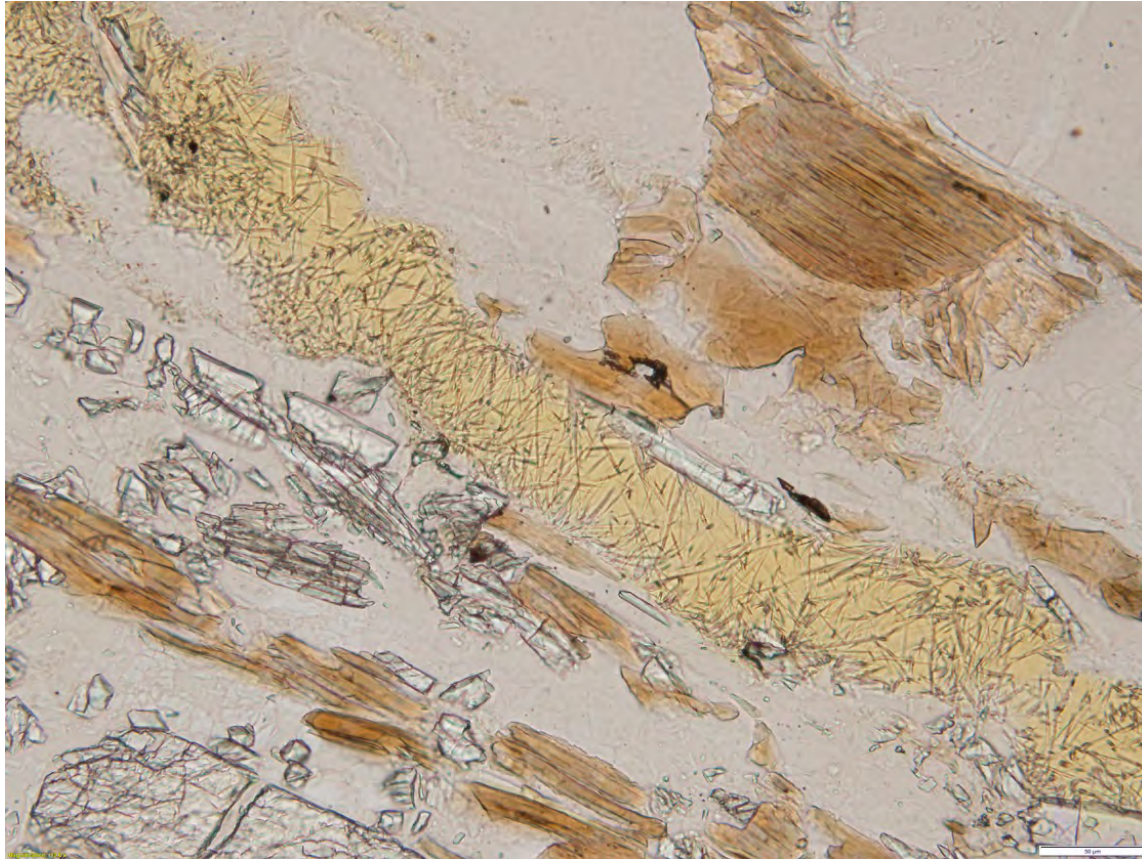
Ettringite in Cracks

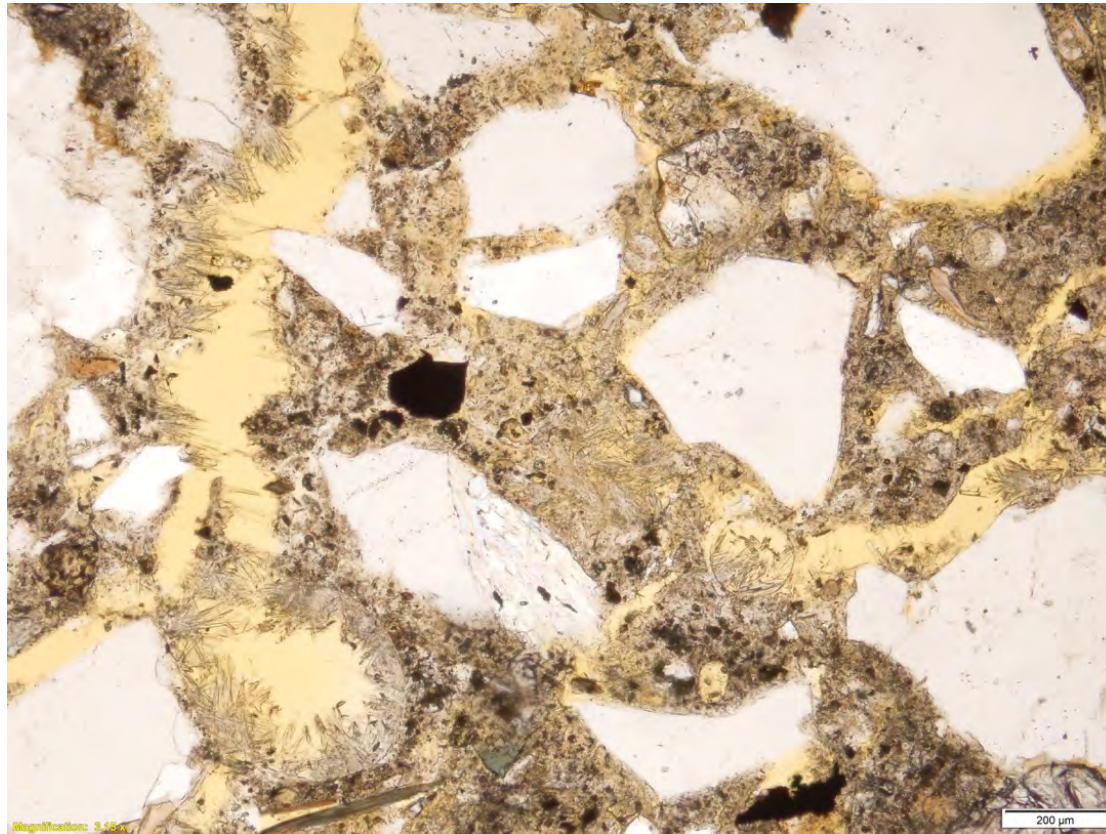
Ettringite Formation in Concrete Void Space Caused By Pyrrhotite Oxidation

- When iron sulfides oxidize it produces iron oxides and sulfuric acid
- Iron oxides occupy more space than original molecules
- Sulfuric acid attacks the concrete paste weakening it and it forms secondary expansive minerals such as ettringite
- Bottom line: the concrete is weakened with internal stresses growing from the swelling materials in the concrete

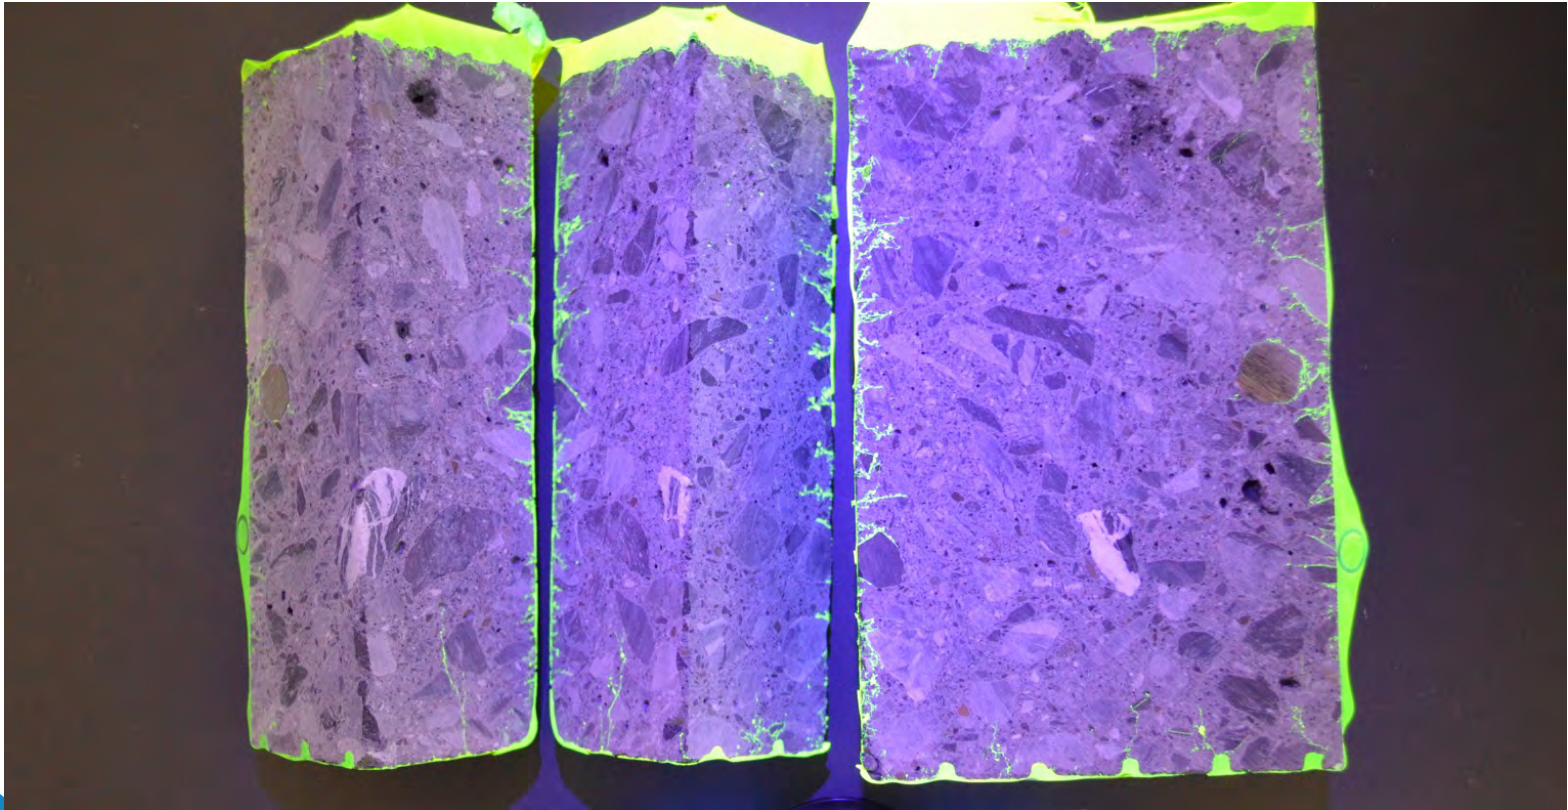
Concrete Core without Pyrrhotite

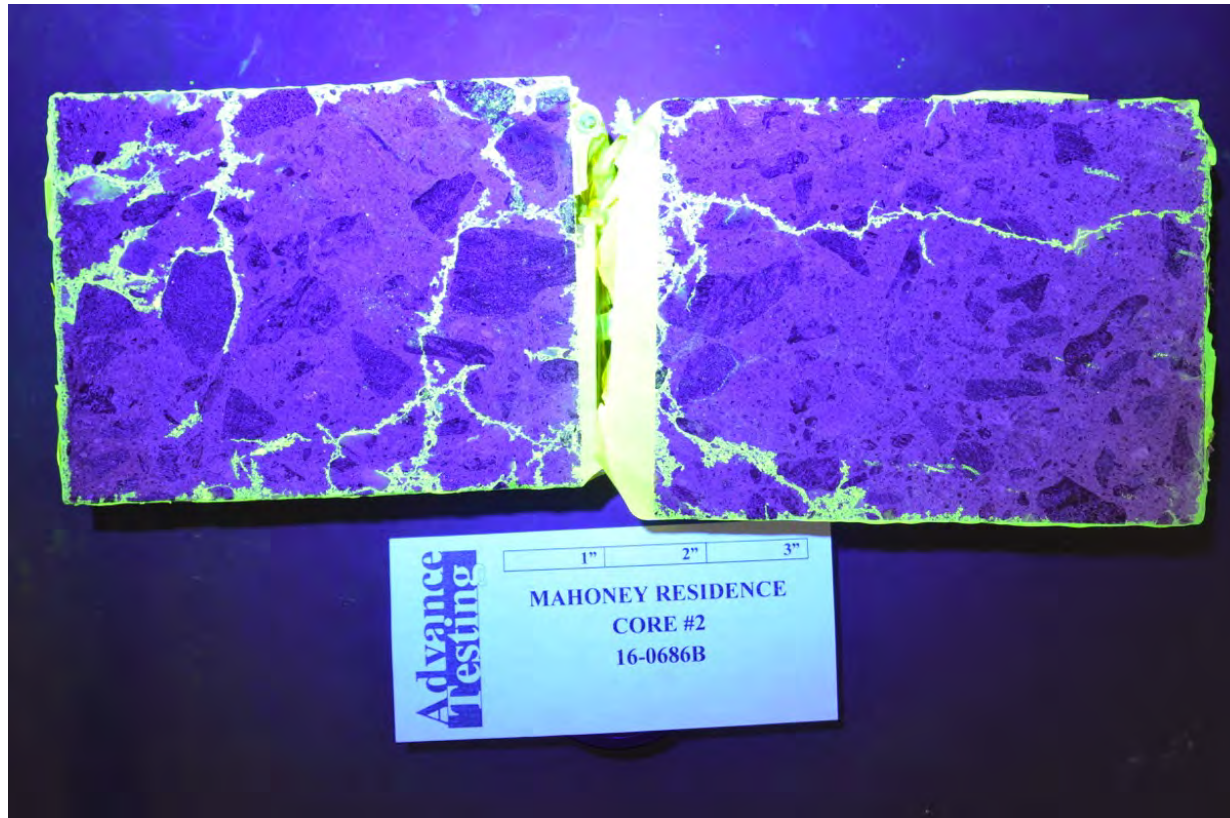
Pyrrhotite in Impacts on Concrete

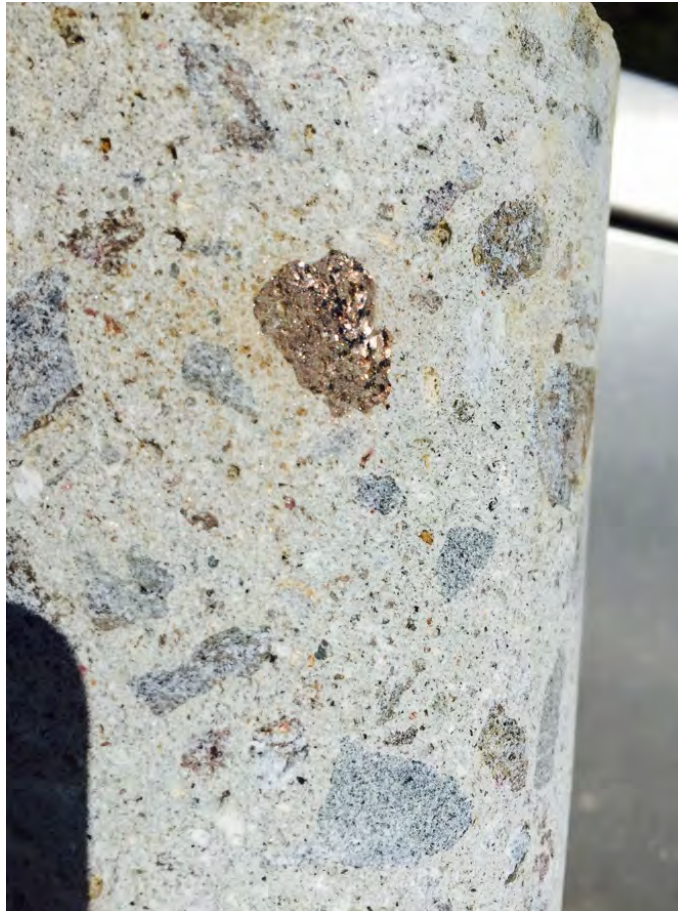
Core With Large Piece of Pyrrhotite

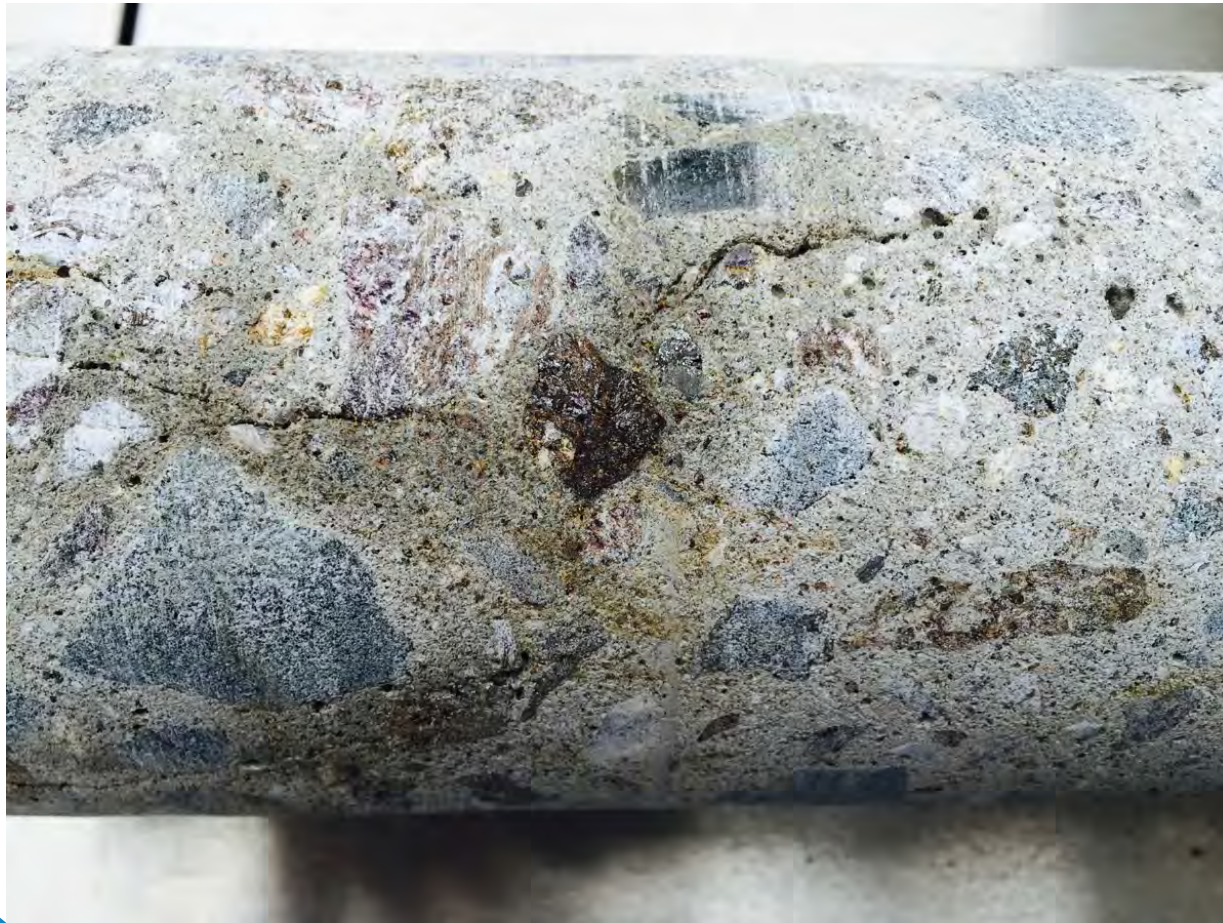
Core with Visible Cracking From Aggregate Particle

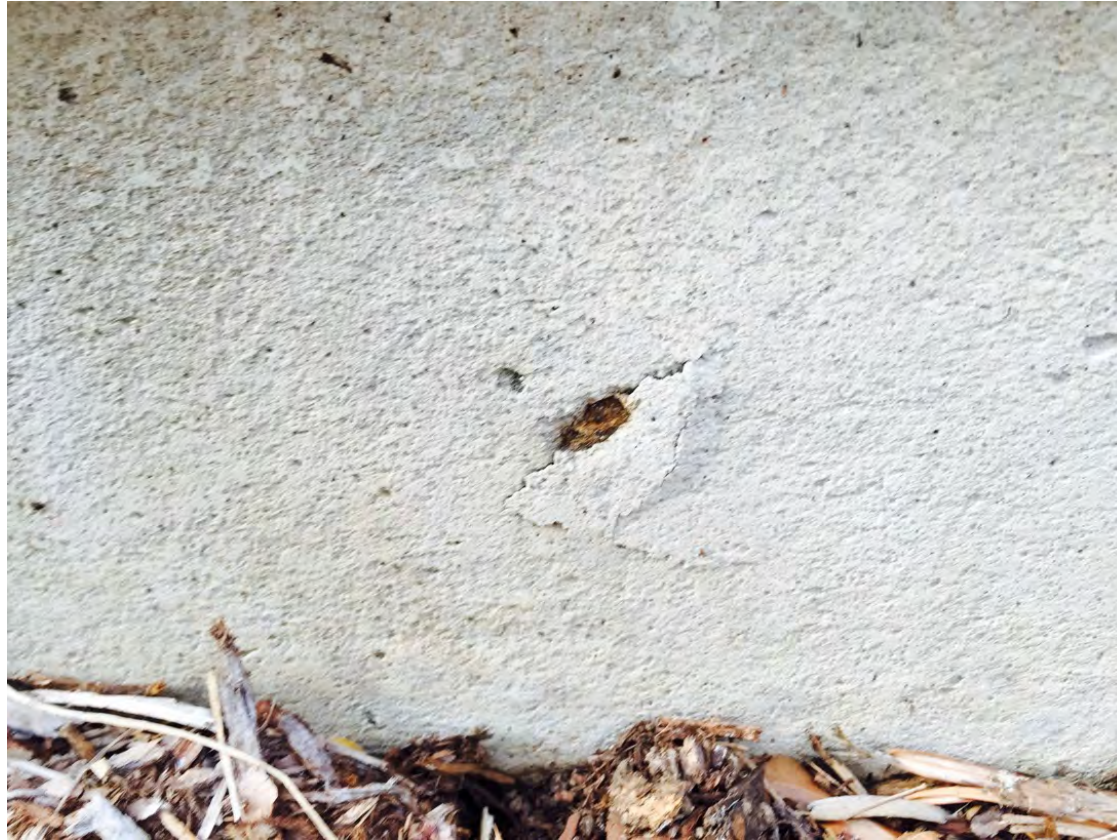
Aggregate Rusting and Popping Out of Concrete

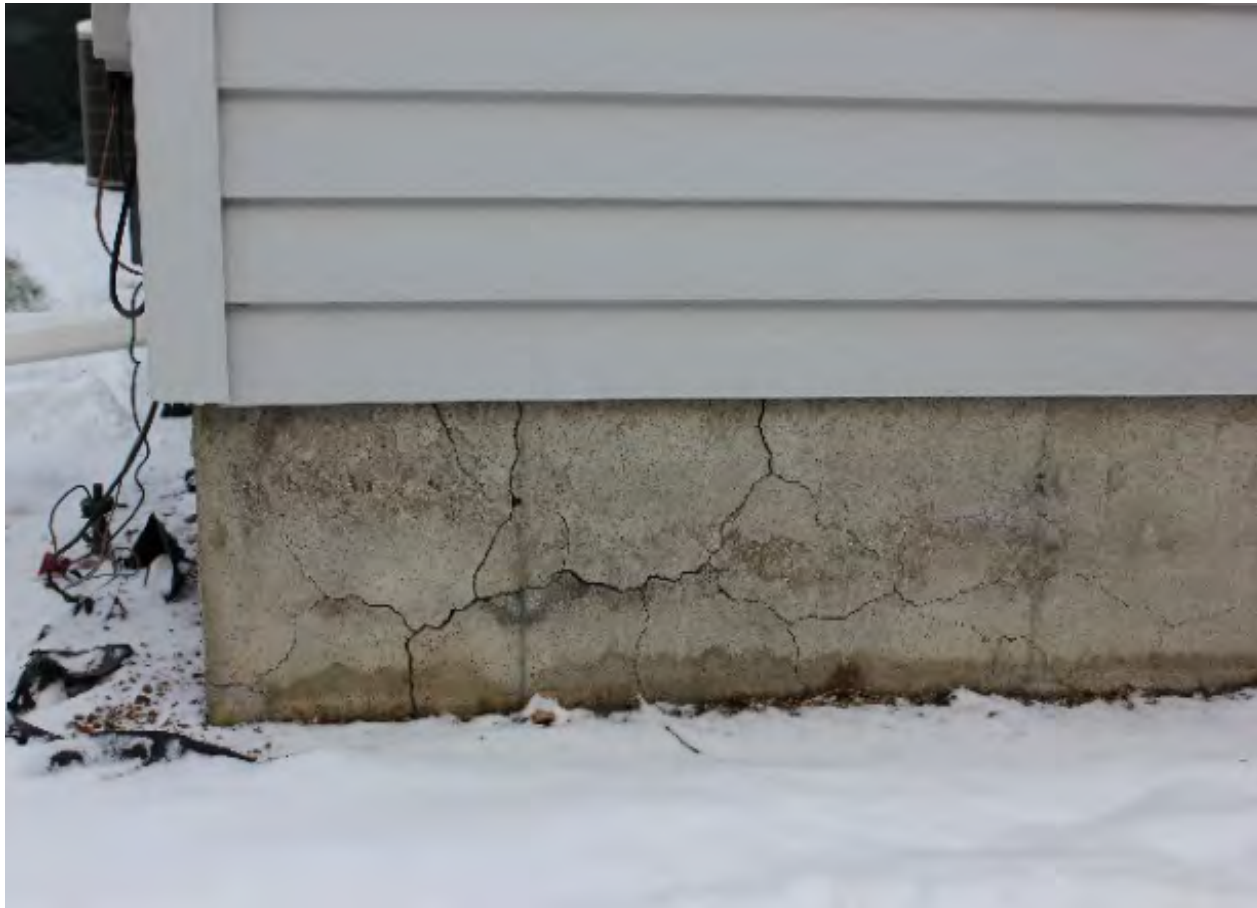
Damage to Concrete Foundations

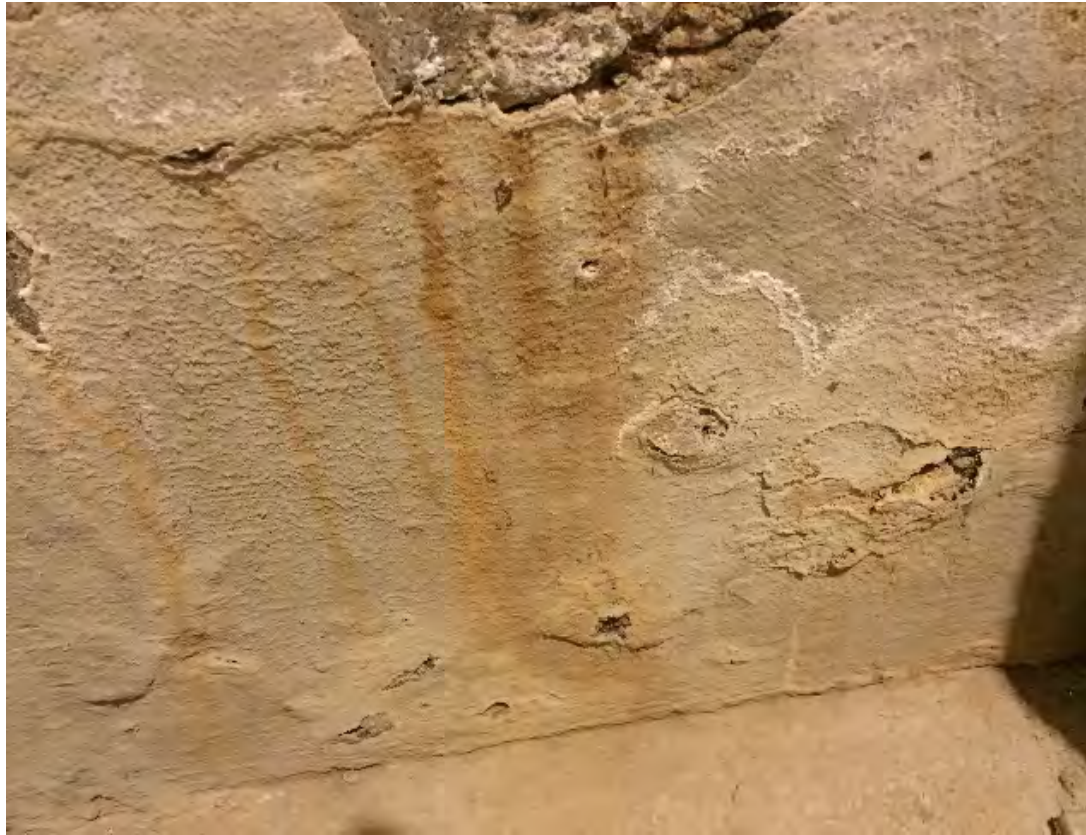
Concrete Foundation Damage

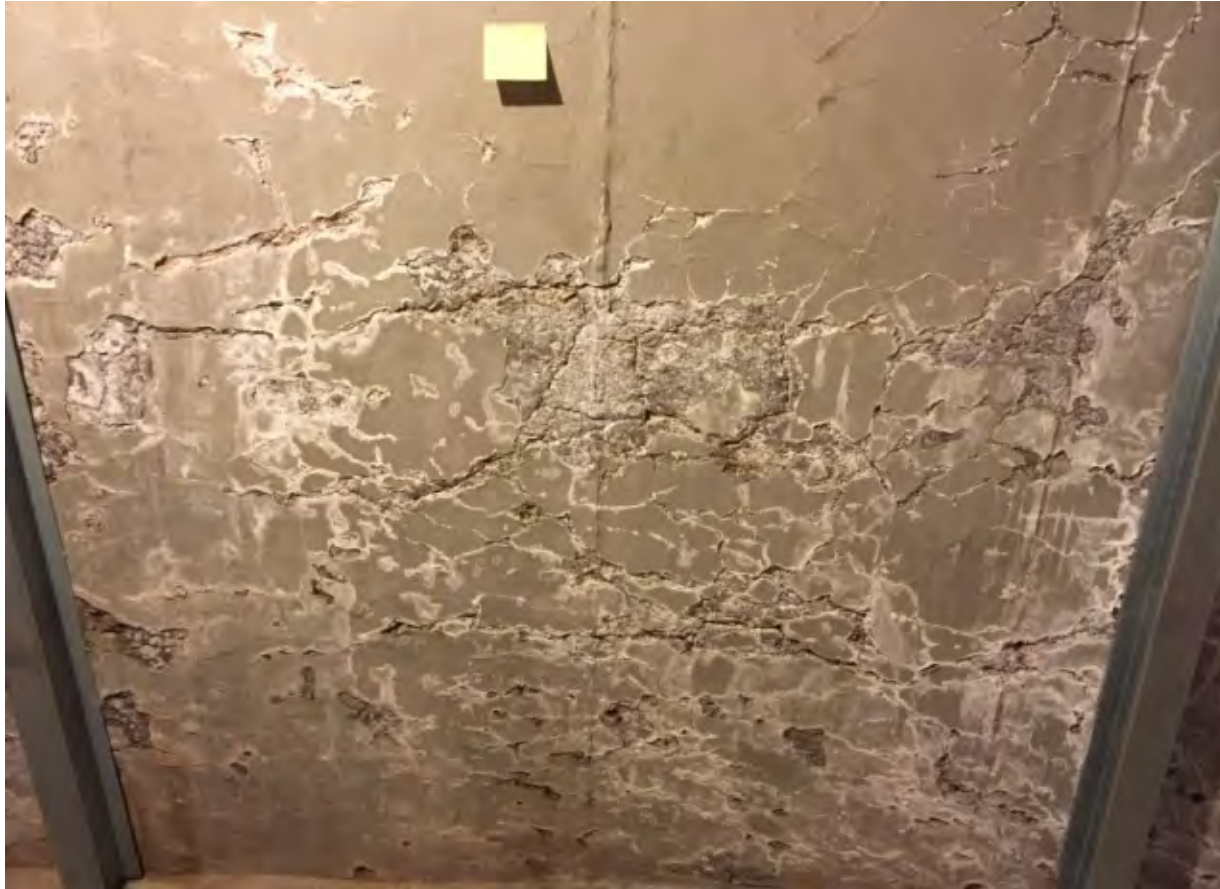
Concrete Damage

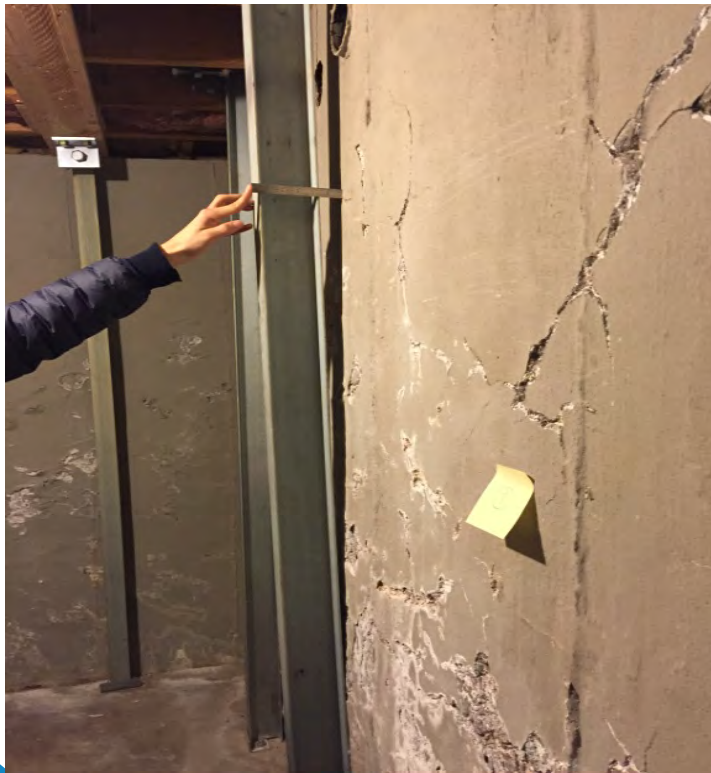
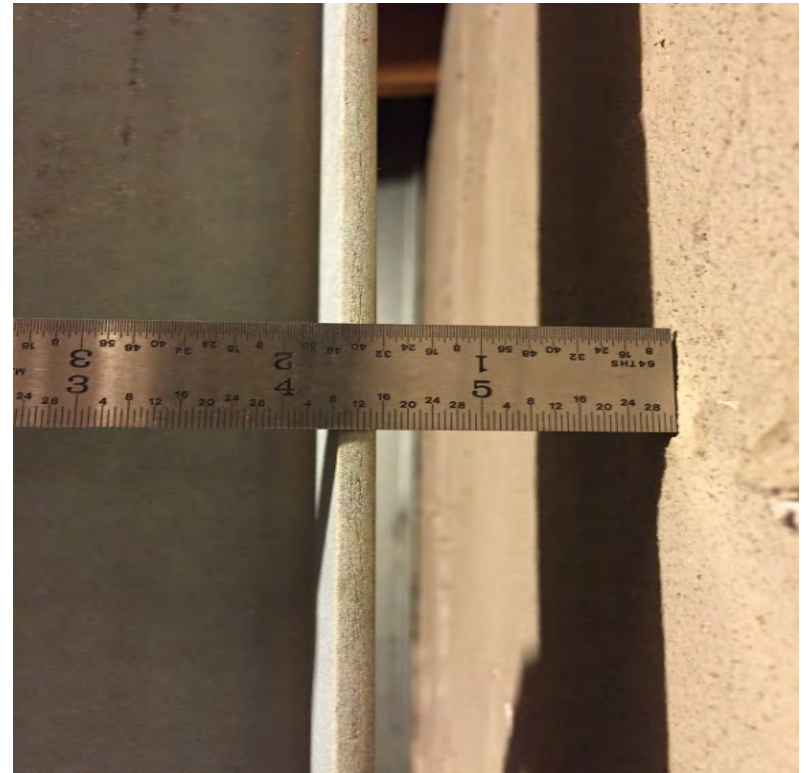
Concrete Damage

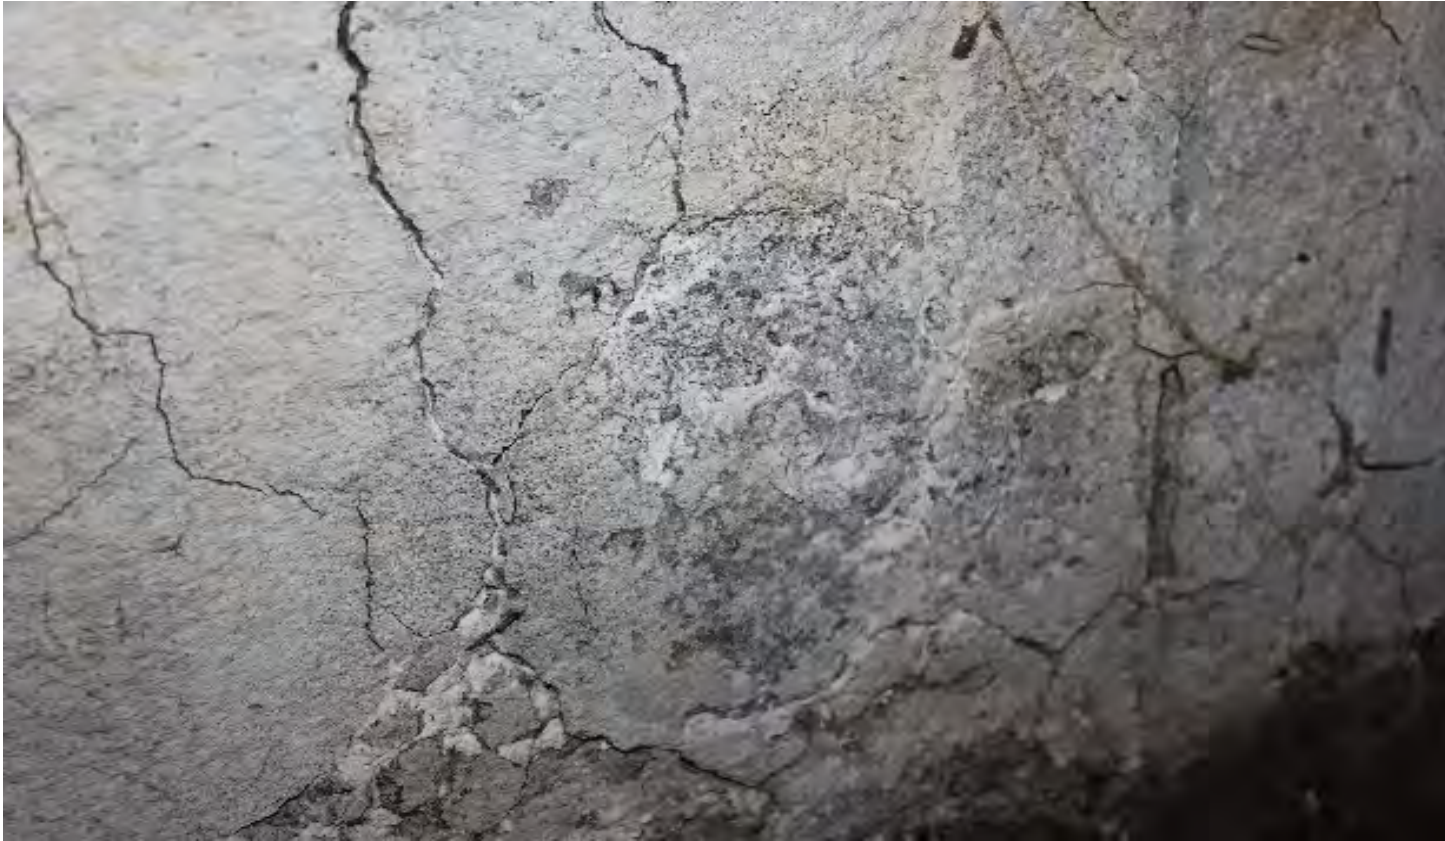
Concrete Damage

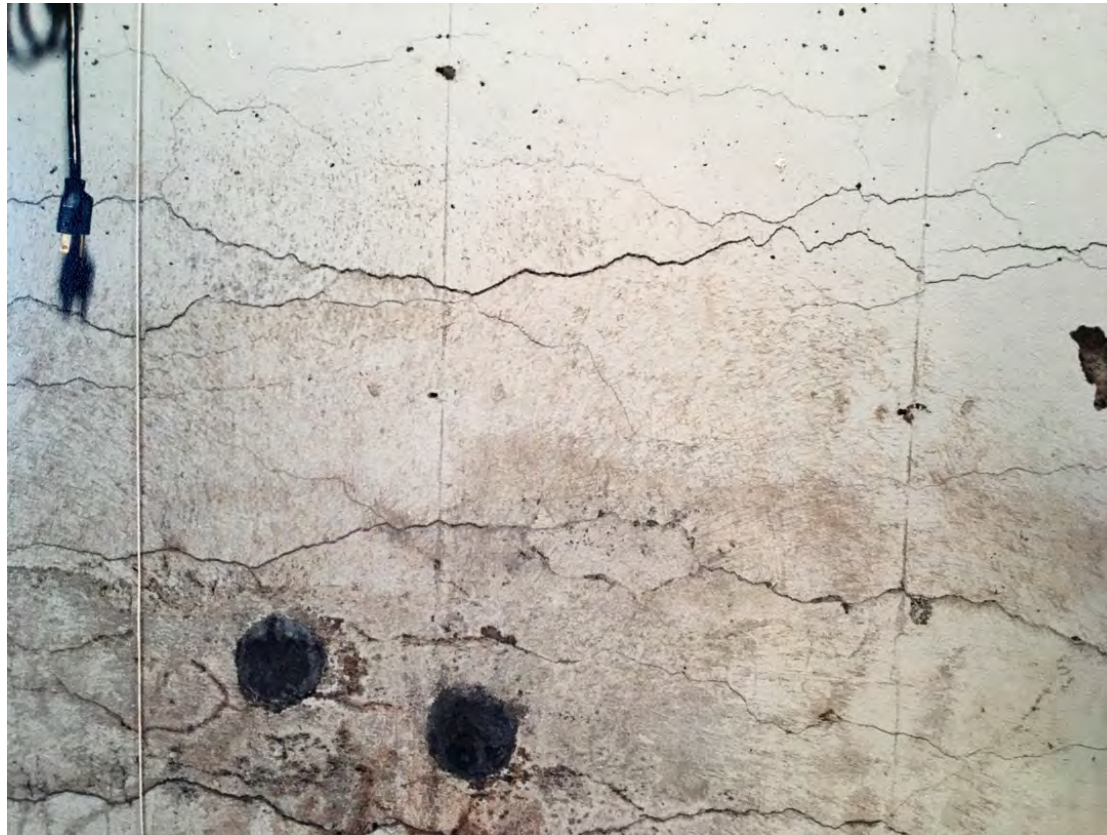
Concrete Damage
