*Reducing Cracks in New Bridge
Curbs*

2019 NESMEA

Eric Caron and Eshan V. Dave
University of New Hampshire

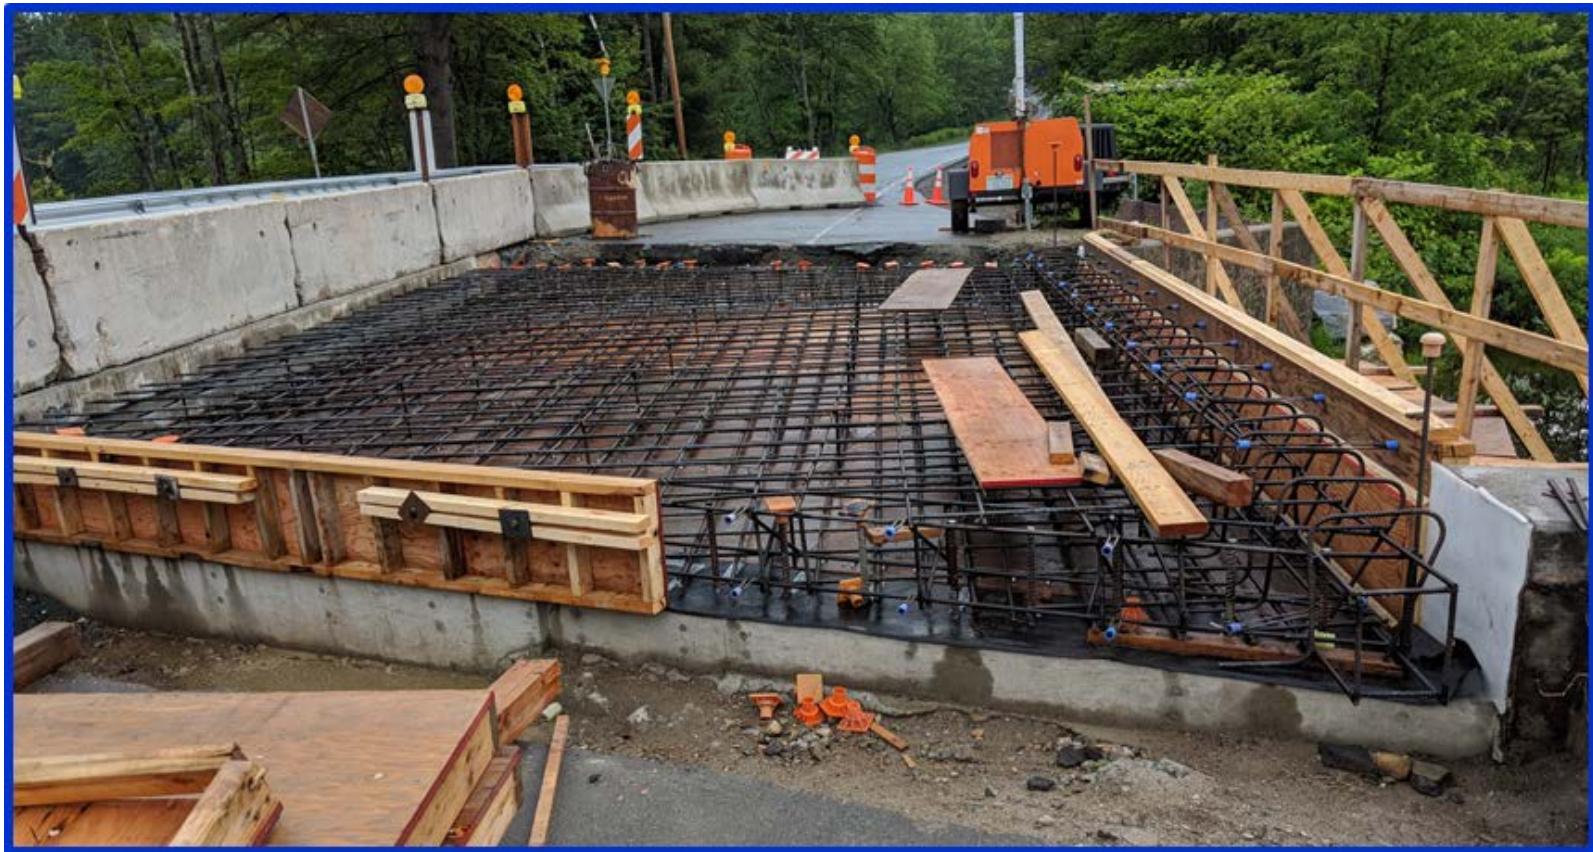
Background: Curb Construction

- Prefer to replace deck and curb at the same time
- Typically replace one side at a time

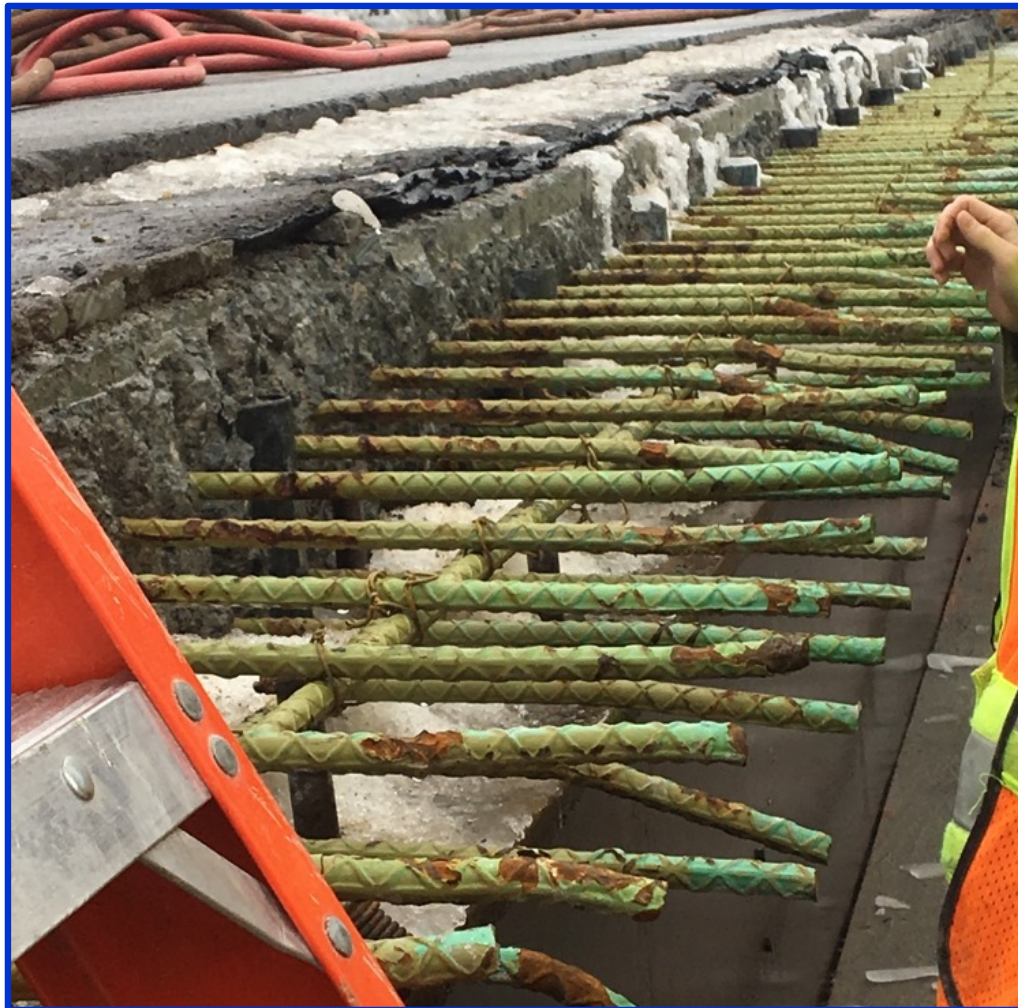
- Curb removal

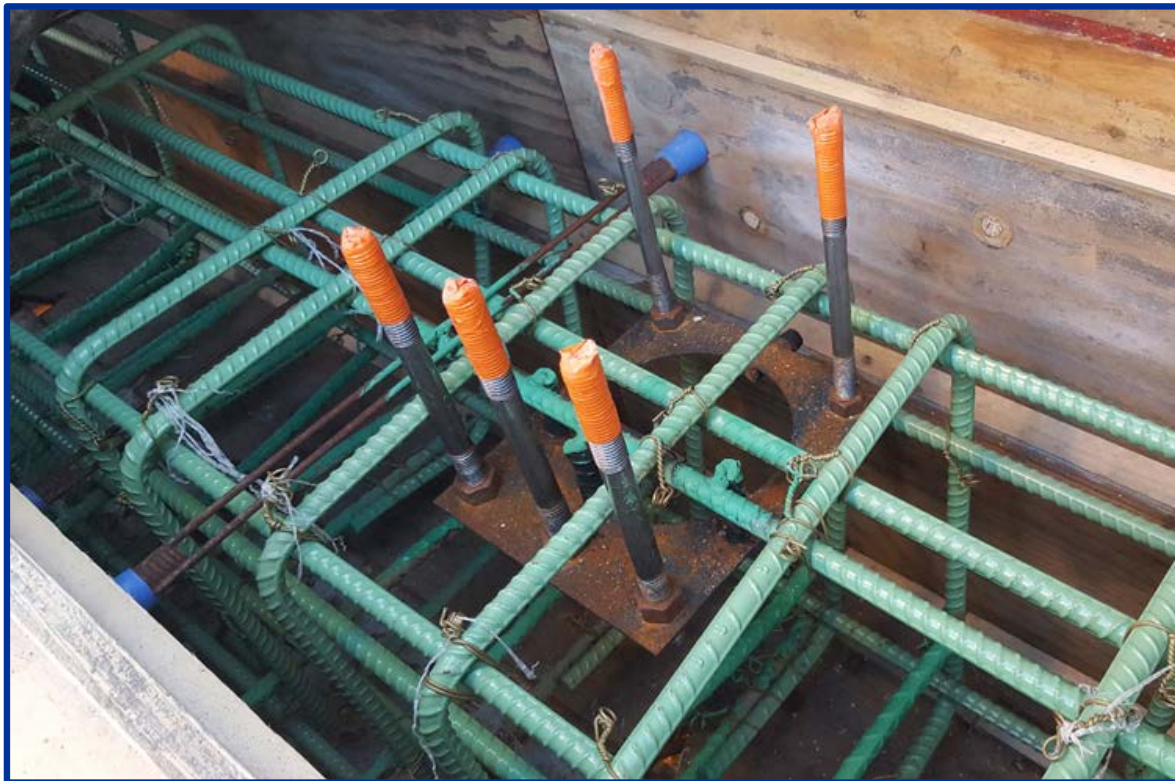
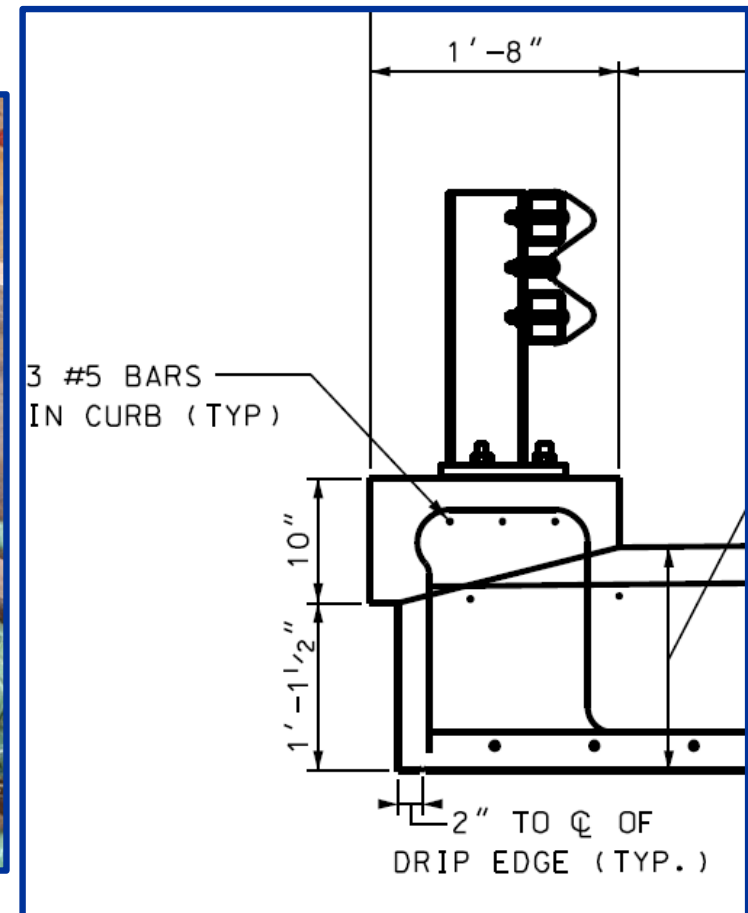
- Reinforcement and formwork installed
 - Guardrail post assemblies installed
 - Additional reinforcement around guardrail posts

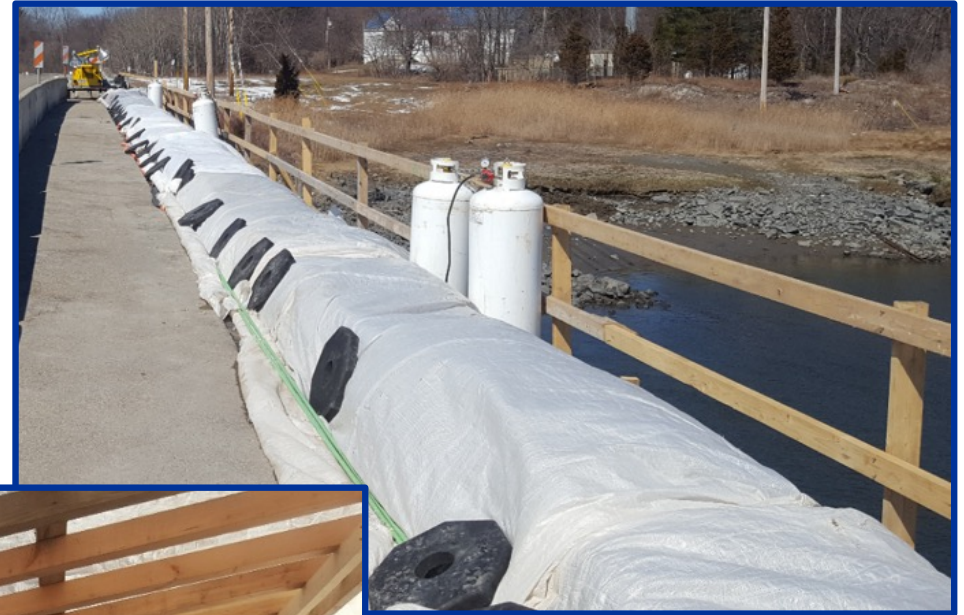
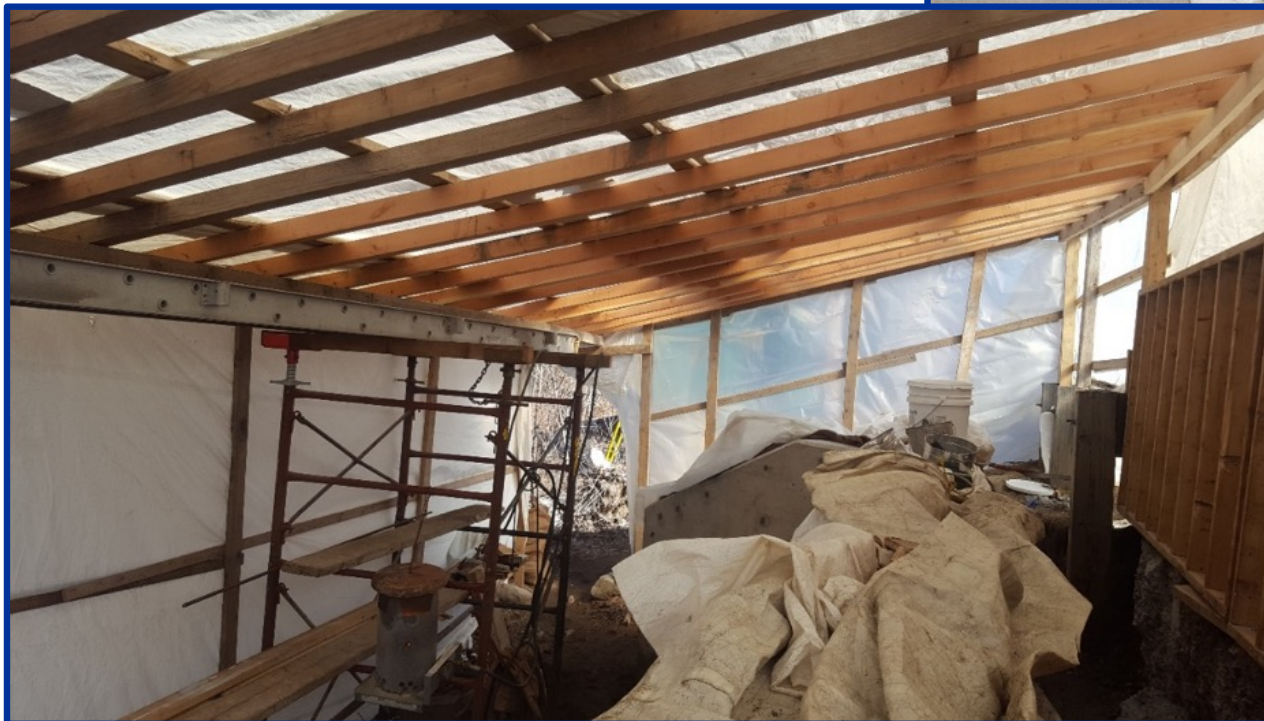
- Wet Cure

- PCC is wet cured 5 to 7 days
- Curbs are often placed in winter
- Winter wet cure duration is often shortened

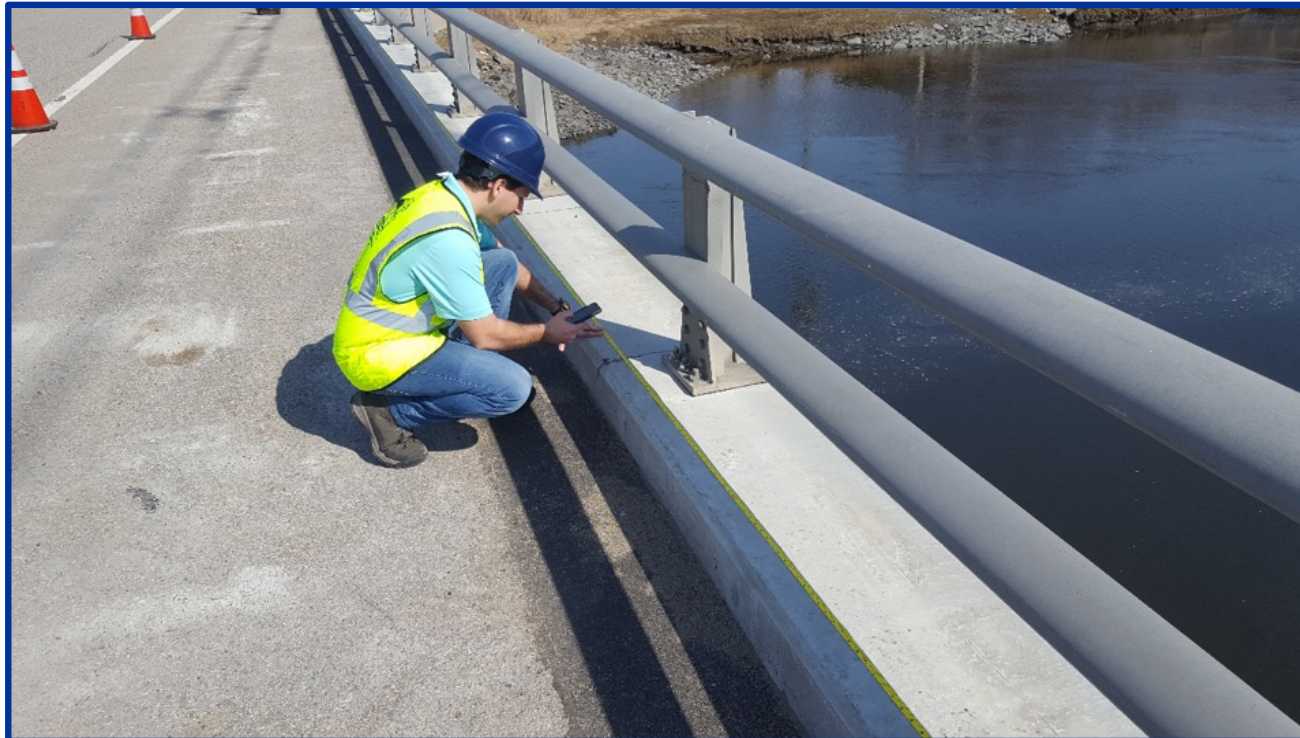
- Investigation Process

- 1) Pre-visit site research
- 2) Site visits
- 3) Additional data collection (batch slips, compressive strength etc.)
- 4) Post-processing

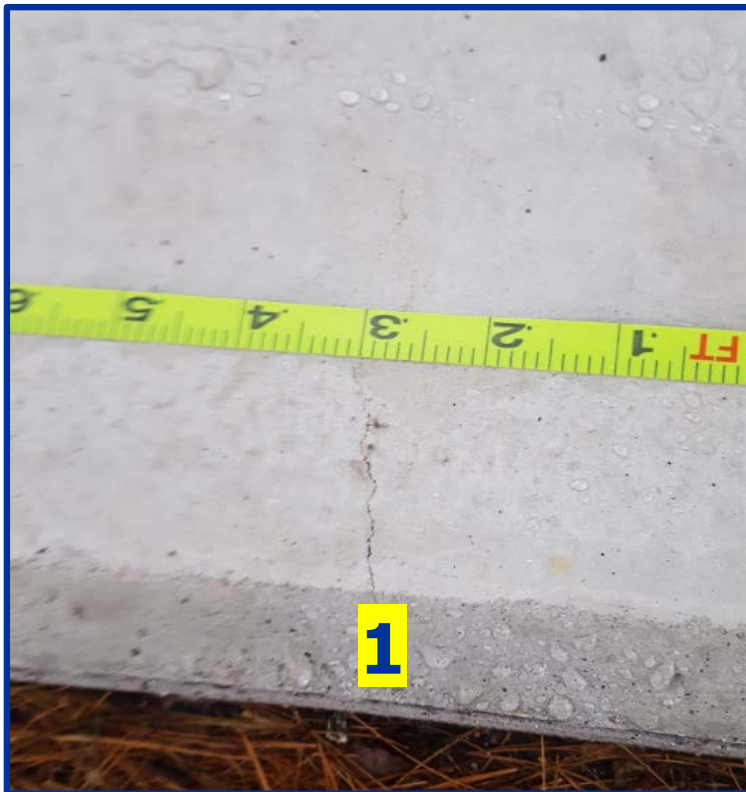
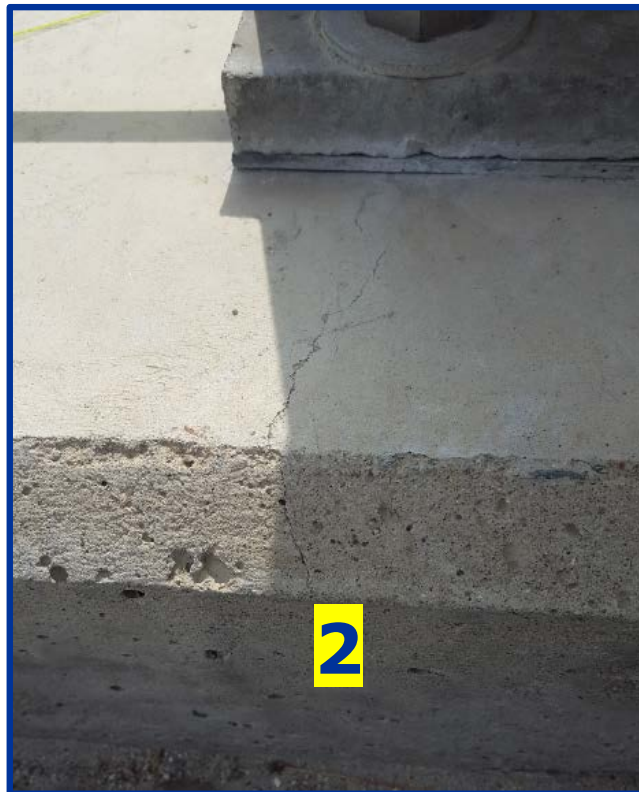
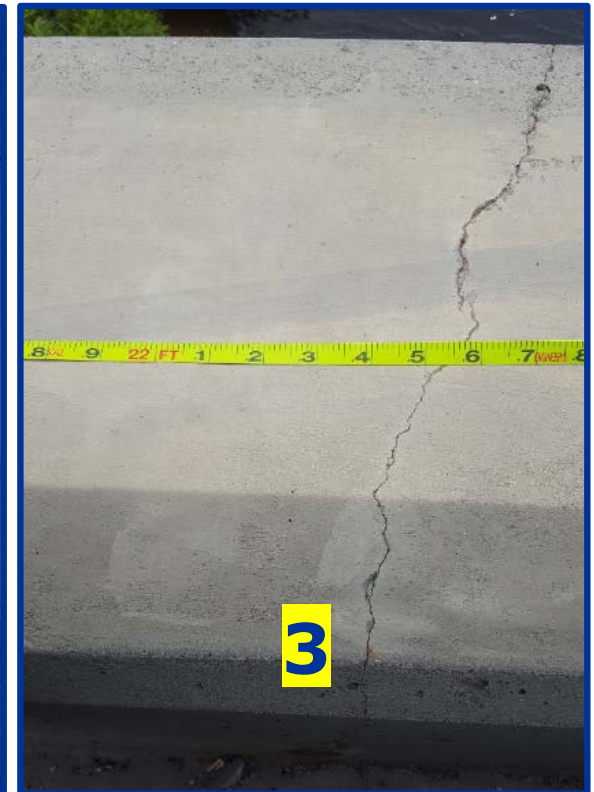
- Length Index (LI)

- 1 Partial or limited cracking on one or two faces.
- 2 Nearly full cracking along one face with partial cracking along another.
- 3 Full cracking along at least two faces or extending from guardrail post to roadway.

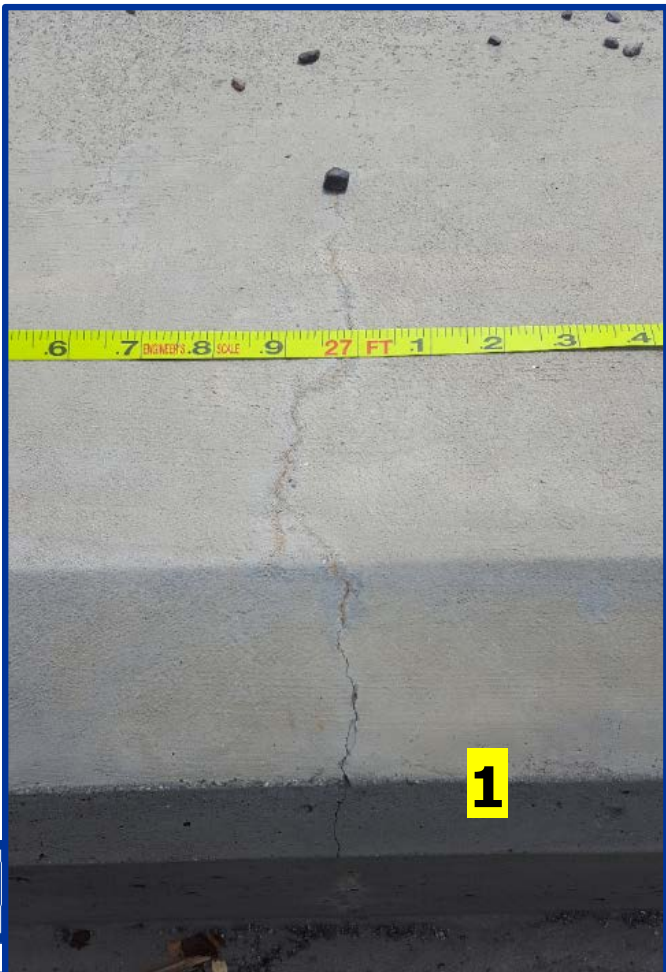
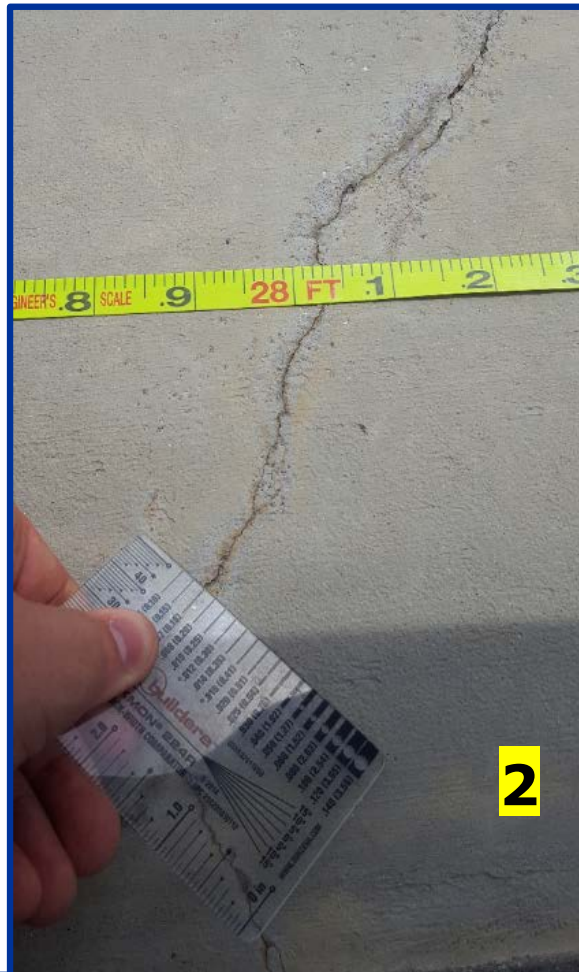
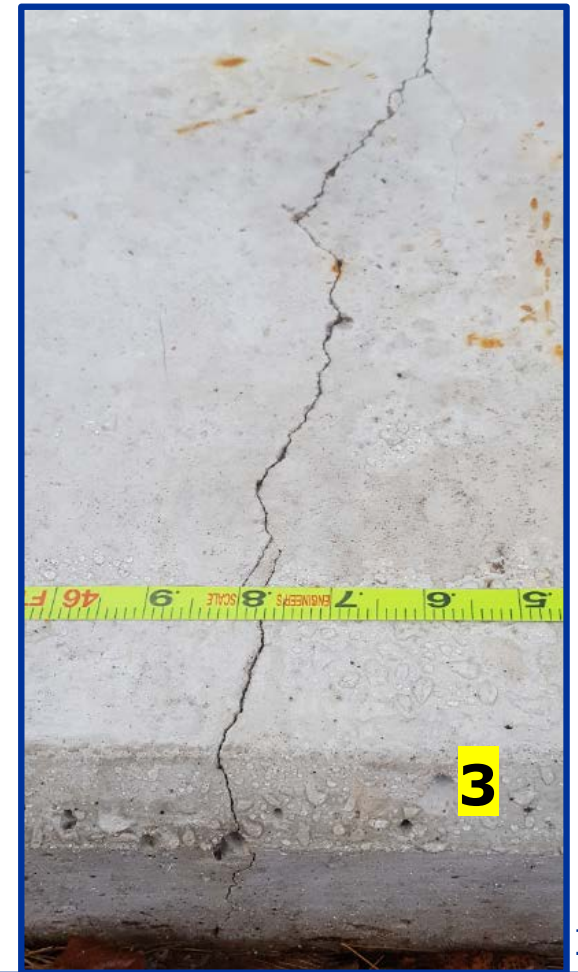
- Intensity Index (II)

Intensity Index	
1	Crack width < 0.007 "
2	Crack width ≥ 0.007 " but < 0.016 "
3	Crack width ≥ 0.016 "

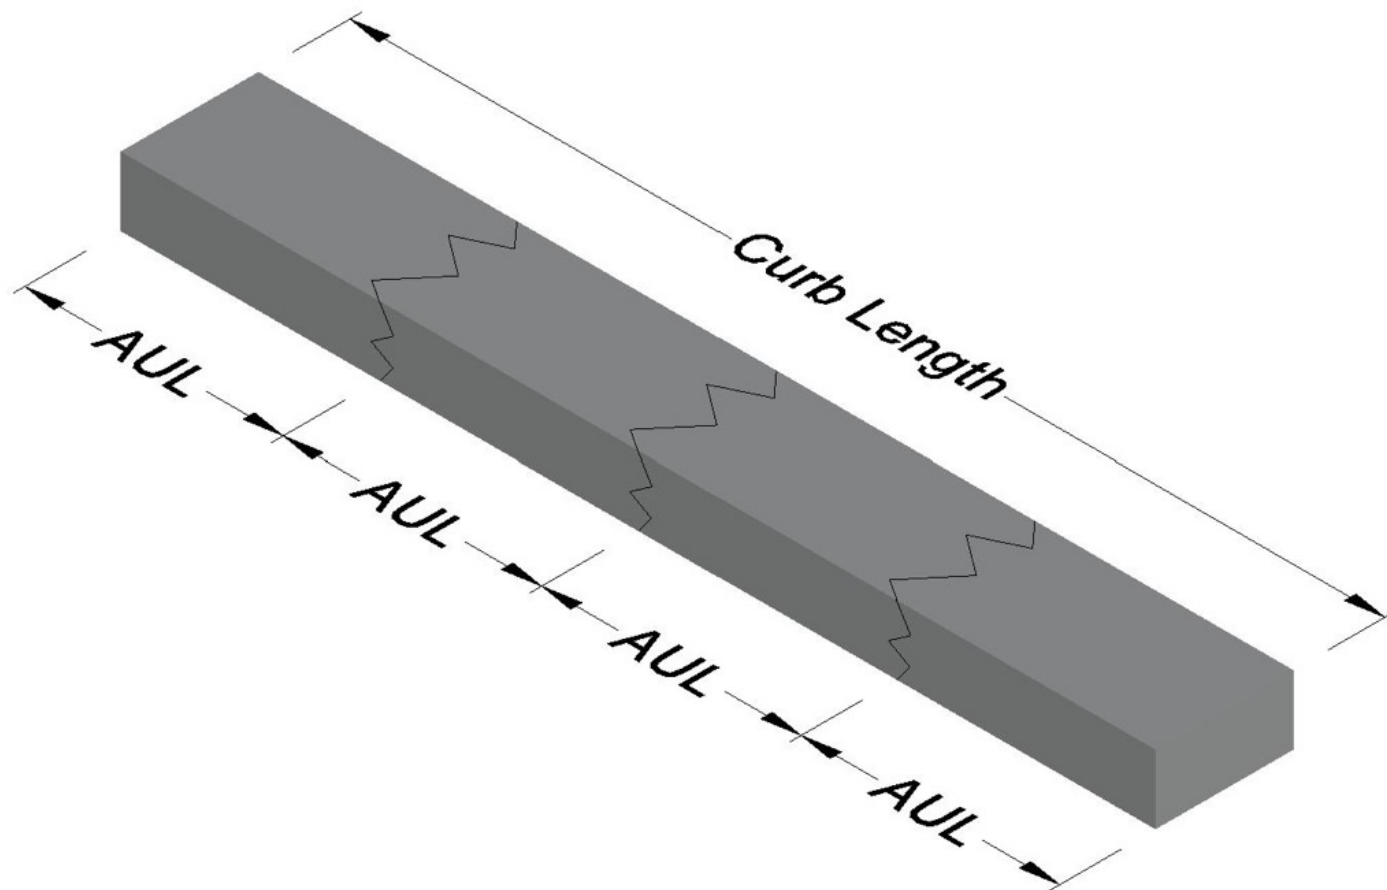
- Average Uncracked Length (AUL)

$$= \frac{\text{Curb Length}}{1 + (\# \text{ Cracks})}$$

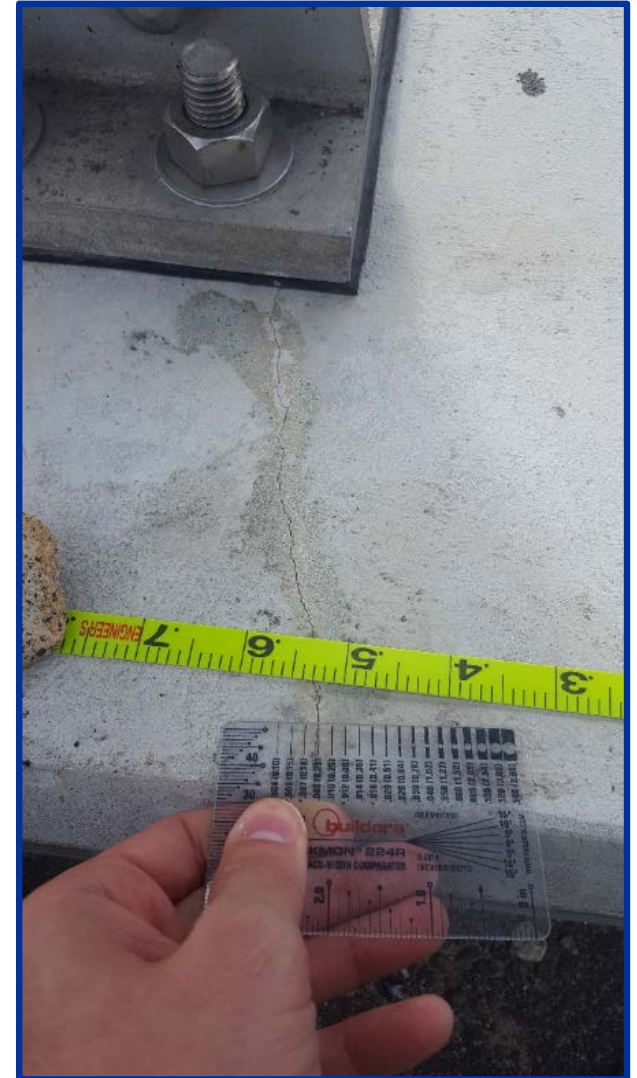
- Curb Cracking Index, CCI

$$= \frac{\text{Average Uncracked Length}}{\text{Average Severity Index}}$$

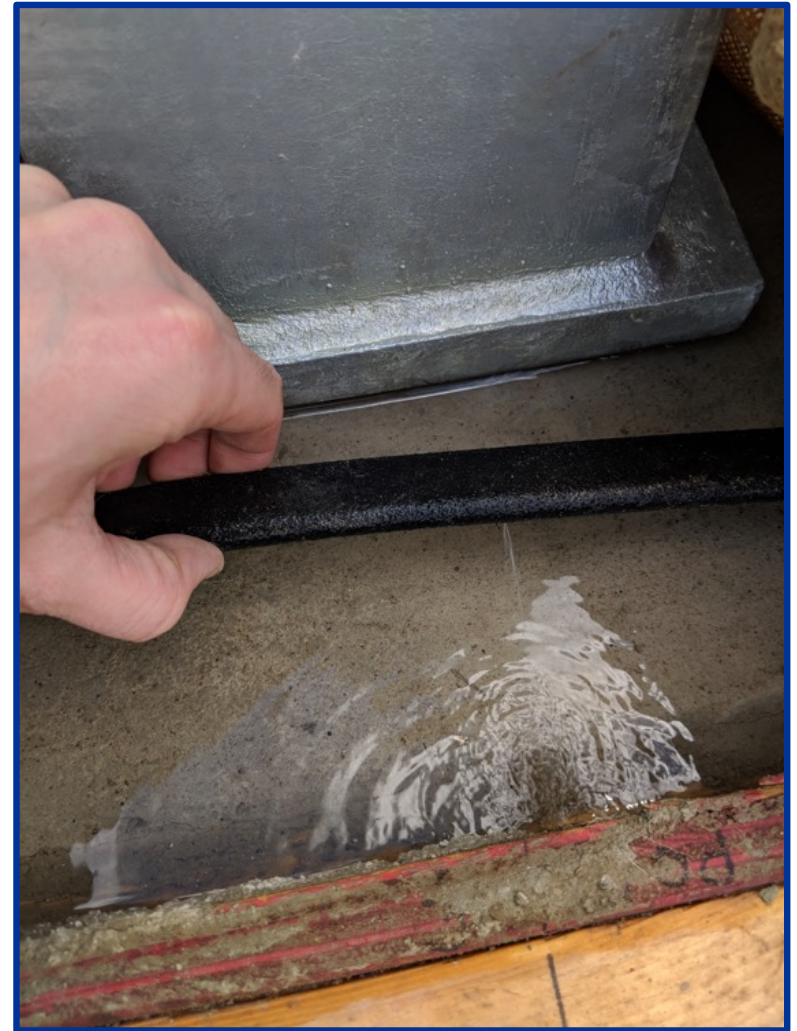
Research Methodology: Site Variables

- Bridge curb pairs replaced during the study had a variable applied to one of the curbs
- Tested variables
 - 14-day wet cure compared to traditional 5 to 7-day wet cure
 - PCC mix, NHDOT A mix compared to NHDOT AA mix

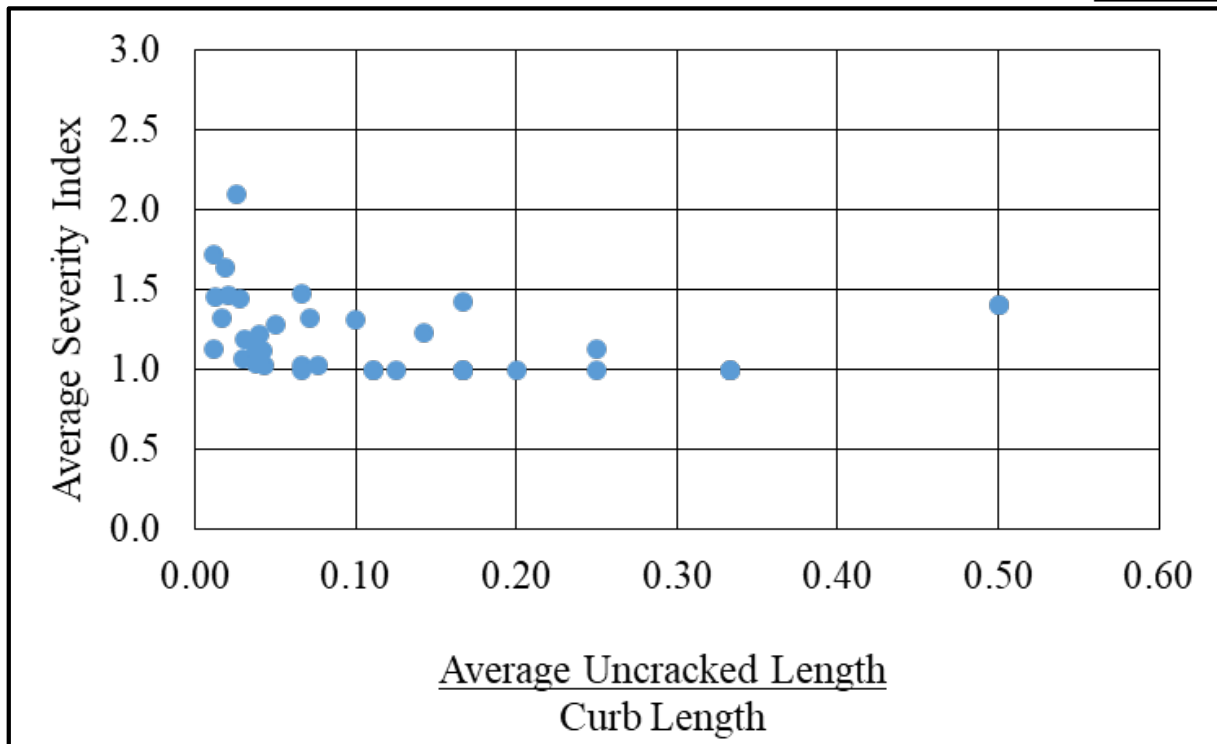
Distribution of Cracks

- 83% are of reasonable width
- Shorter AUL, higher SI

Length Index			Total
		1	2	3	
Intensity Index	1	525	64	116	705
	2	22	14	100	136
	3	0	0	8	8
Total		547	78	224

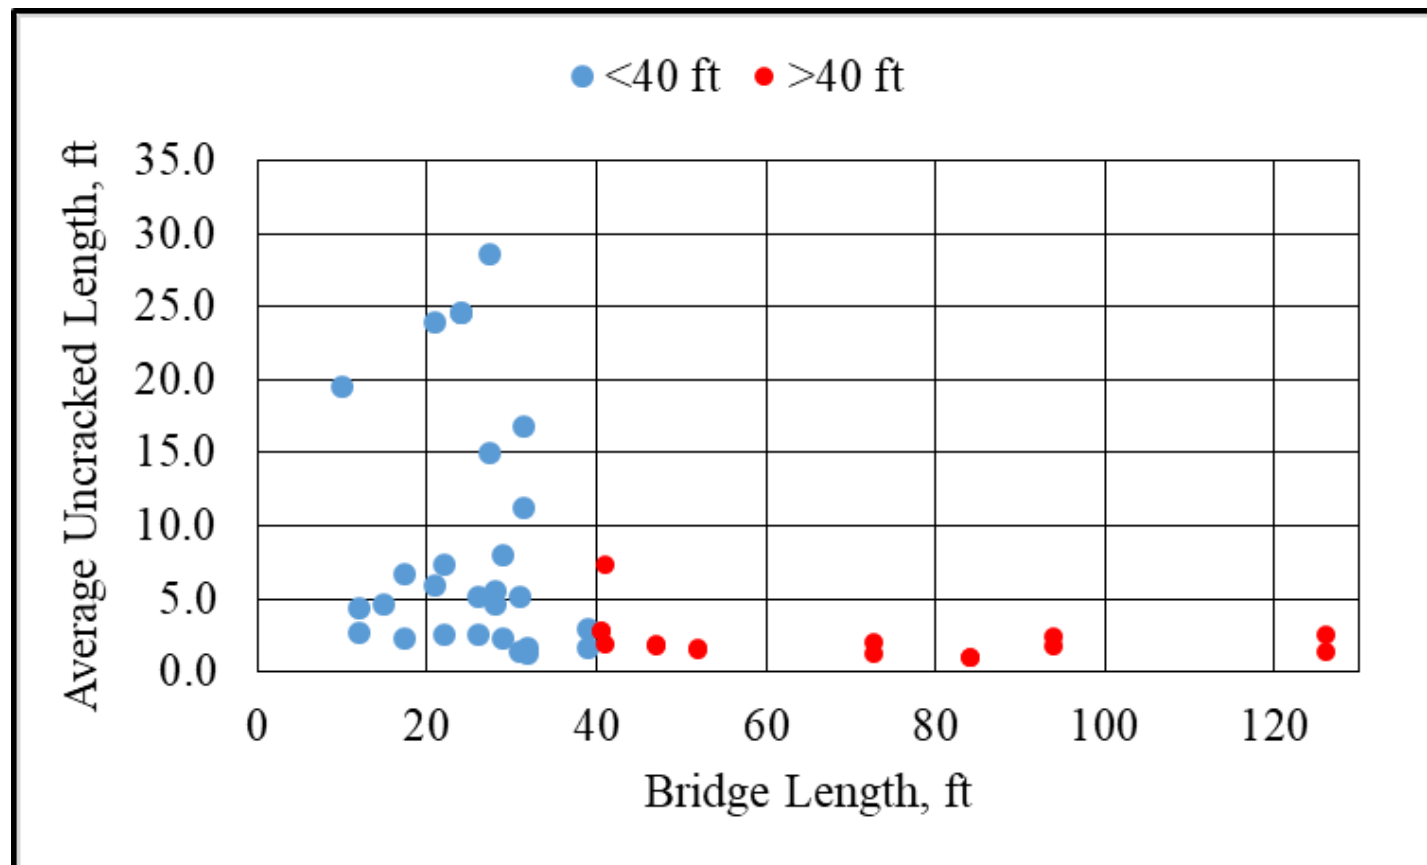
Bridge Length

- Noticeable change near 40 ft in length
- Around 30-40 ft concrete slab structures are switched to steel I-beams with concrete deck

- 83% of curb cracks are less than the maximum reasonable width as outlined by ACI 224R-01
- Curbs with more cracking tend to have more severe cracking
- Curbs on bridges over 40 ft. in length tend to have more cracking
- Less cracking occurs at the ends of curbs compared to the rest of the curb

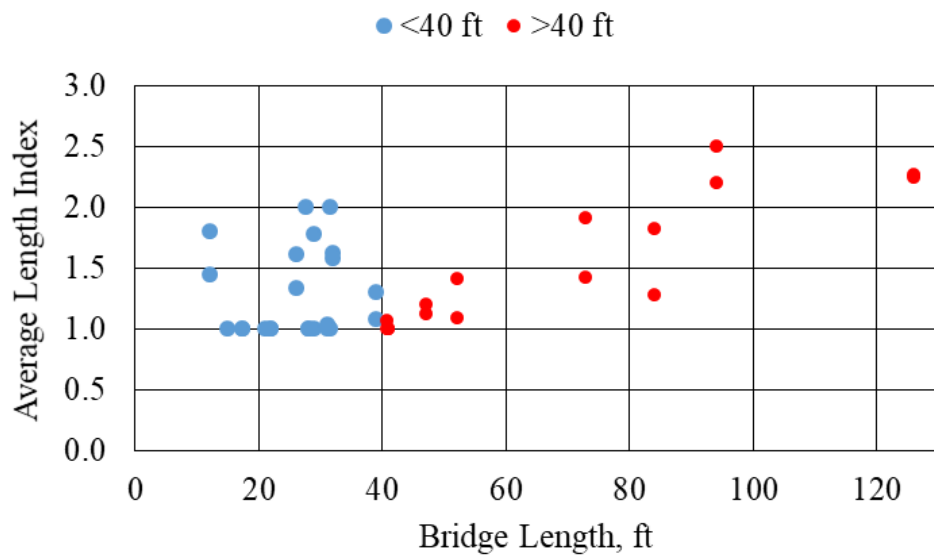
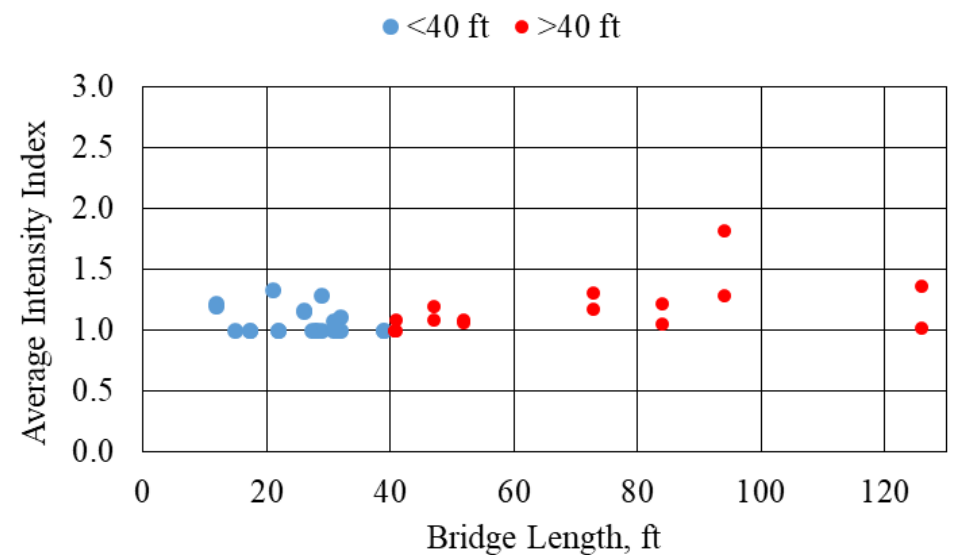
Bridge Length

t-test <40 ft & >40 ft	p-value $\alpha < 0.05$	Outcome
Average Length Index	0.119	Not Significant
Average Intensity Index	0.077	Not Significant
Average Uncracked Length	0.0004	Significant

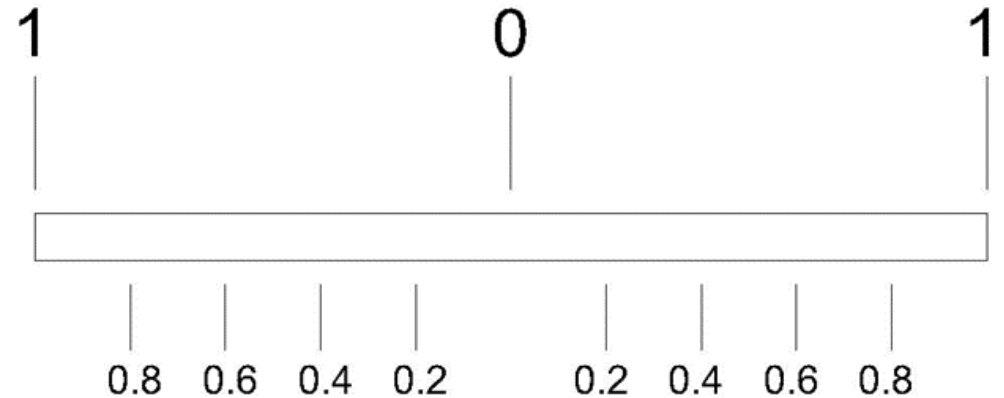
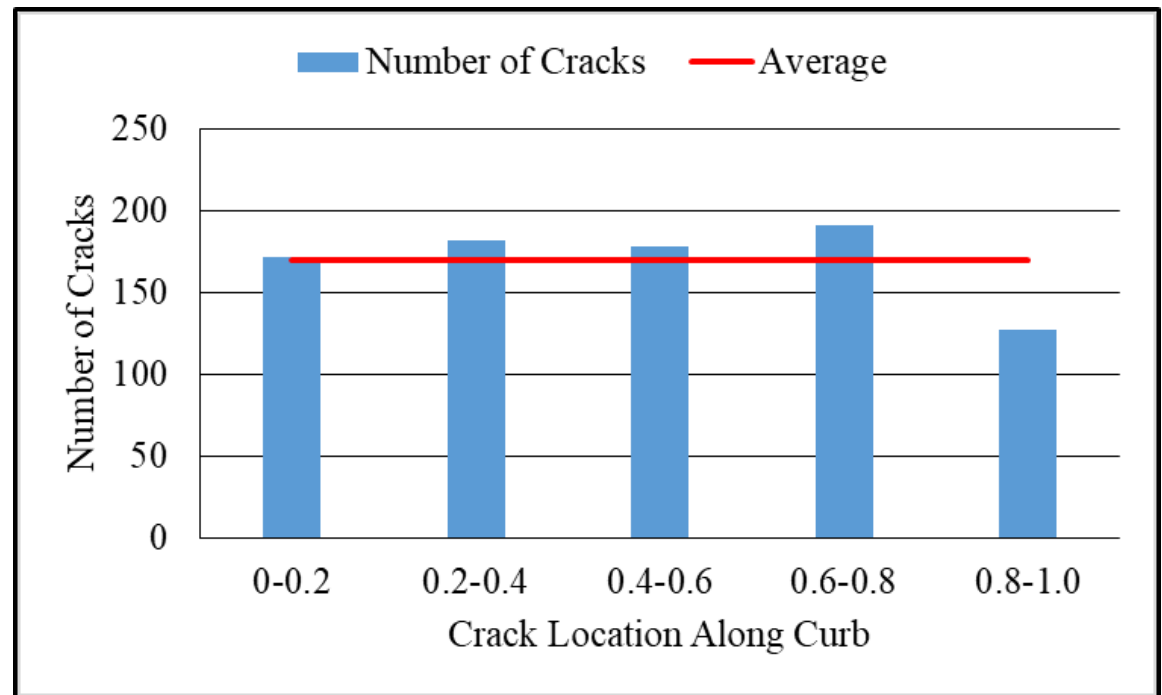
Location Along Curb

- Each crack assigned a value of 0 to 1
 - 0 corresponds to center of curb
 - 1 corresponds to end of curb
- Less cracking at the ends of the curb
- Statistical testing confirms these findings

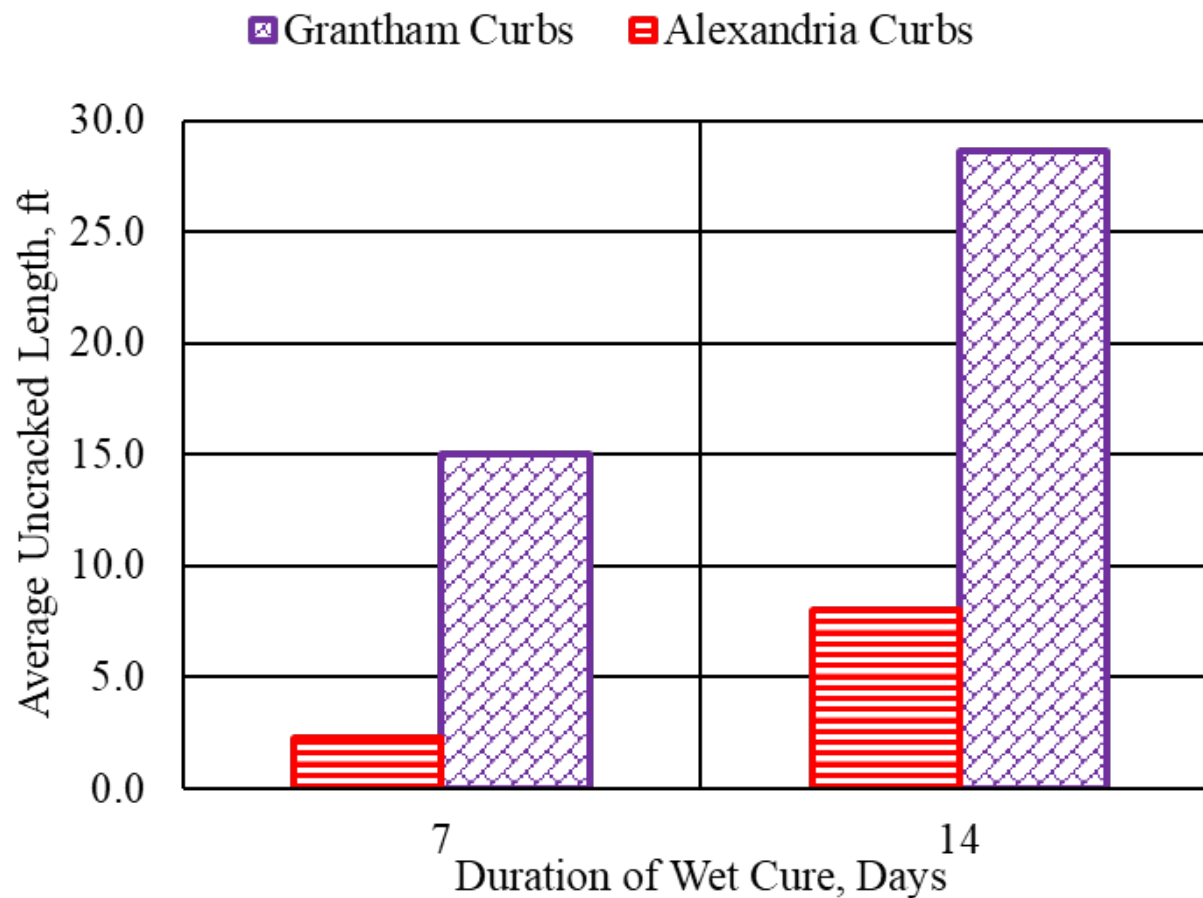
Wet Cure Duration

- t-tests do not indicate significance (all data)
- Curb pairs indicate 14-day wet cure reduces the amount of cracking compared to 7-day

- Curbs with a 7-day wet cure have more cracking as compared to their neighboring curb wet cured for 14-days
- Curbs placed with a higher cementitious content have more cracking compared to their neighboring curb
- Curbs with a higher compressive strength have more cracking compared to their neighboring curb
- Proximity to guardrail post have minimal effect on cracking behavior

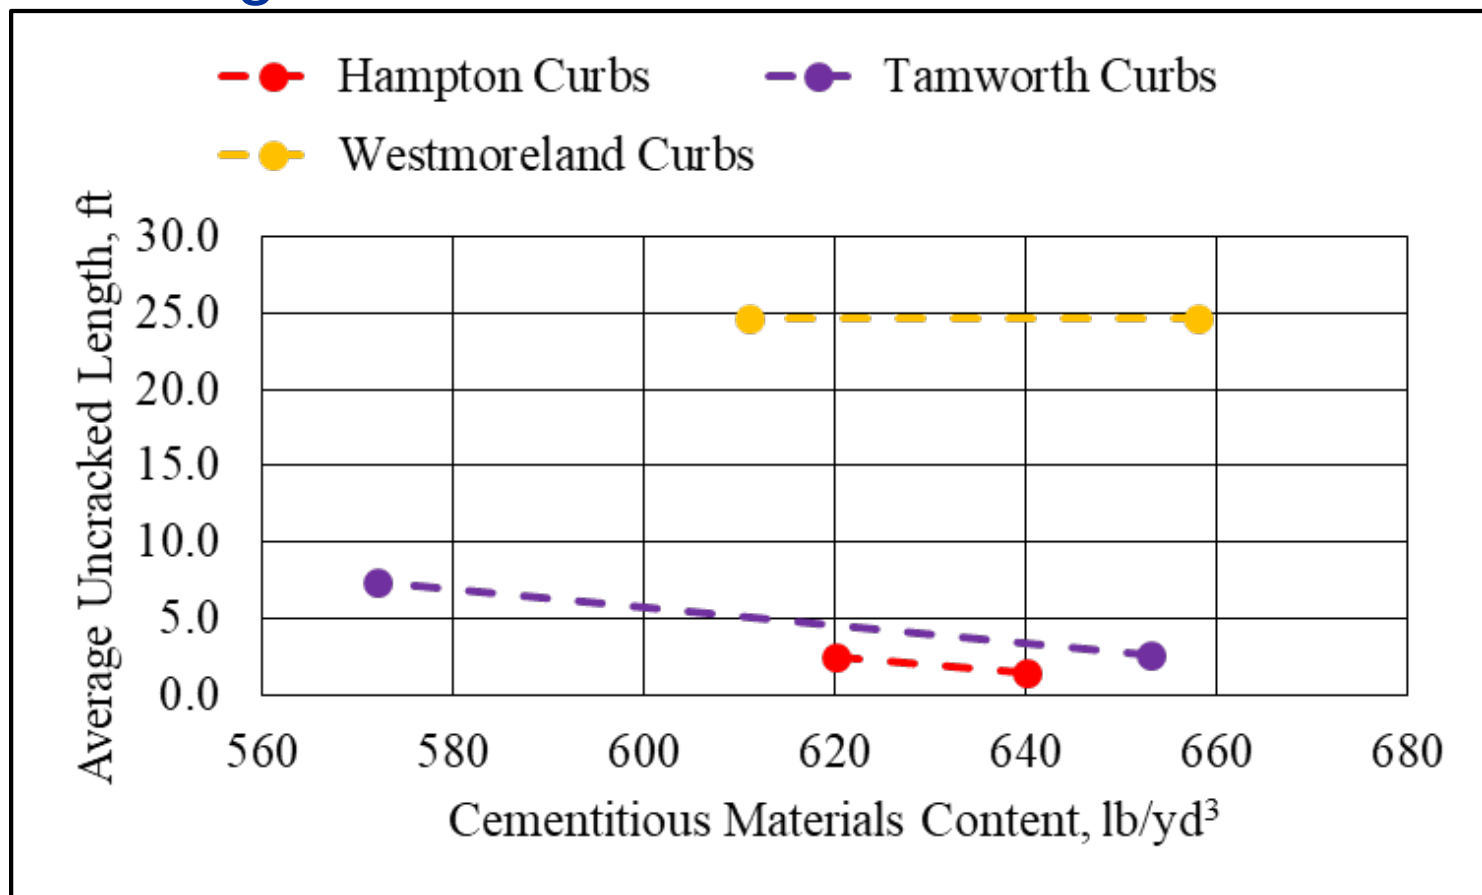
Cementitious Materials Content

- Not significant according to t-tests
- Curb pairs indicate lower cementitious content produces curbs with a greater AUL

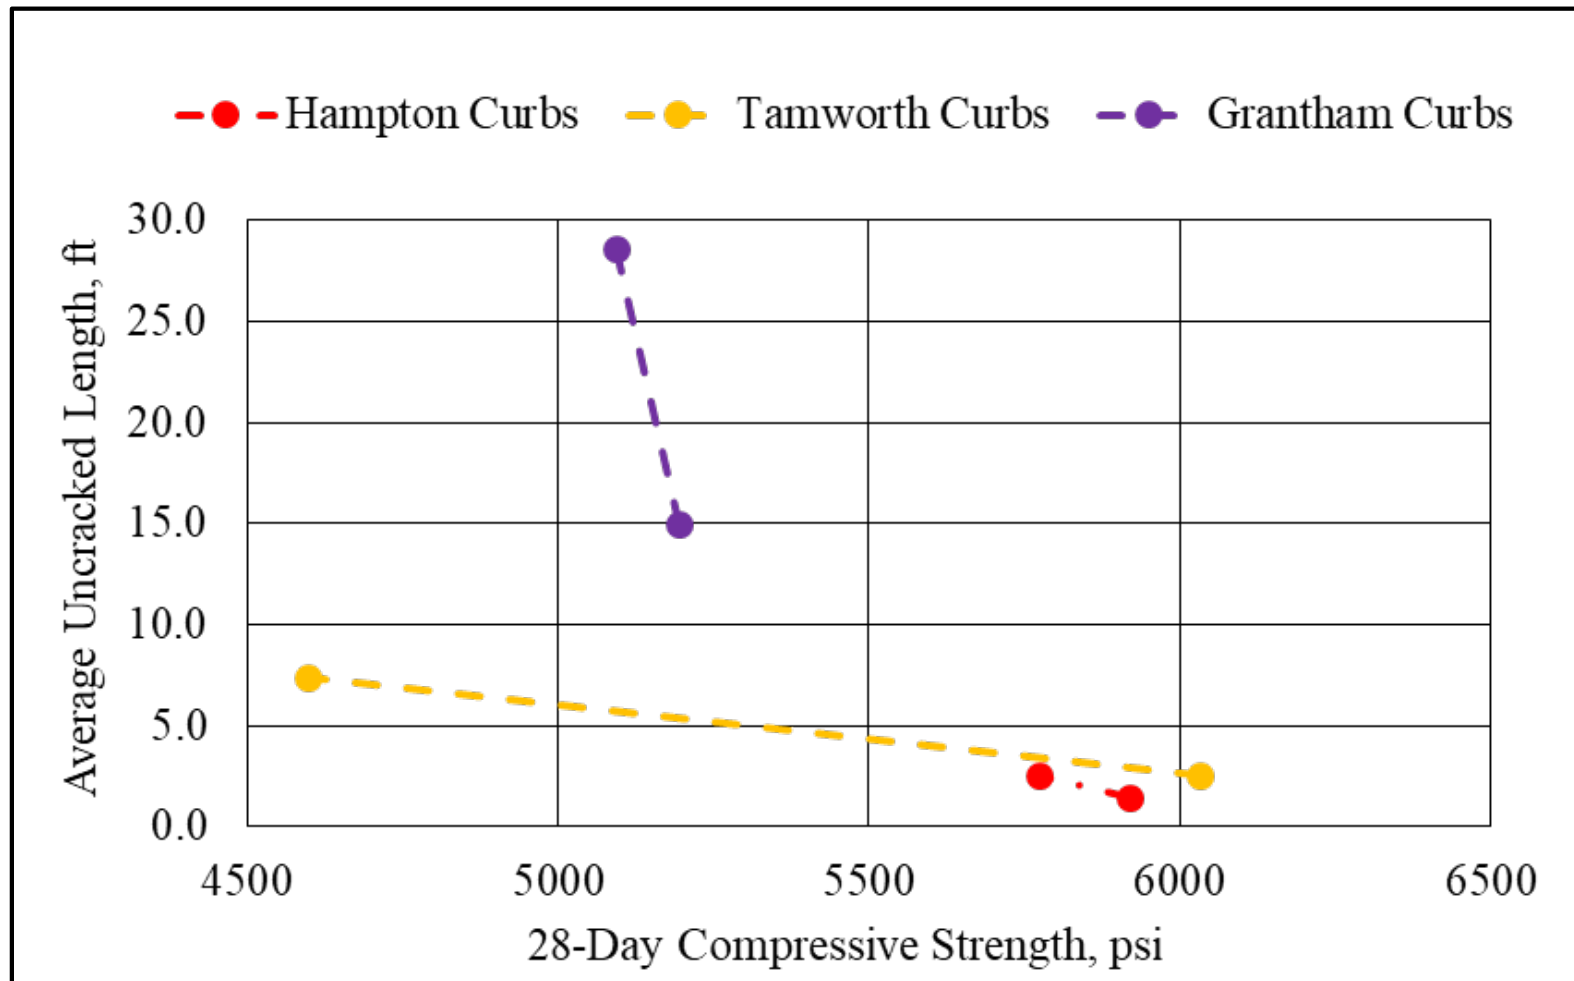
28-day Compressive Strength

- Curb pairs indicate higher compressive strength leads to shorter AULs
