*Reducing Cracks in New Bridge
Curbs*

2019 NESMEA

Eric Caron and Eshan V. Dave
University of New Hampshire

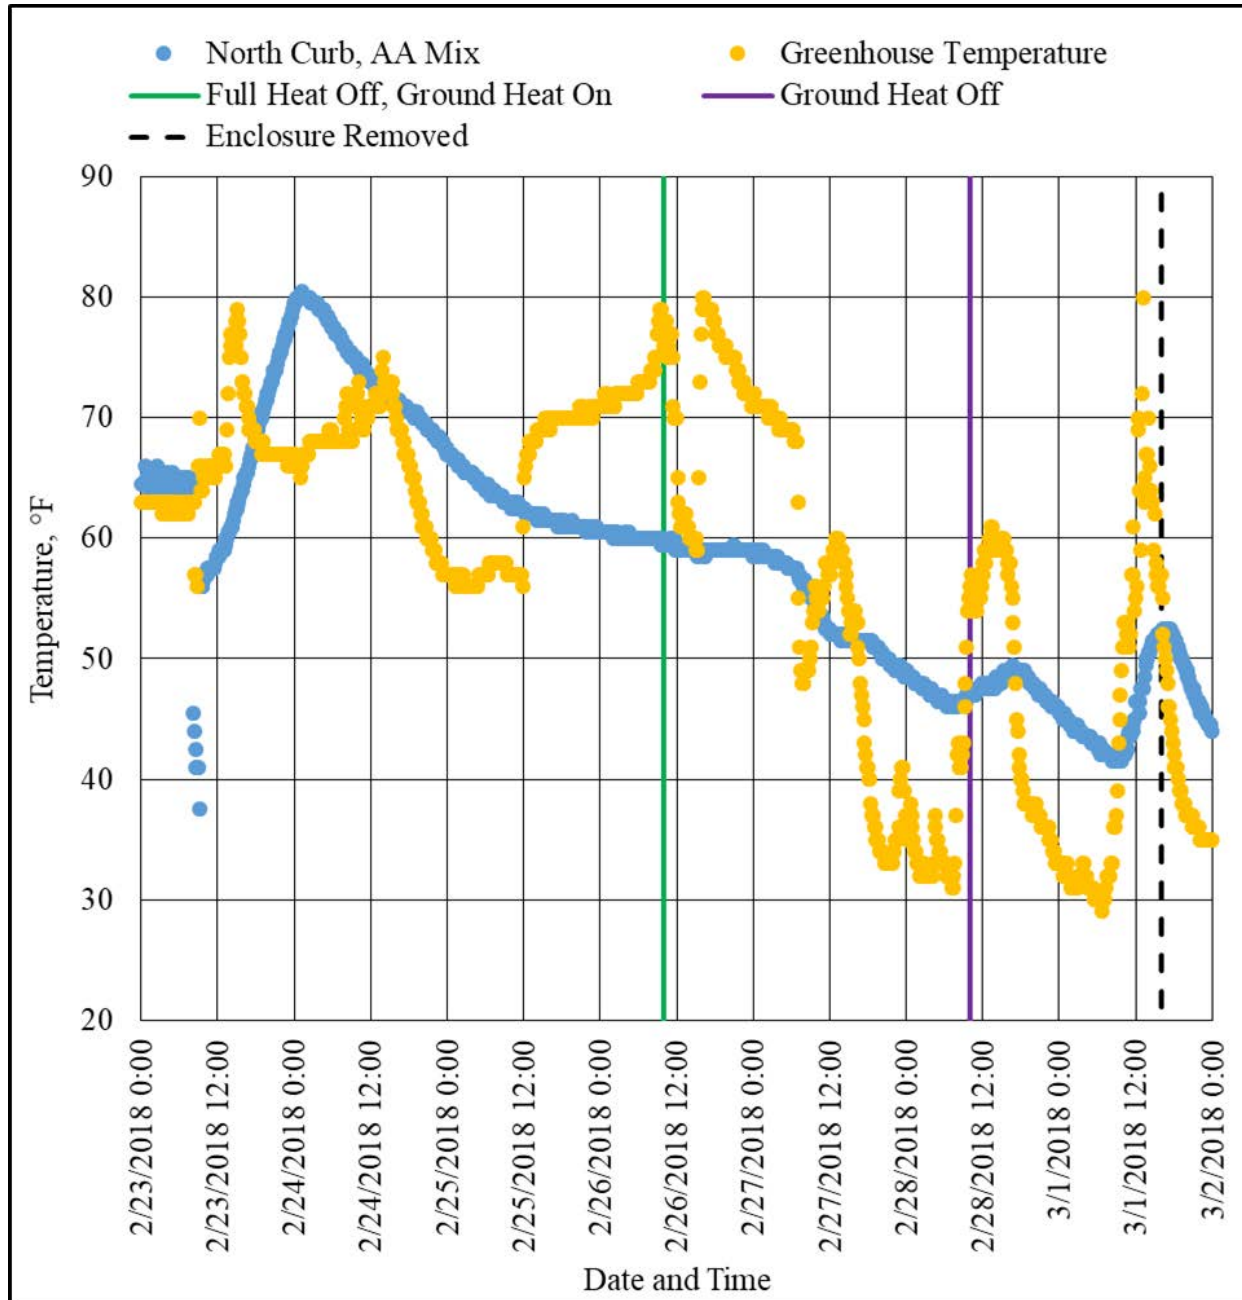
Curing Temperature

- Indicates curing procedure prevents concrete freezing or becoming too hot at an early age.

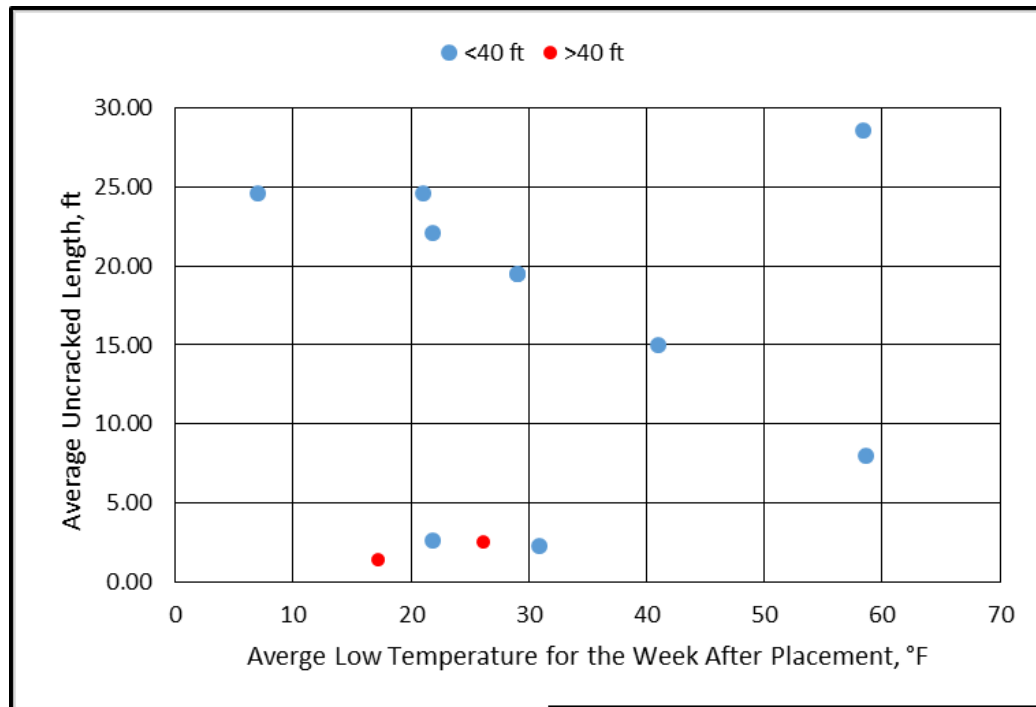
Appendix – Weather After Placement

t-test	p-value $\alpha < 0.05$	Outcome
Average Length Index Daily Low on Day of Placement <32°F & >32°F	0.428	Average length index of a curb does not significantly differ for curbs placed below 32°F compared to those placed above 32°F.
Average Intensity Index Daily Low on Day of Placement <32°F & >32°F	0.804	Average intensity index of a curb does not significantly differ for curbs placed below 32°F compared to those placed above 32°F.
Average Uncracked Length Daily Low on Day of Placement <32°F & >32°F	0.858	Average uncracked length of a curb does not significantly differ for curbs placed below 32°F compared to those placed above 32°F.
