The Assessment of Alkali-Silica Reactivity In Massachusetts Highway Structures, Now

The 90th Annual Meeting of the North East States
Materials Engineers Association

Matthew R. Sherman, P.E
21-22 October 2014

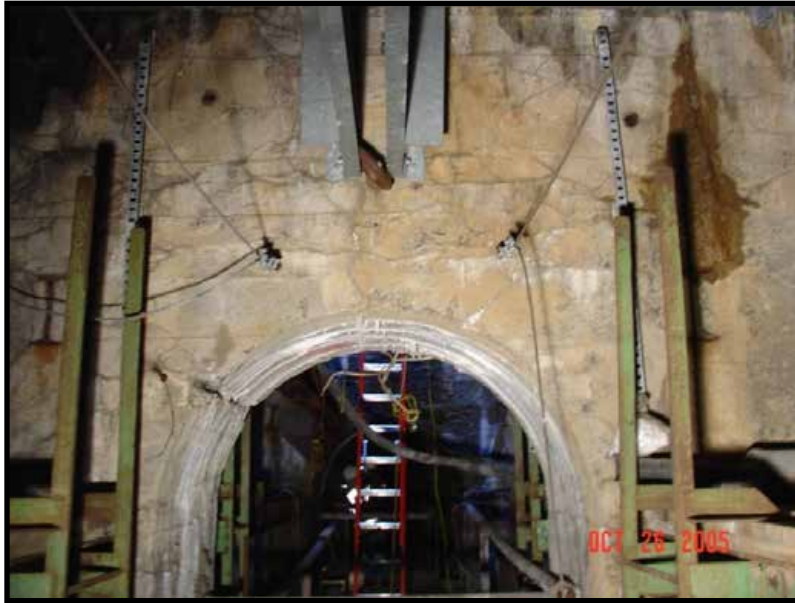
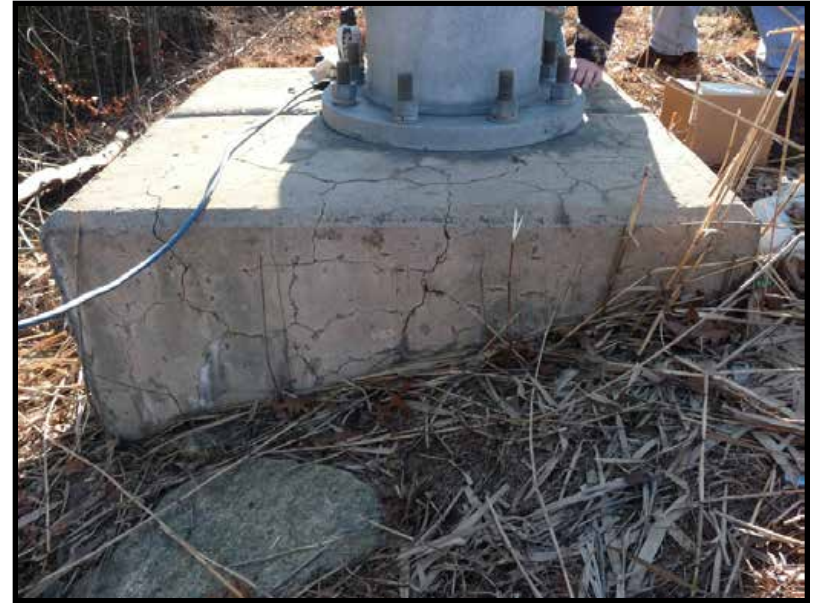
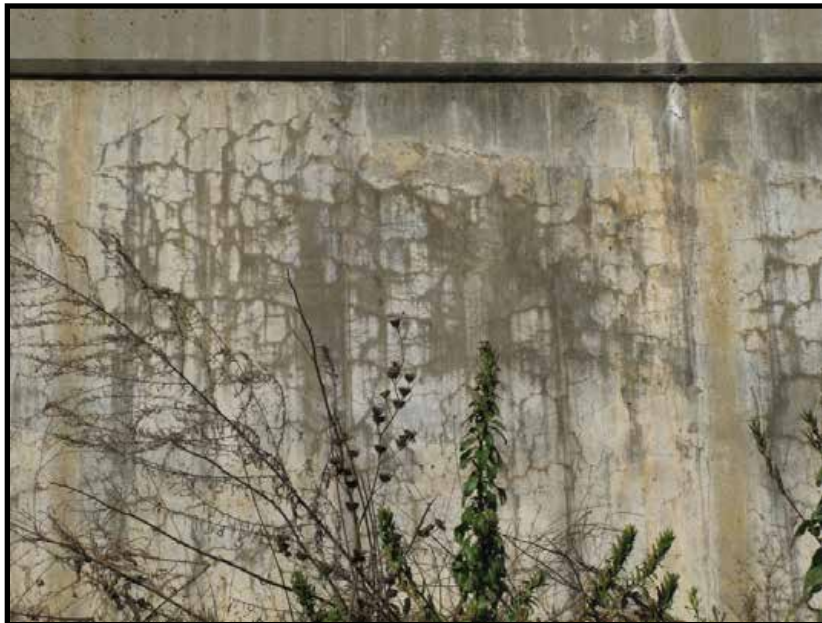
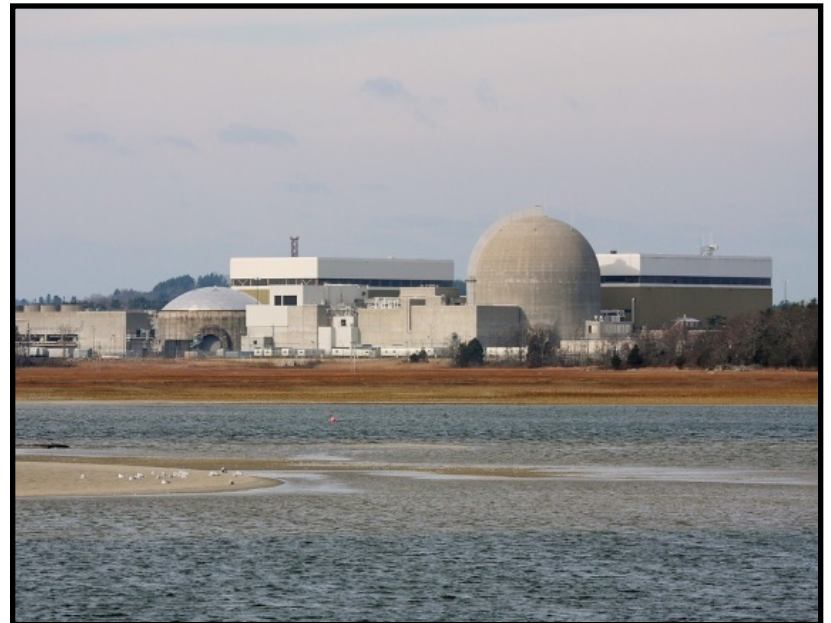
ASR Manifestations in New England

- Global
 - Expansion, deformation, relative movement, and displacement.
- Cracking
 - Apparent pattern-cracking
 - Broad brownish zone
 - Damp appearance
 - Surface deposits – gel exudation
 - Pop-out of reactive aggregate

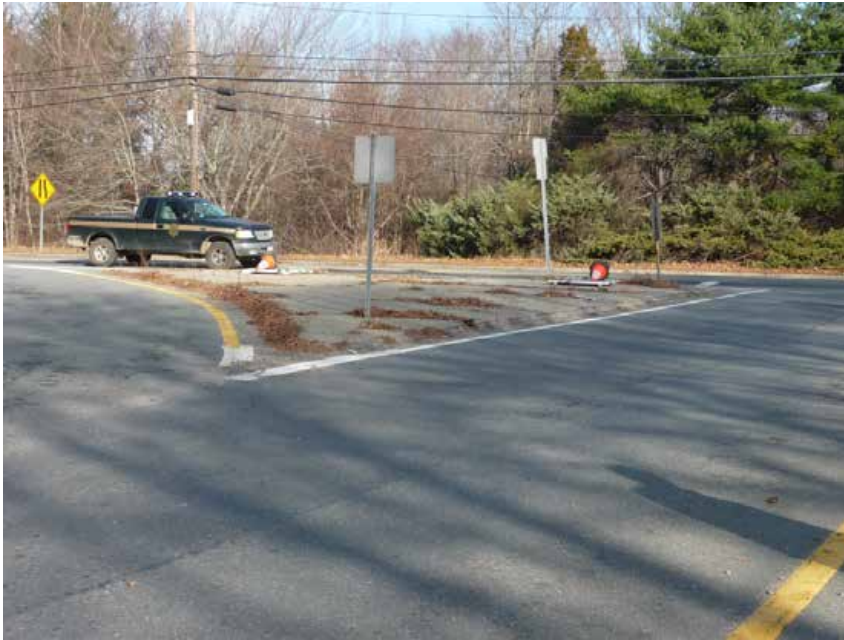
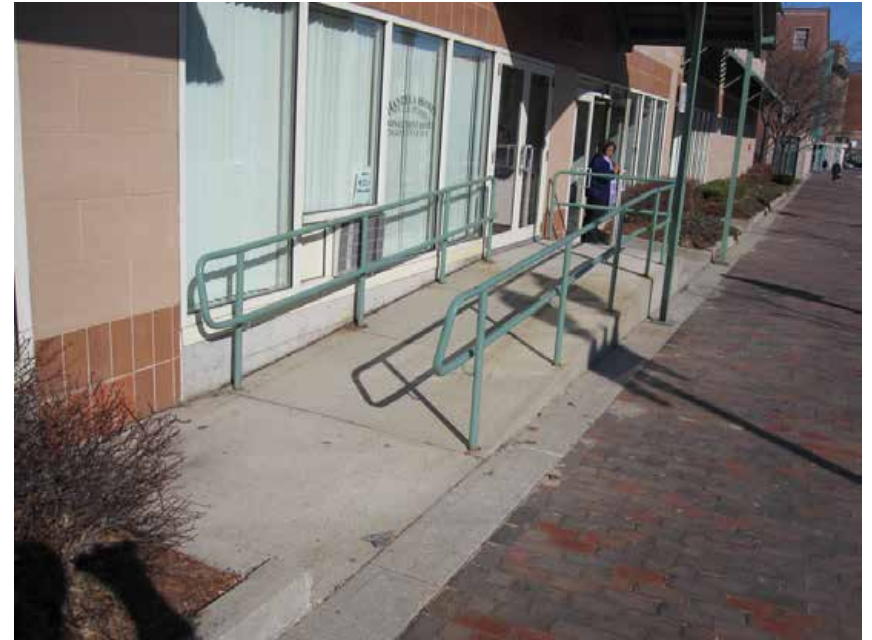
Rating 0 - Examples

Rating	Effect of ASR on Performance of Element or Structure	Management Plan
0	Negligible	<ul style="list-style-type: none"> No ASR-specific response required. Reassess only if warranted by new information or changes noted in course of other routine work.

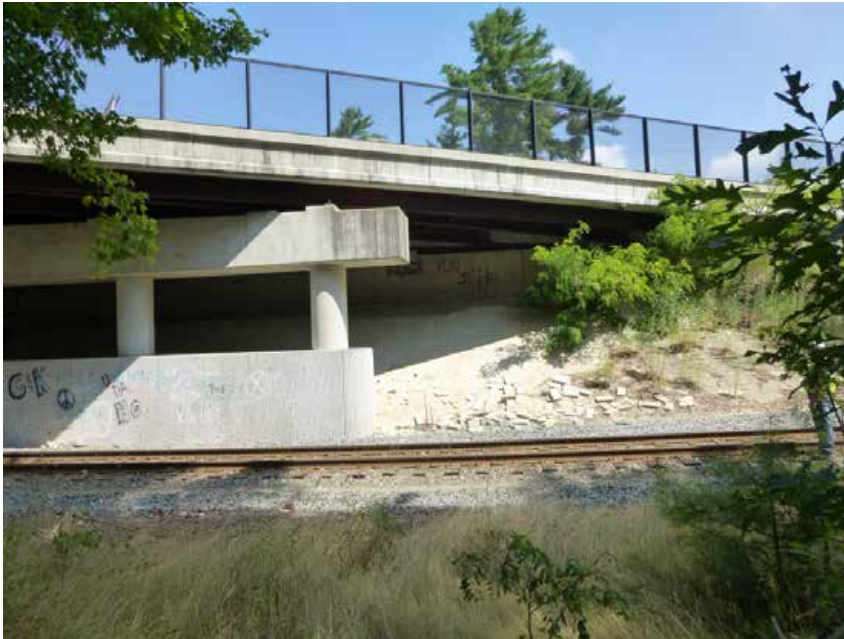
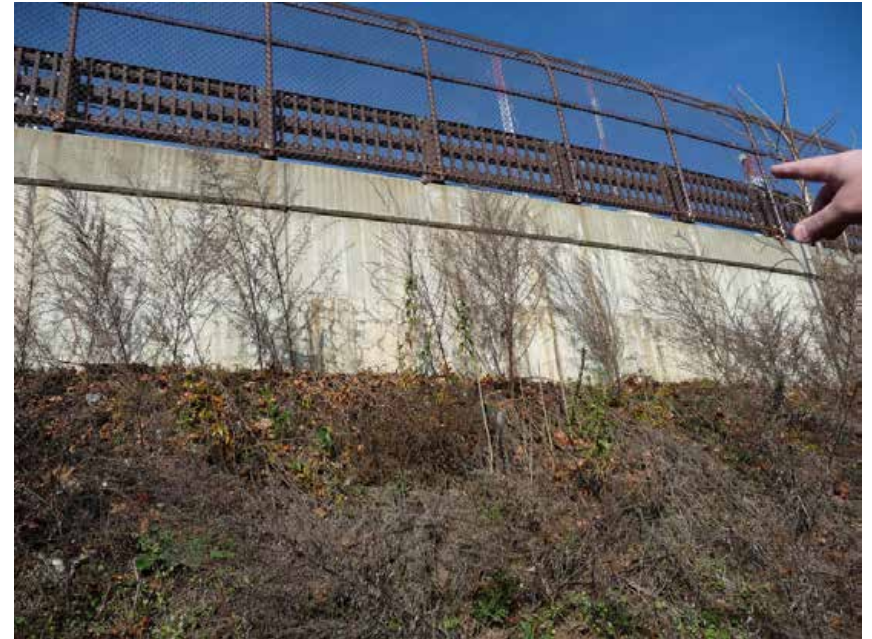
Rating 1 - Examples

1	Minor	<ul style="list-style-type: none"> • Visually inspect <u>every two years</u> for signs of large changes in condition (new spalling, staining, “alligator cracking” with cracks wider than 1/32 in.) • For bridge structures, add note to NBIS report to alert inspectors of potential ASR during future inspections. • If possible, minimize moisture intrusion to increase service life. • Repeat detailed ASR inspection and risk assessment during second MassDOT NBIS inspection cycle for bridges or after 4 years for structures not covered by routine inspections.
---	-------	--

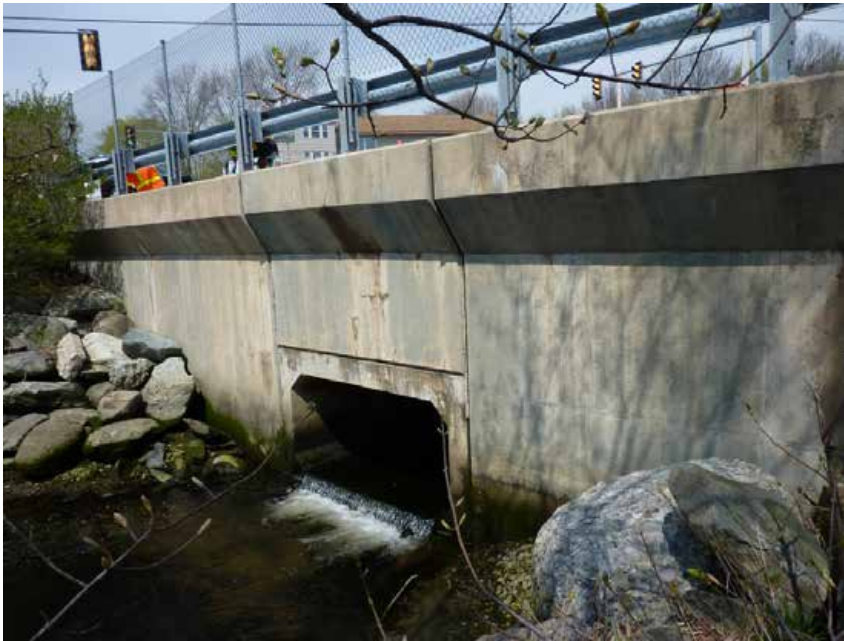
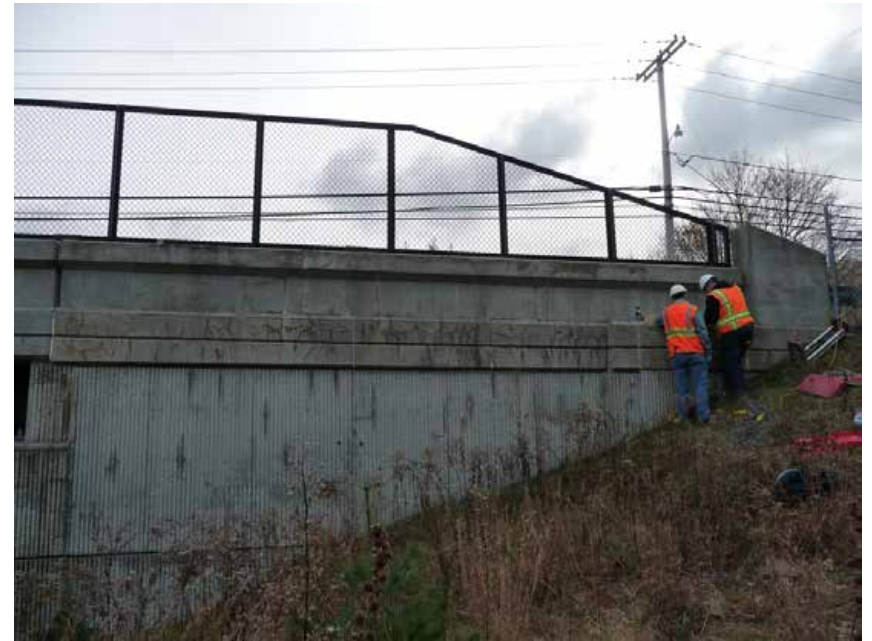
Rating 2 - Examples

2	Moderate	<ul style="list-style-type: none"> Visually inspect <u>annually</u> for signs of large changes in condition (new spalling, staining, “alligator cracking” with cracks wider than 1/32 in.). If possible, minimize moisture intrusion to increase service life. Perform detailed crack survey and CI measurements as part of NBIS inspections for bridges or with local staff for other structures <u>every two years</u> and repeat ASR risk assessment. If a new ASR rating is assigned, modify current management plan and act accordingly.
---	----------	--

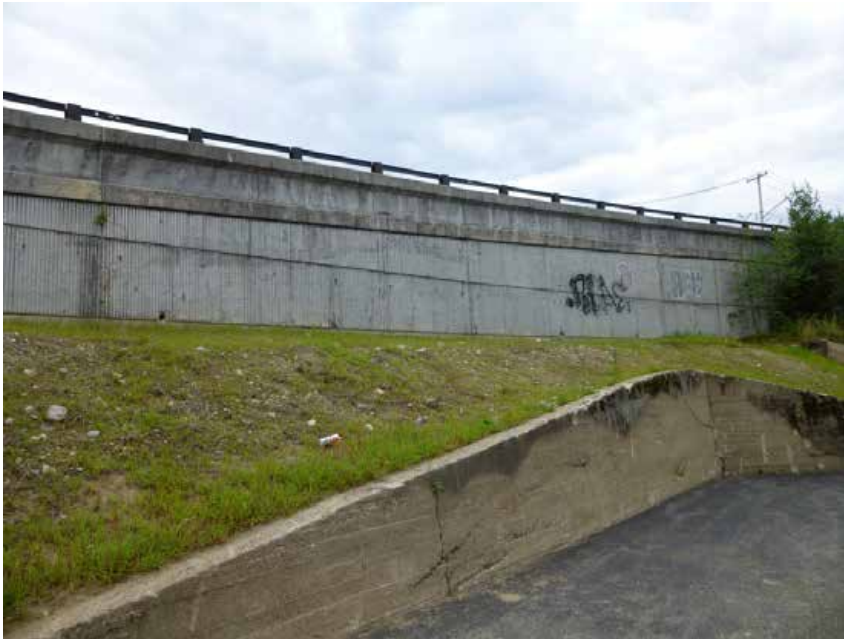
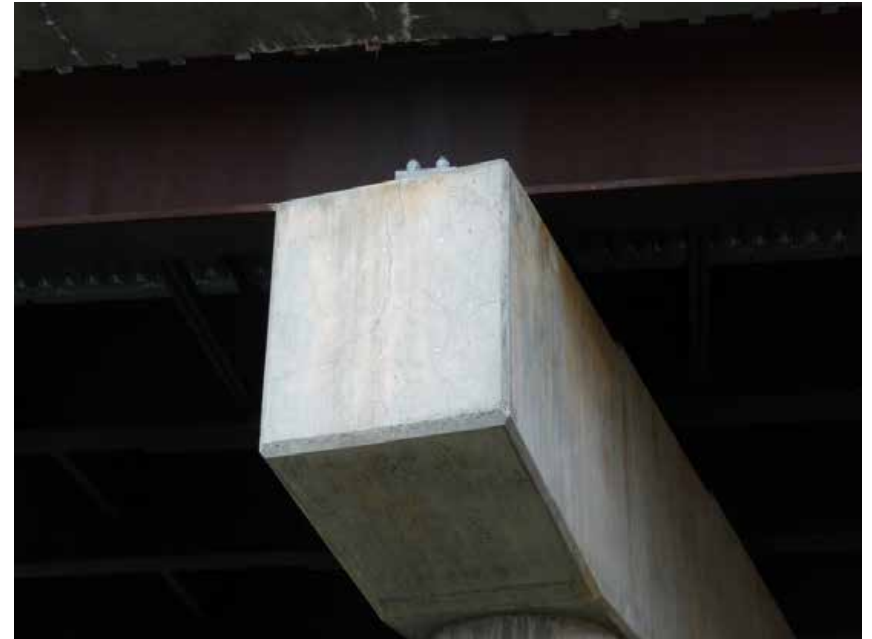
Rating 3 - Examples

3	Appreciable	<ul style="list-style-type: none">• Visually inspect and perform detailed crack survey and CI measurement <u>every six months</u> until implementation of a management and maintenance plan.• Prepare and implement a structure-specific management and maintenance plan. This may include one or more of the following options depending on factors such as the expected time to scheduled replacement, replacement value of the structure(s), relative cost analysis, and local monitoring capabilities.<ul style="list-style-type: none">• Structural analysis and evaluation and/or prediction of remaining service life using reduced concrete properties due to ASR distress. This option may require additional field investigation, non-destructive testing, and extensive laboratory testing to determine reduction of concrete properties and potential future ASR expansion.• Formal monitoring with a scheduled frequency, if indicated by structural analysis and evaluation. This option may require using additional monitoring techniques, such as “tell-tale” markers or crack displacement gages.• Permanent repair and/or strengthening.• Replacement of the structure.

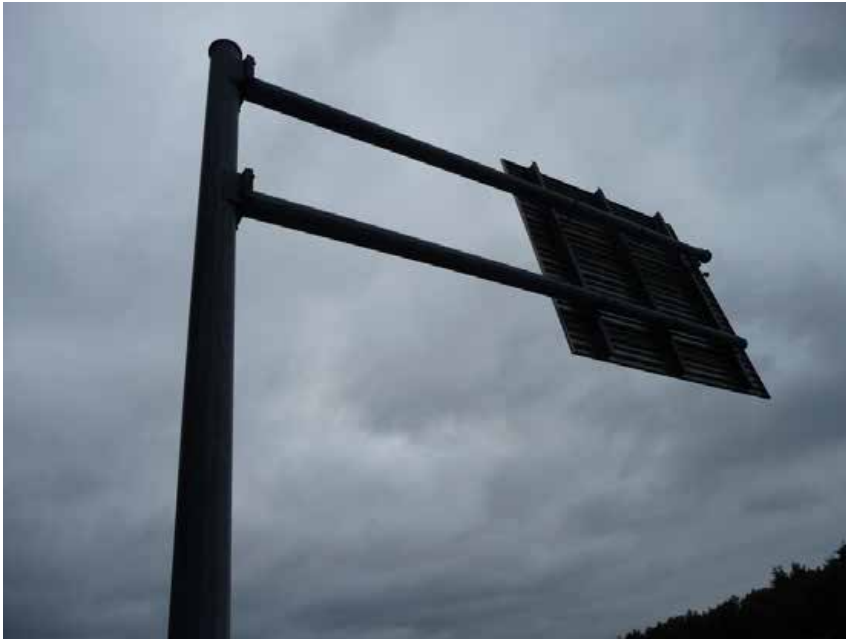
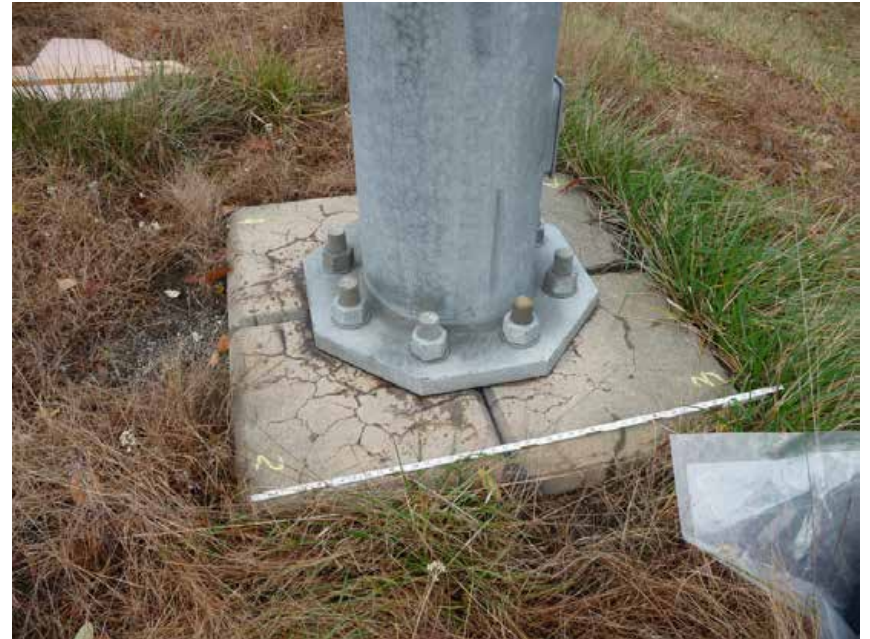
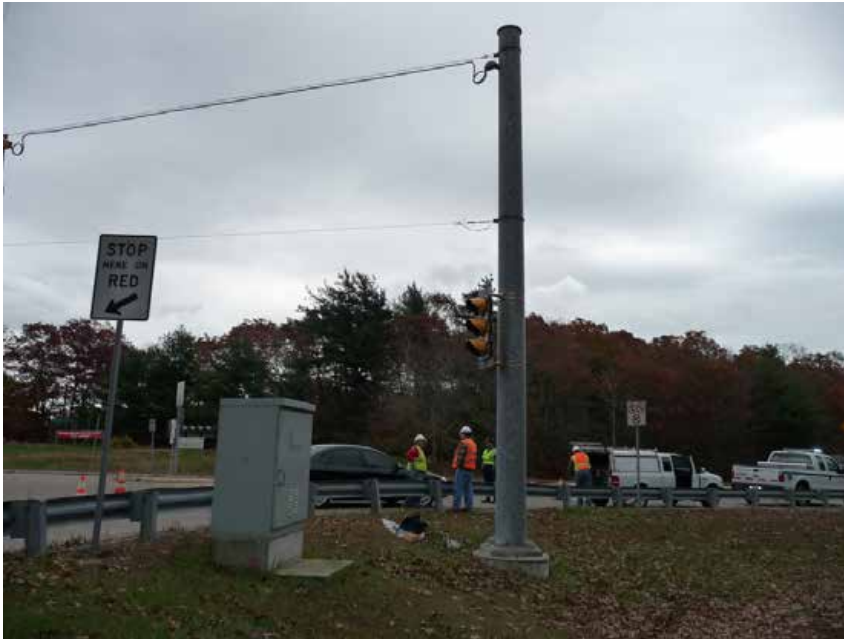
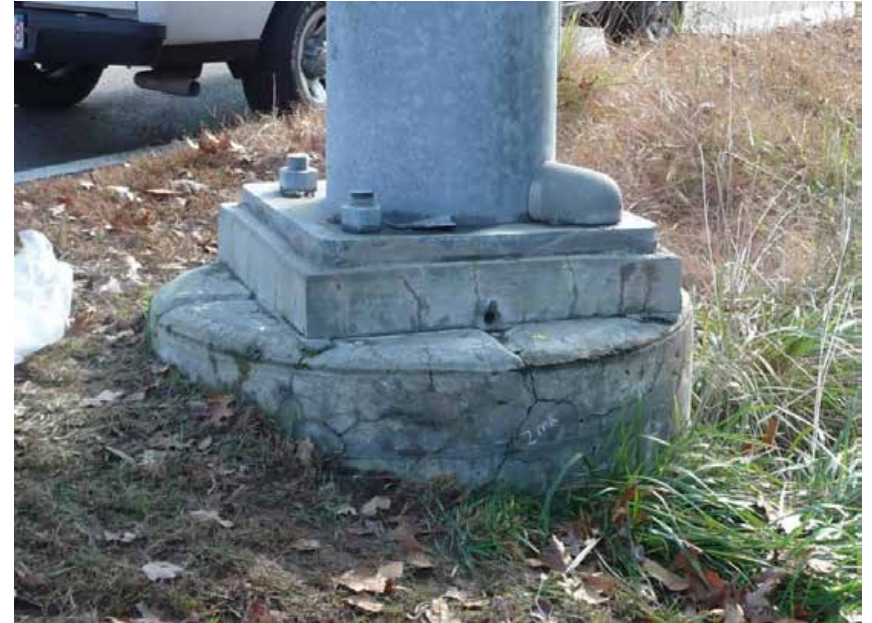
Rating 4 - Examples

4	Significant	<ul style="list-style-type: none"> Visually inspect and perform detailed crack survey and CI measurement <u>every three months</u> until implementation of a management and maintenance plan. Prepare and implement a structure-specific management and maintenance plan, as described for “Rating 3” above.
---	-------------	--
