Backscatter Computed Tomography to Enhance Culvert Rehabilitation

Increase Confidence and Expected Service Life for Rehab Projects

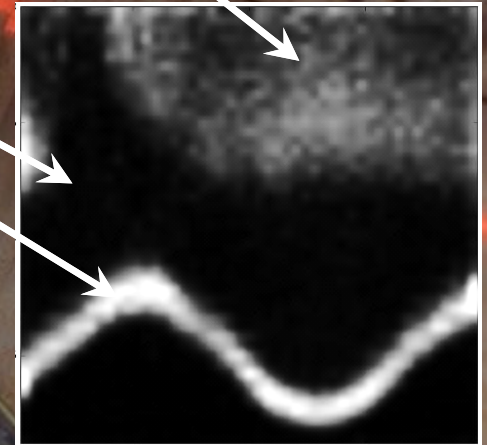
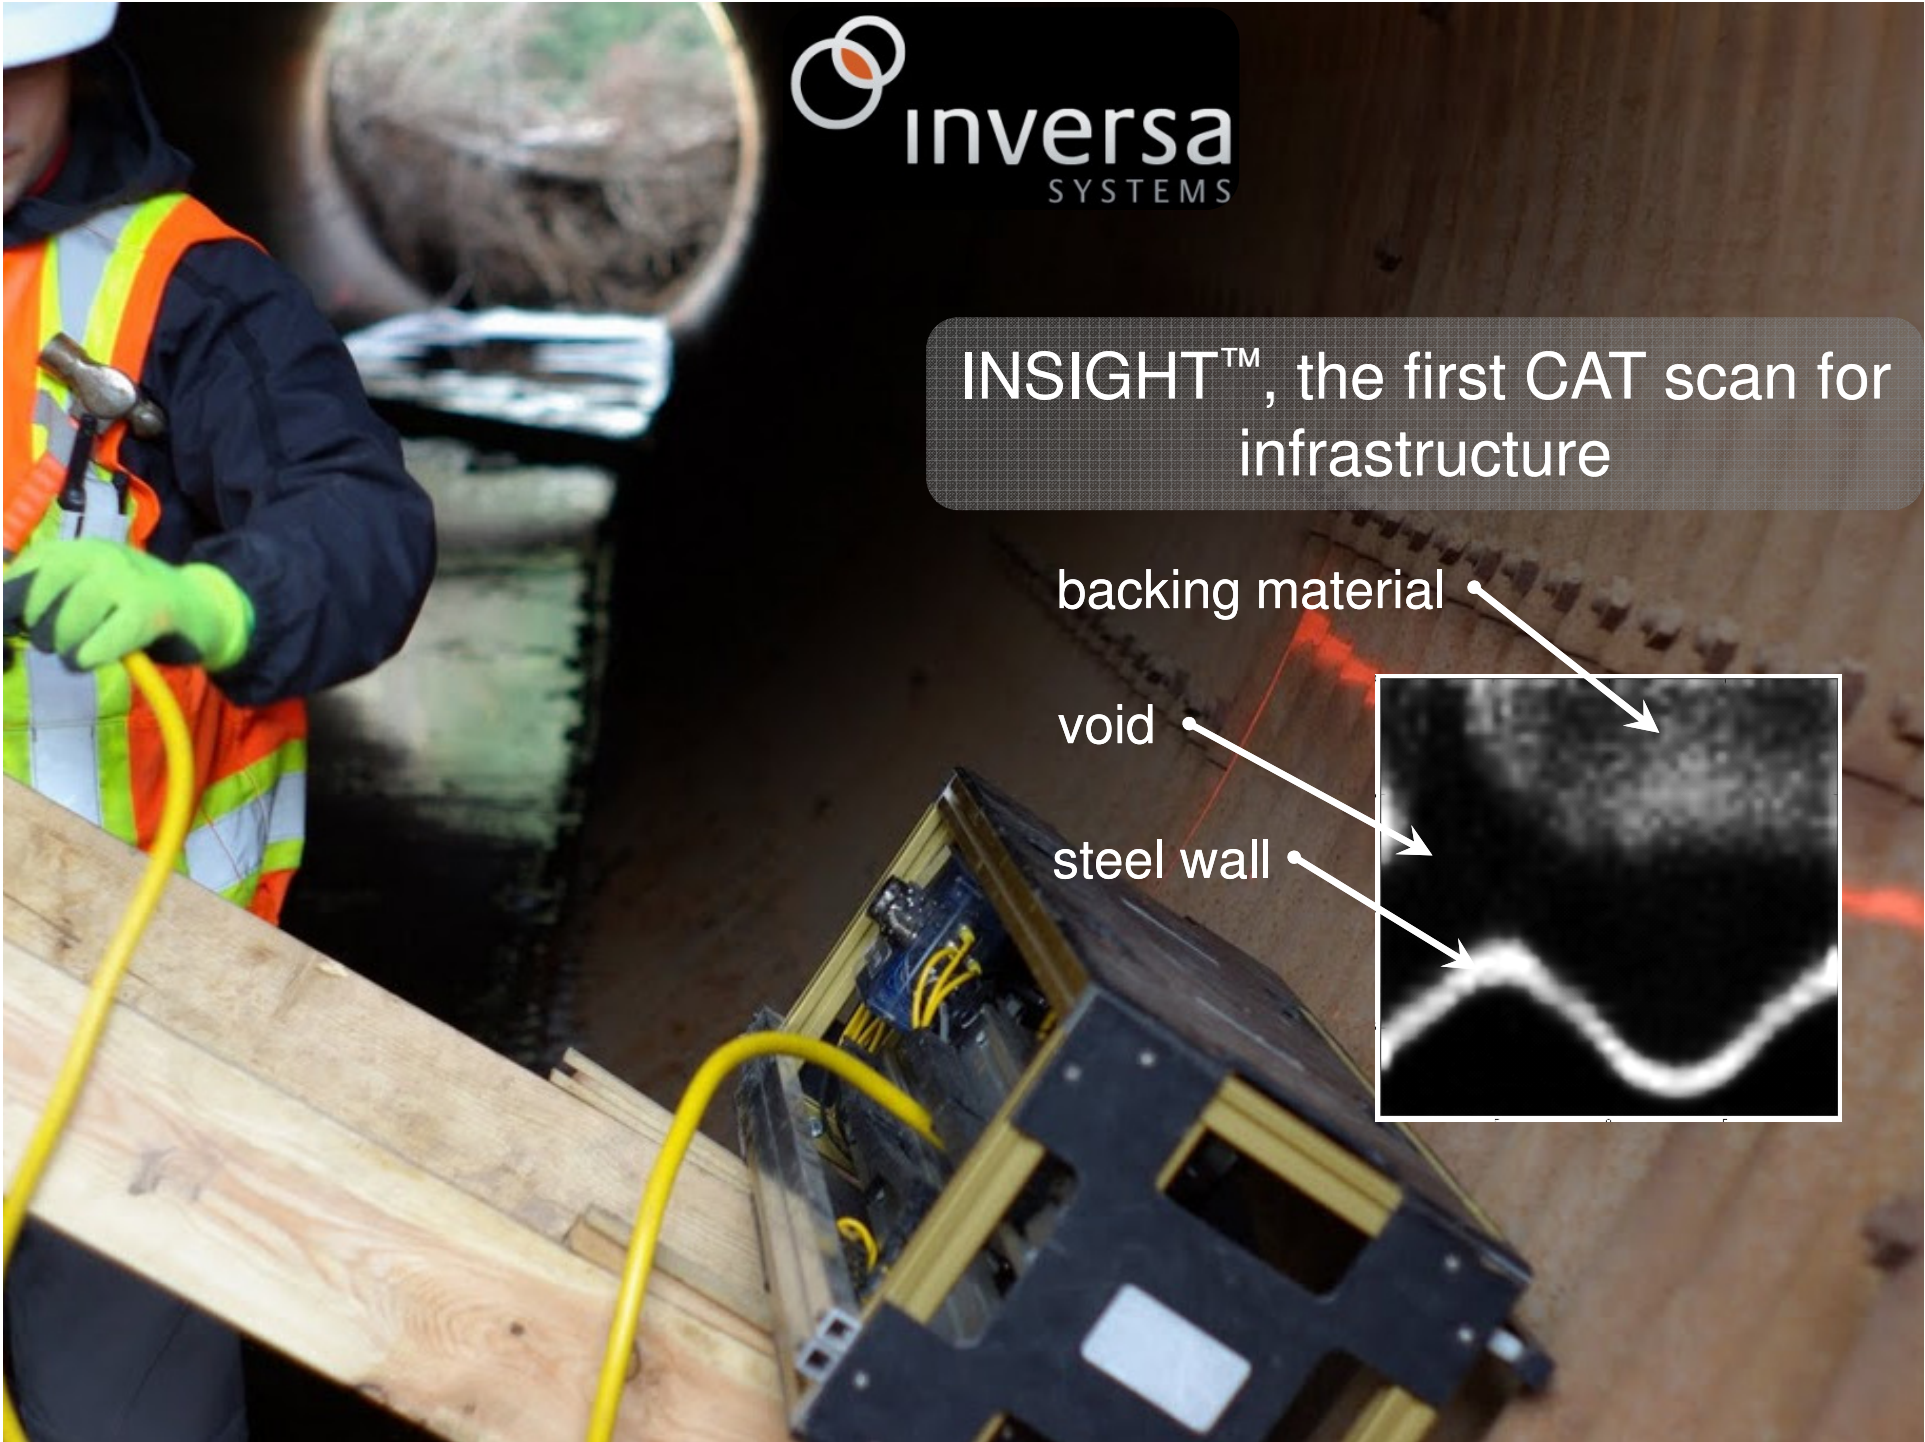
INSIGHT™, the first CAT scan for infrastructure

backing material

void

steel wall

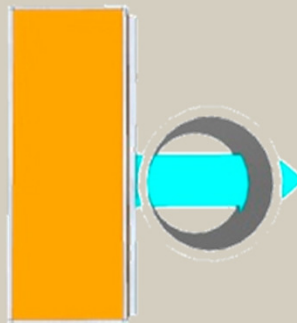
1

Scanner houses radiation collimator and detector

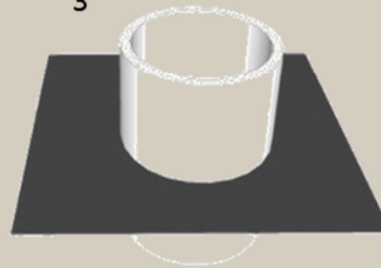
2

Scanner placed adjacent to asset of interest

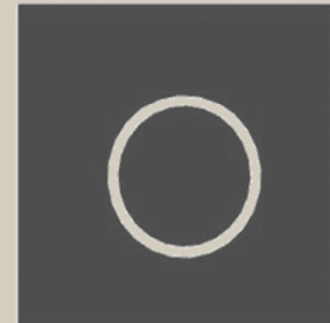
3

Data collected for a single plane through the asset

That data represents a density map of the asset

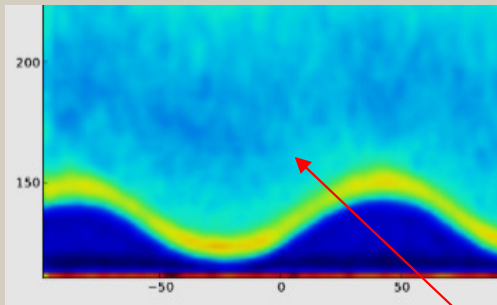
Sample BCT Images No Void

No Void

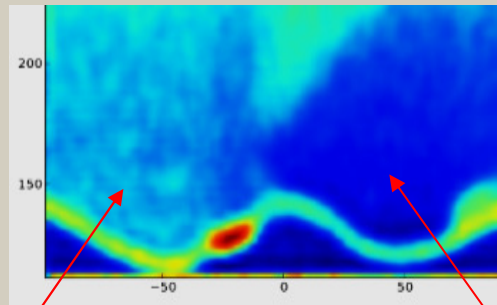
Transition to Void

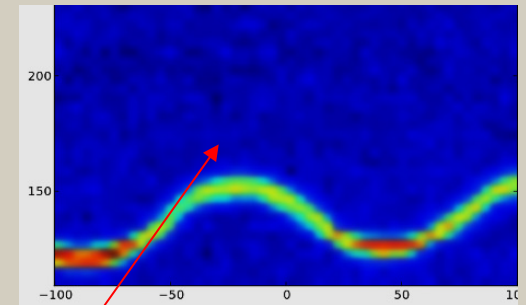
Void

Soil

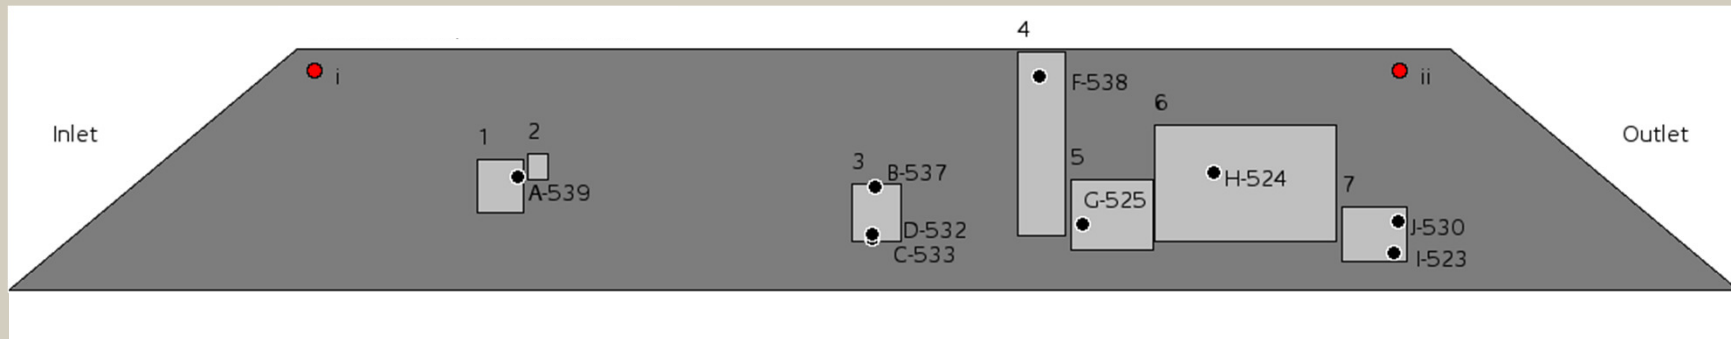
Inversa's Culvert Map

- To scale representation of the culvert including:
 - visual indicators
 - acoustic anomalies
 - BCT locations
- BCT provides conclusive structural diagnostics of the soil envelope
- All data in the culvert map is referenced in complete culvert report

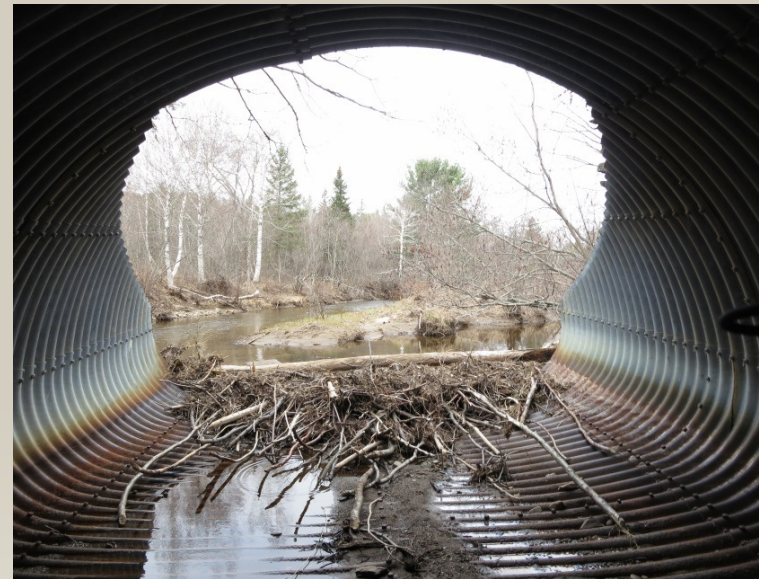
Large Void from Water Piping

A water channel
(piping)

Soil

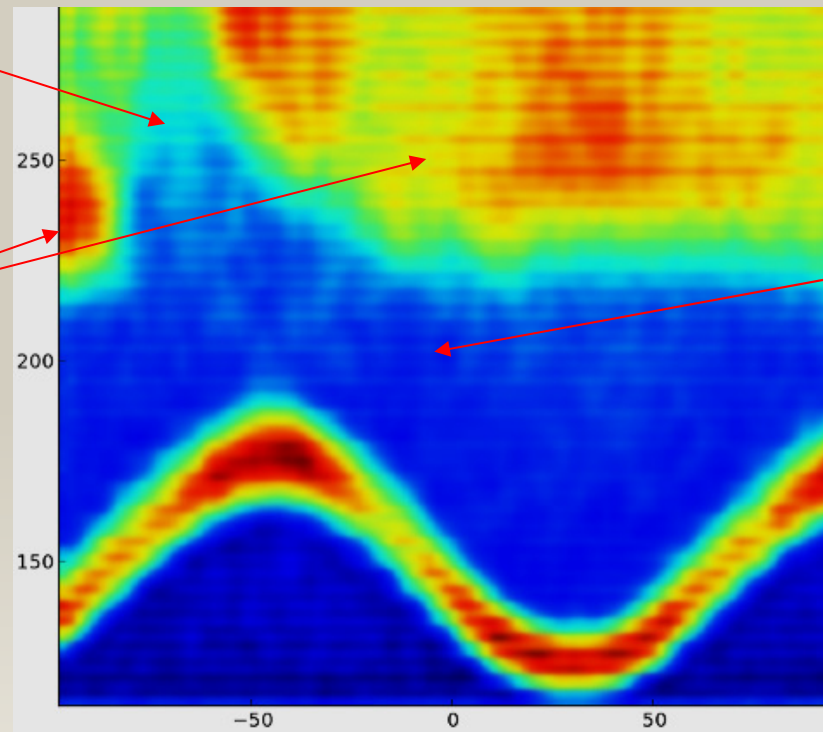
Void

Corrugated
Steel

Uniform Soil Void

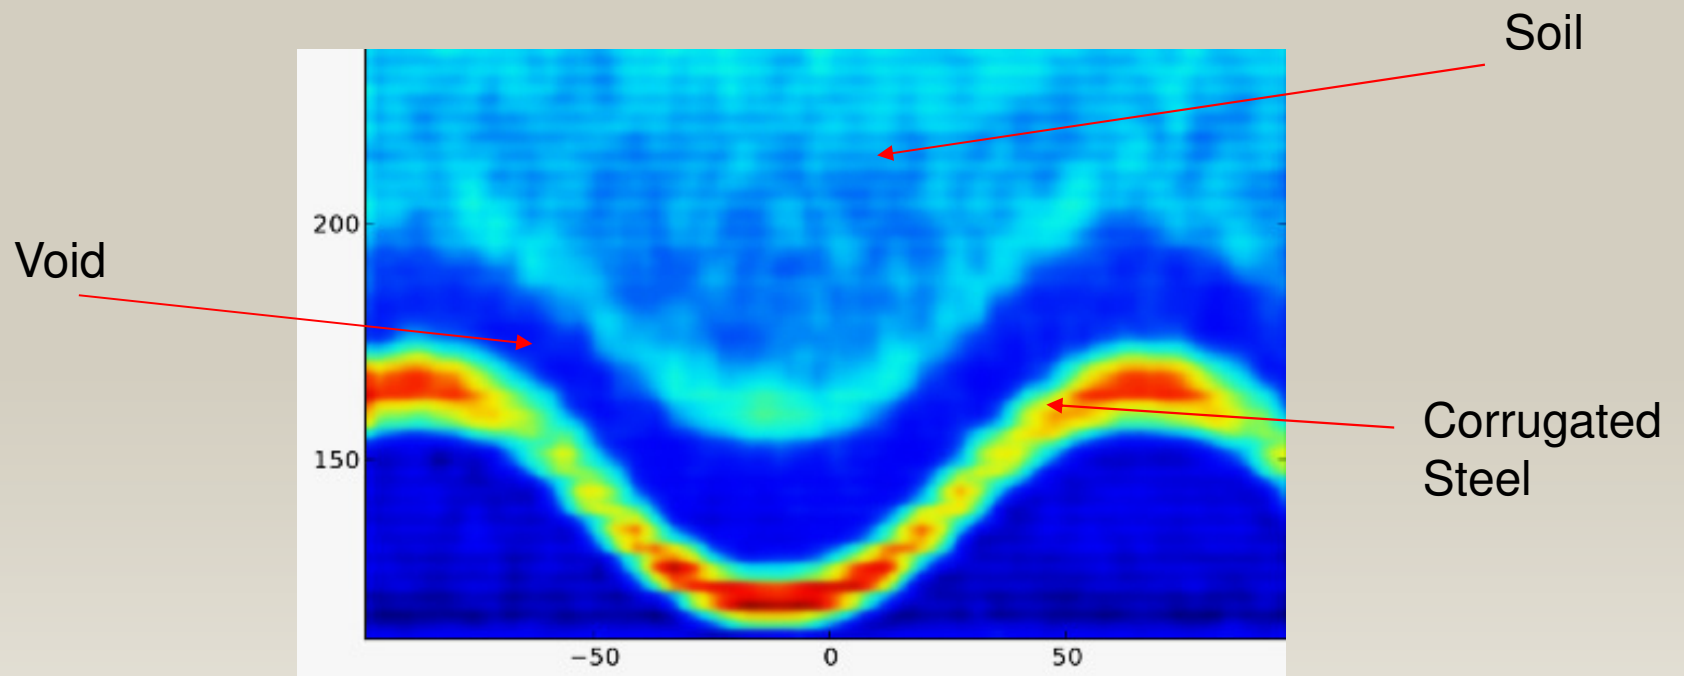
Uniform Void, Pipe Slippage

Corrugated
Steel

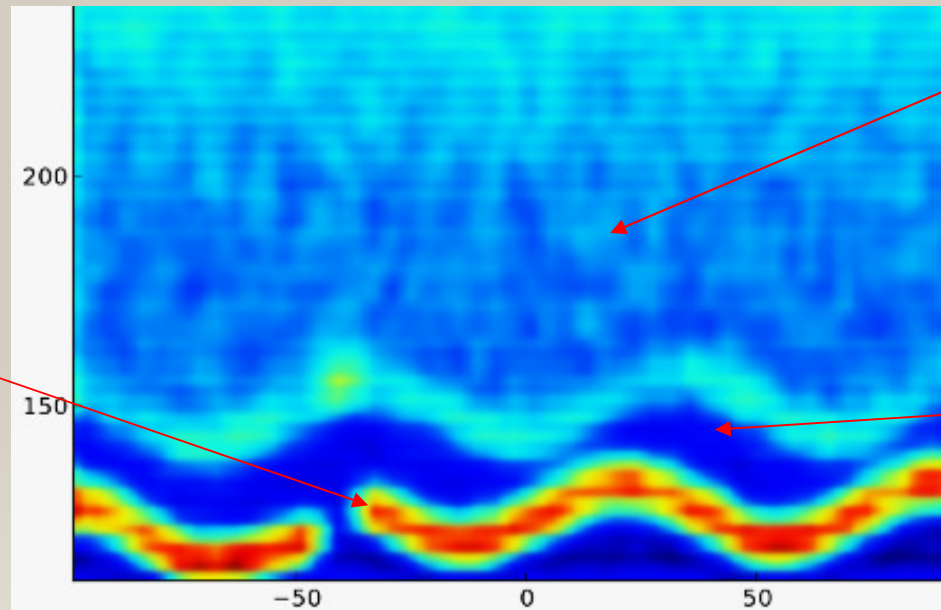
Soil

Void

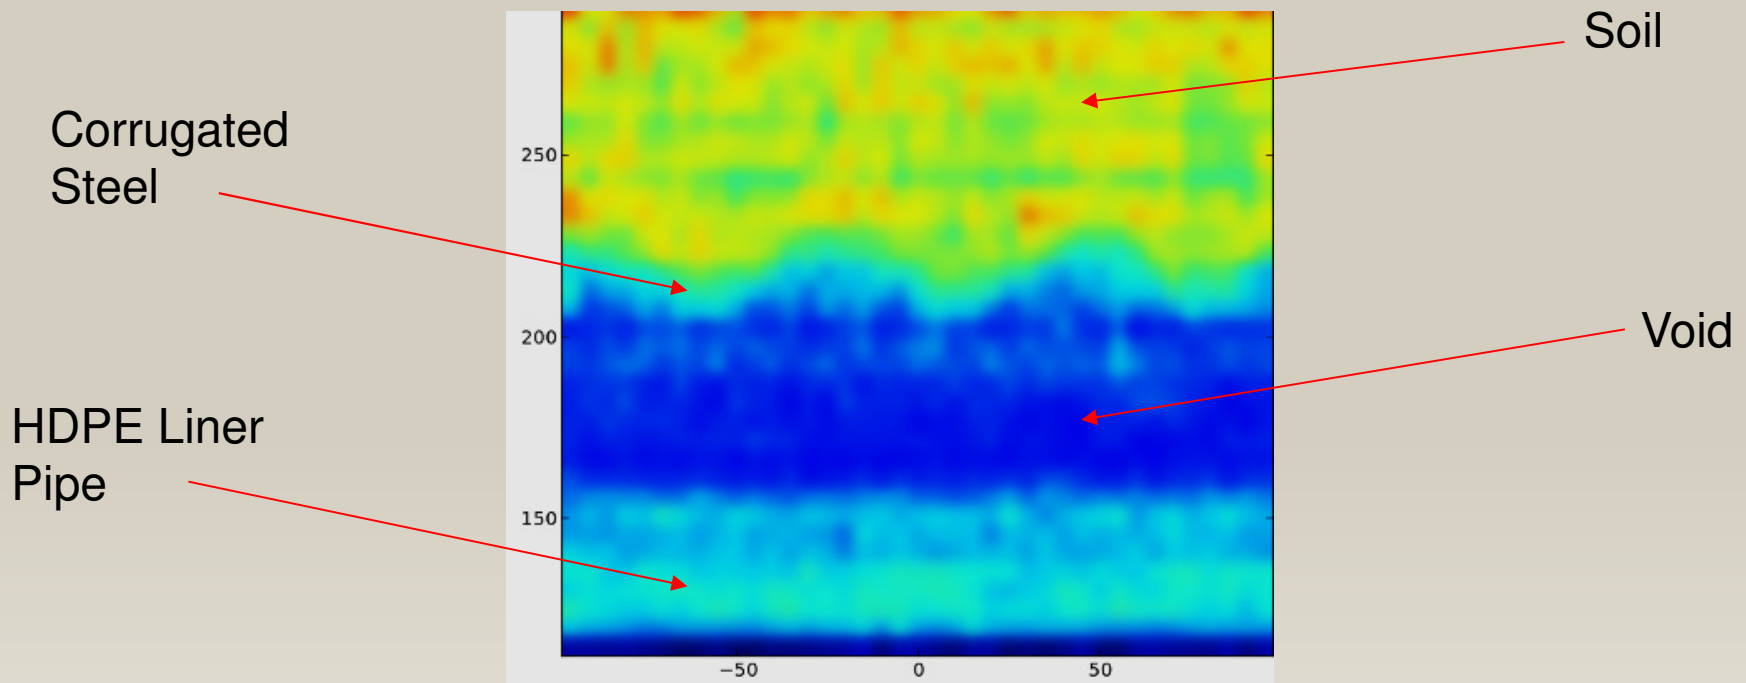
Post Liner Rehab Grout Placement

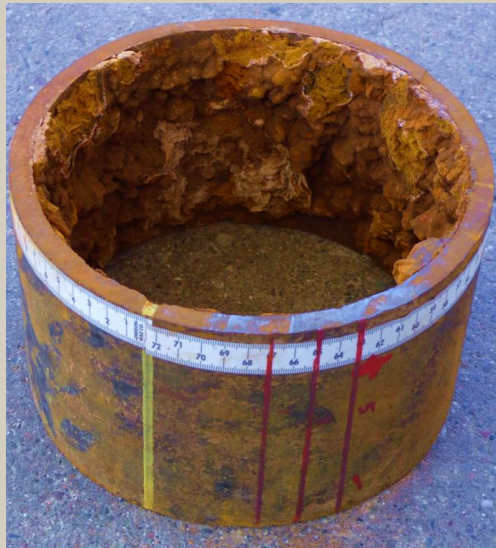
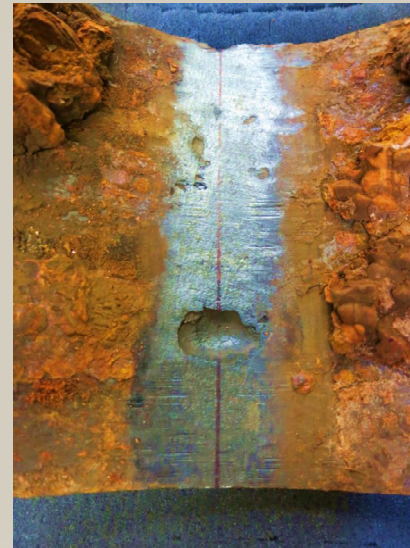
Cast Iron Water Pipe with Corrosion

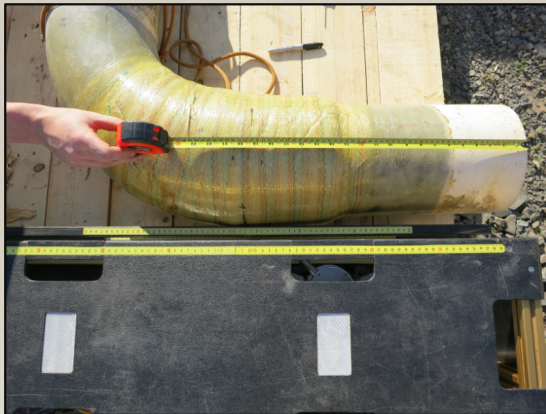
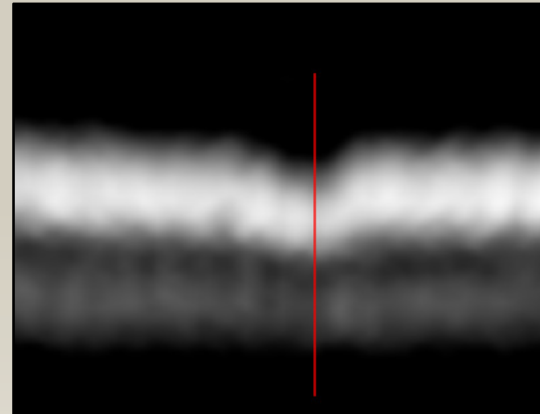
Composite Wrap Repaired Pressure Pipe

A BCT image of weld root corrosion on a out of service pipe sent to Inversa by client for qualification.

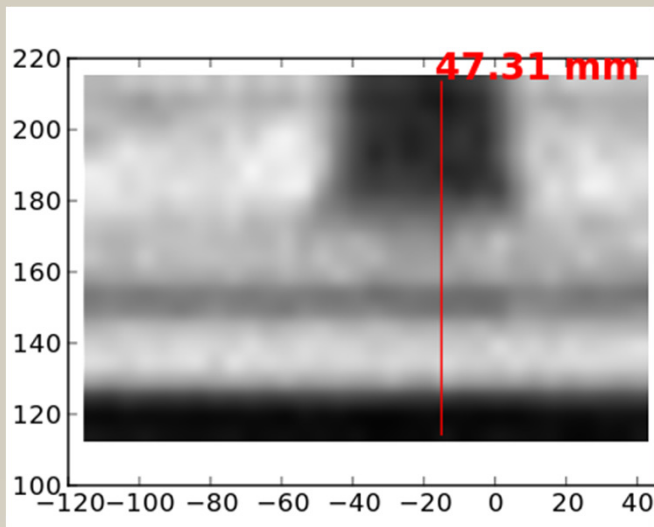
HDPE with Concrete and Void

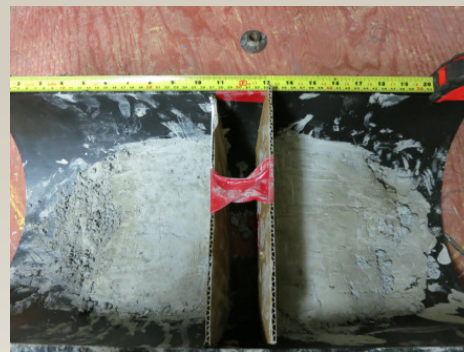
Figure R&D BCT image and graph of 2 layer HDPE pipe with concrete and simulated air gap

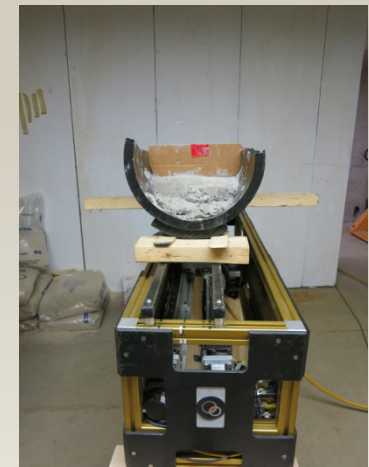
Figure R&D physical setup two 21mm thick layers of HDPE filled with concrete
