# Northeastern States Materials Engineer's Association

## Re-visiting Traffic Speed Deflectometry in Connecticut

Portland, ME  
Alex Bernier, PE MSc.  
Connecticut Advanced Pavement  
Laboratory  
Connecticut Transportation Institute  
University of Connecticut

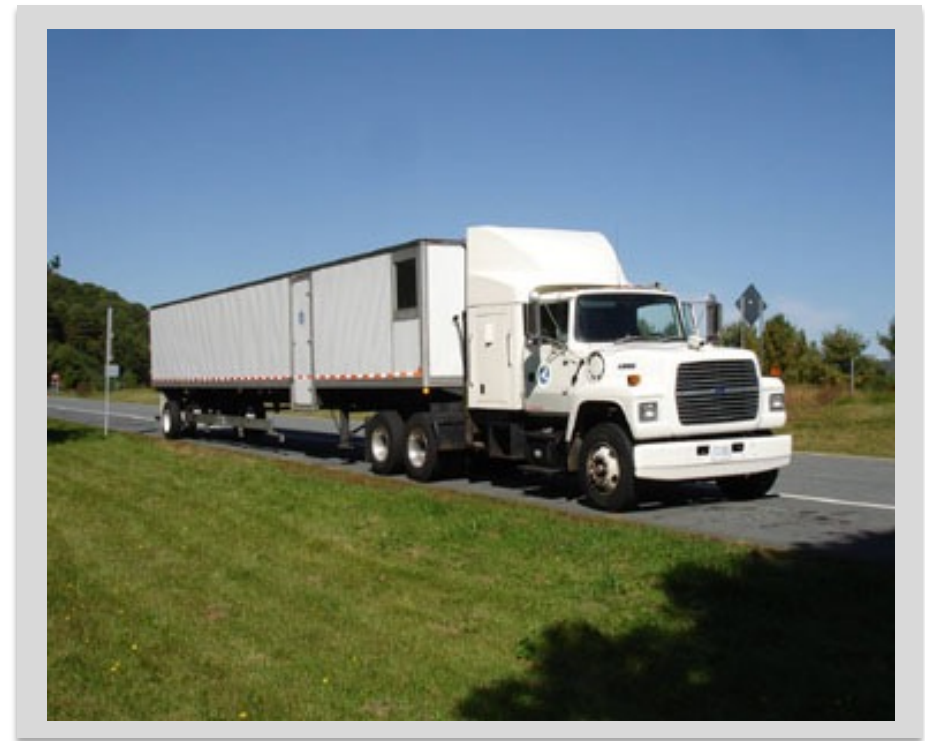
# Historical Experience: Rolling Weight Deflectometer

- September 2007
- 212 Lane Miles
- 26 Roadways
- Mean deflection values ranged from 5 to 13 mils
- ARA Analysis:
  - 15.4% Very Good
  - 61.5% Good
  - 23.1% Fair

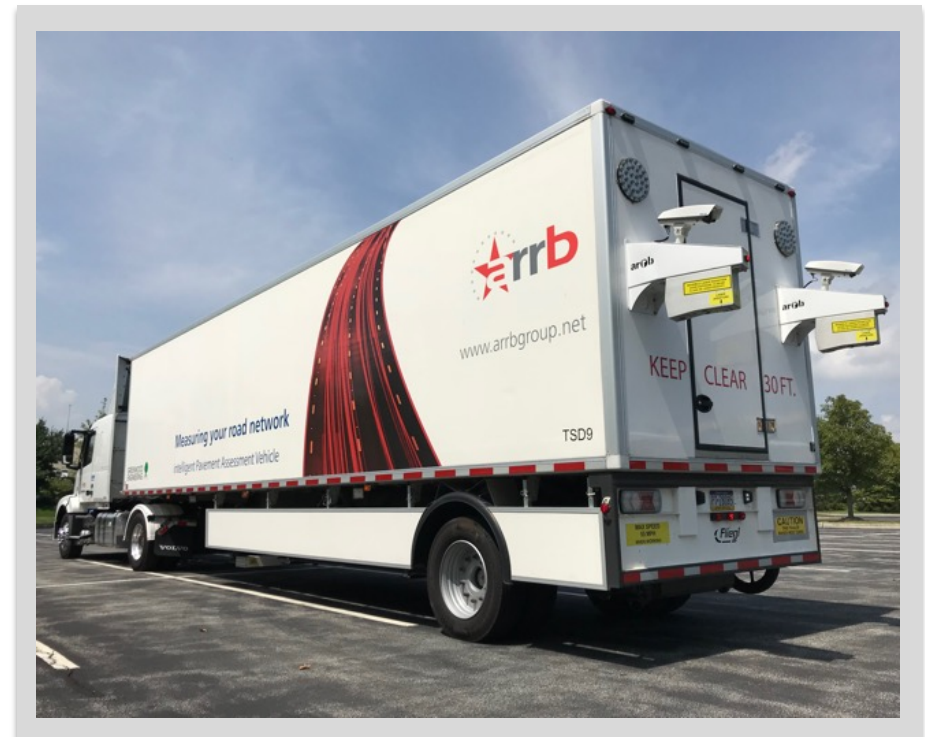
# The Device: Traffic Speed Deflectometer

- Surveyed over 1,300+ miles in 2018
  - 640 Miles Composite
  - 715 Miles Flexible
  - 16.6 Miles Concrete
- Recently completed 1,000+ mile survey this year

*IRI, Cracking, Rutting, Continuous Deflection, Geometry, Texture, GPS, Imaging*

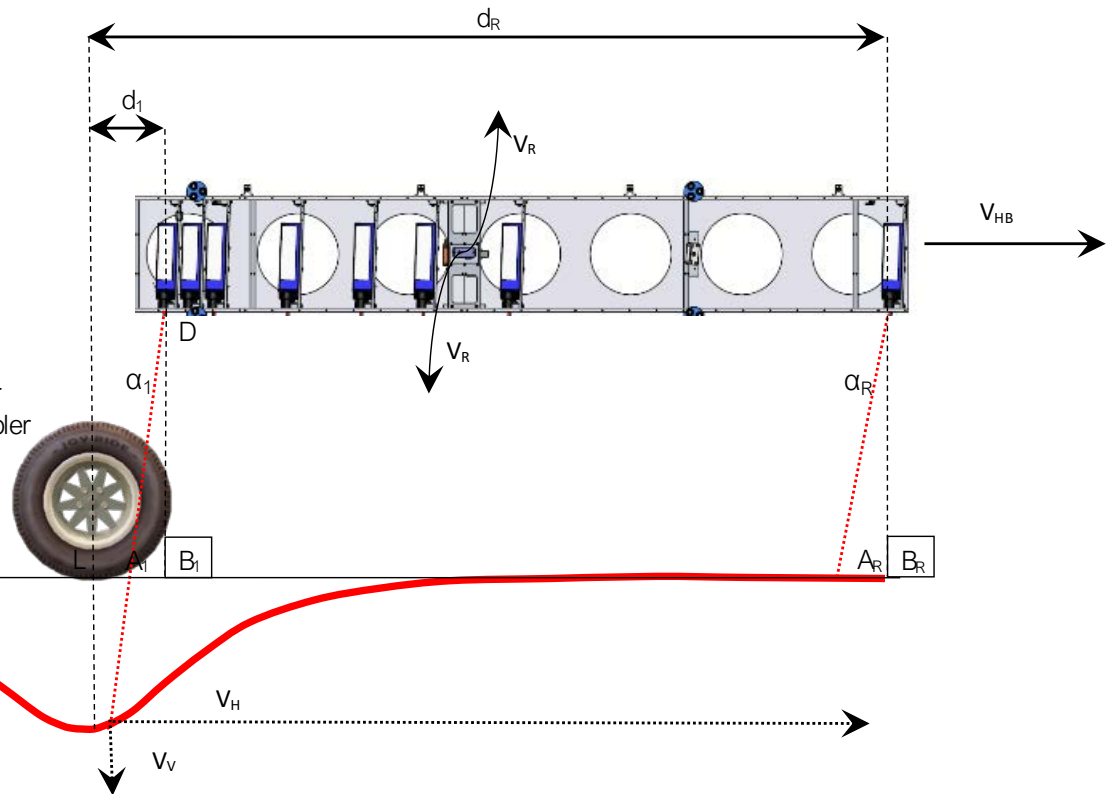
# Dynamic Deflection Measurement

- L = centre of load (known fixed)
- D = the doppler (known fixed)
- $D_1$  = distance from load to Doppler (known fixed)
- $D_R$  = distance from load to Reference Doppler (known fixed)
- $\alpha_1$  = the angle of the measurement Doppler (calibrated fixed)
- $\alpha_R$  = the angle of reference Doppler (calibrated fixed)
- $A_1$  = doppler measurement location (calculated)
- $A_R$  = doppler measurement location (reference calculated)
- $B_1$  = vertical projection of the measurement (calculated)
- $B_R$  = vertical projection of the reference measurement (calculated)

- $V_{\text{raw}}$  = Vertical velocity of pavement surface – raw measure by Doppler
- $V_{\text{Hraw}}$  = Horizontal velocity of pavement surface – raw measure by Doppler
- $V_{\text{HB}}$  = Horizontal velocity of beam – measured by DMI
- $V_r$  = Velocity of beam rotation – measured by gyroscope

- Vertical velocity of pavement surface =  $V_V$
- Horizontal velocity of pavement surface =  $V_H$
- Deflection Slope =  $V_V/V_H$

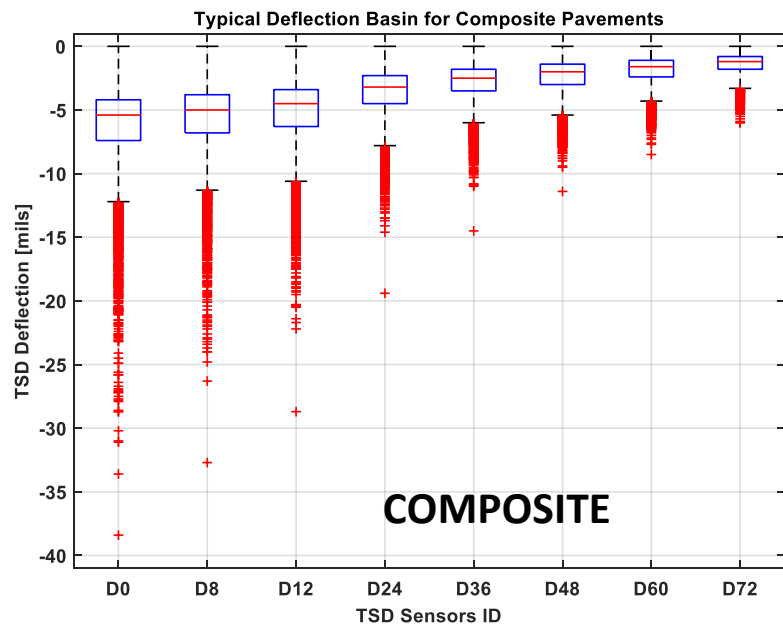
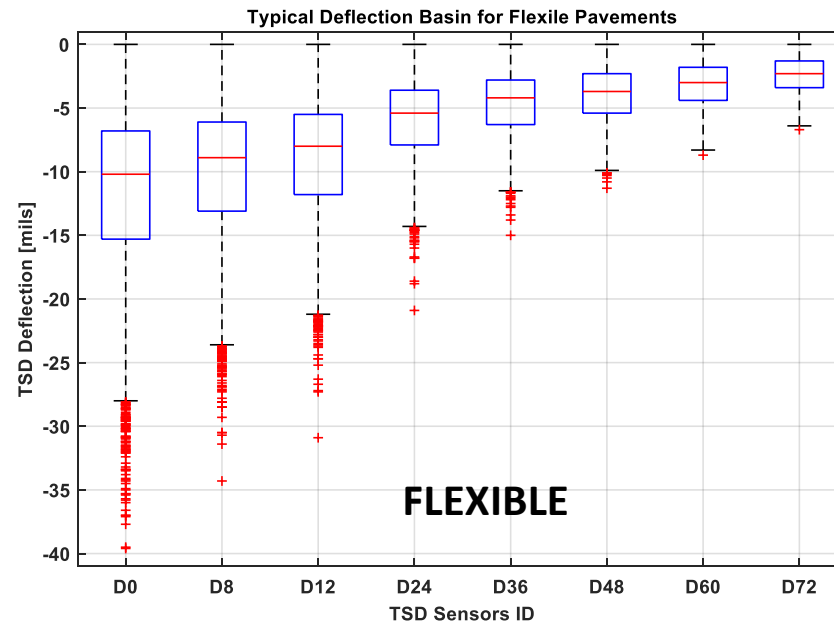
## Sample Distribution of Deflection Basins

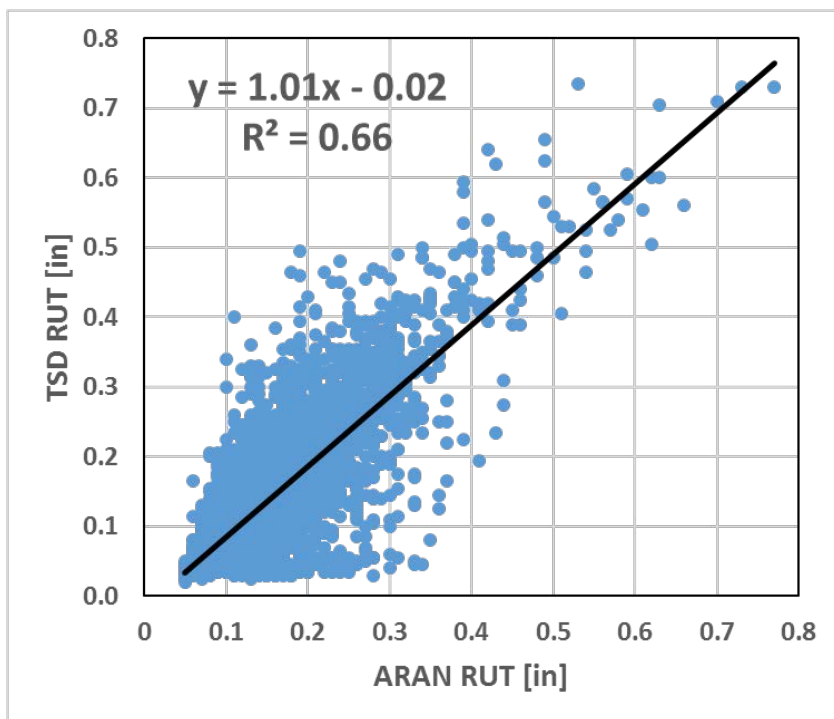
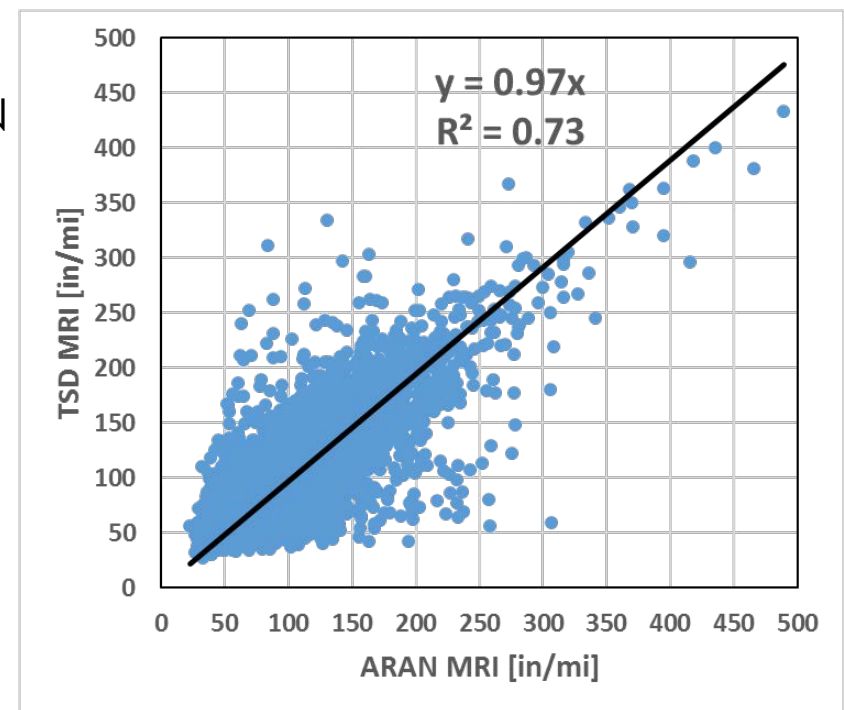
TSD vs. ARAN  
MRI →  
← RUT

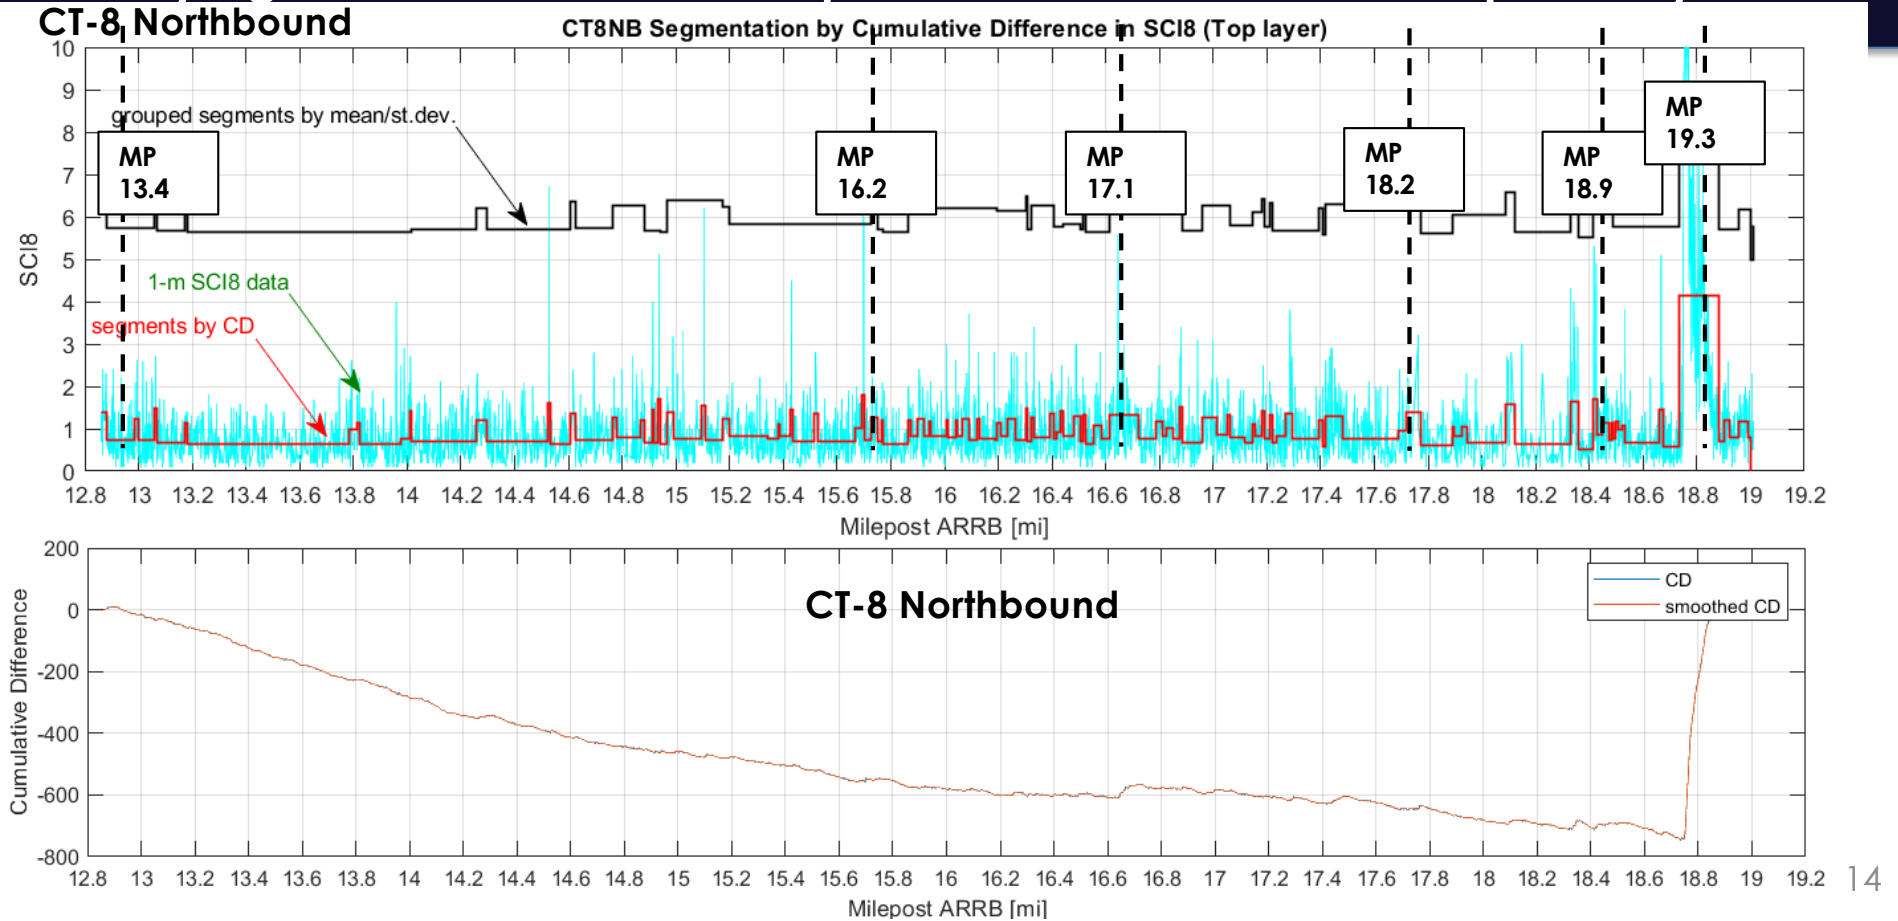
Method 1: Cumulative Difference

## Identifying uniform sections and problematic locations in top AC layer

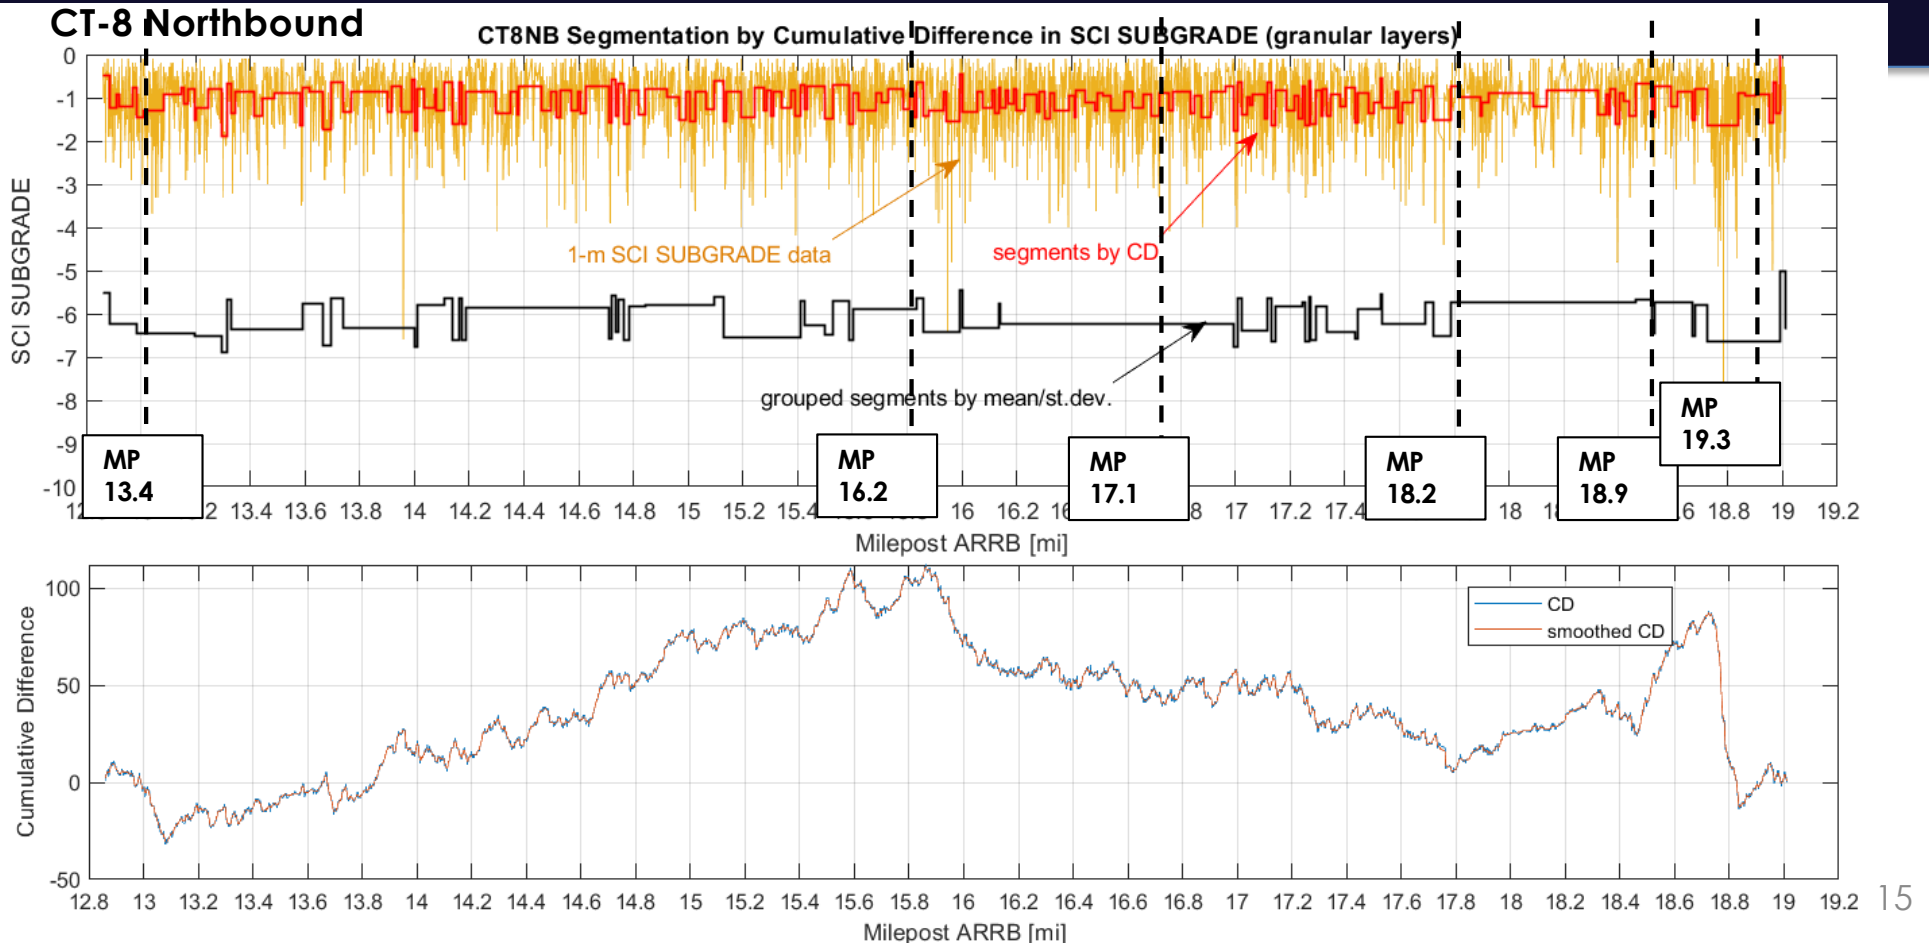
Identifying uniform sections and problematic locations in subbase layers

Method 1: Cumulative Difference

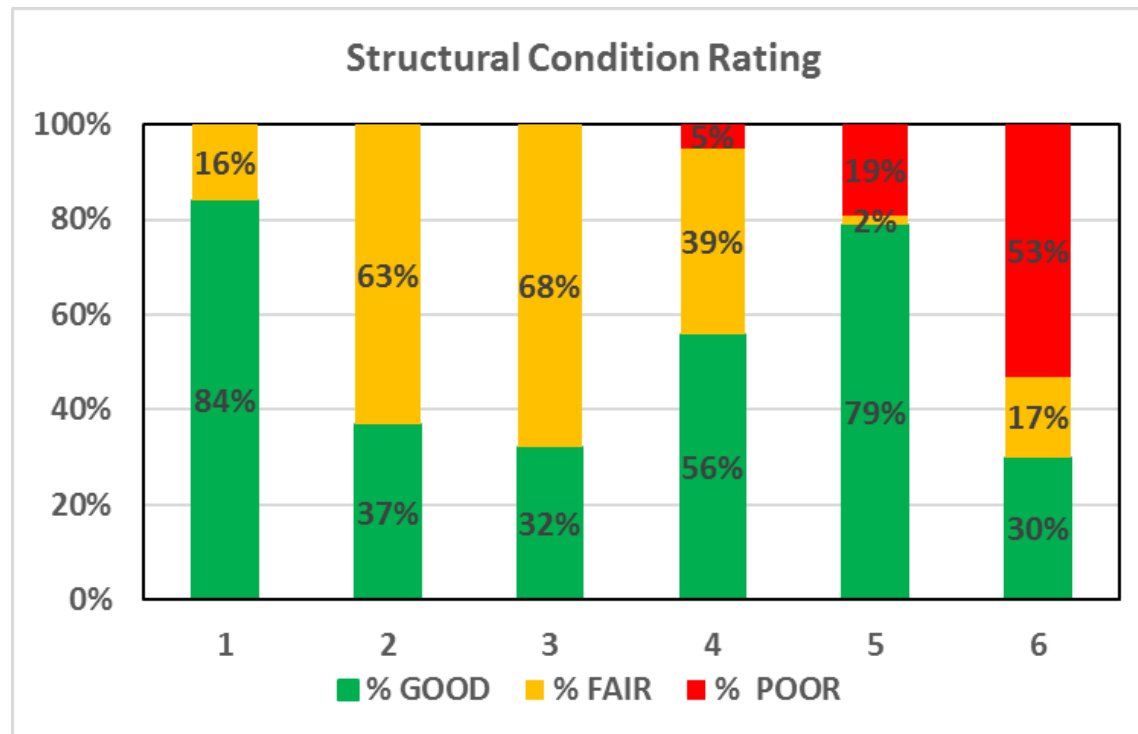
## Summary of Structural Condition as Estimated from the Deflections

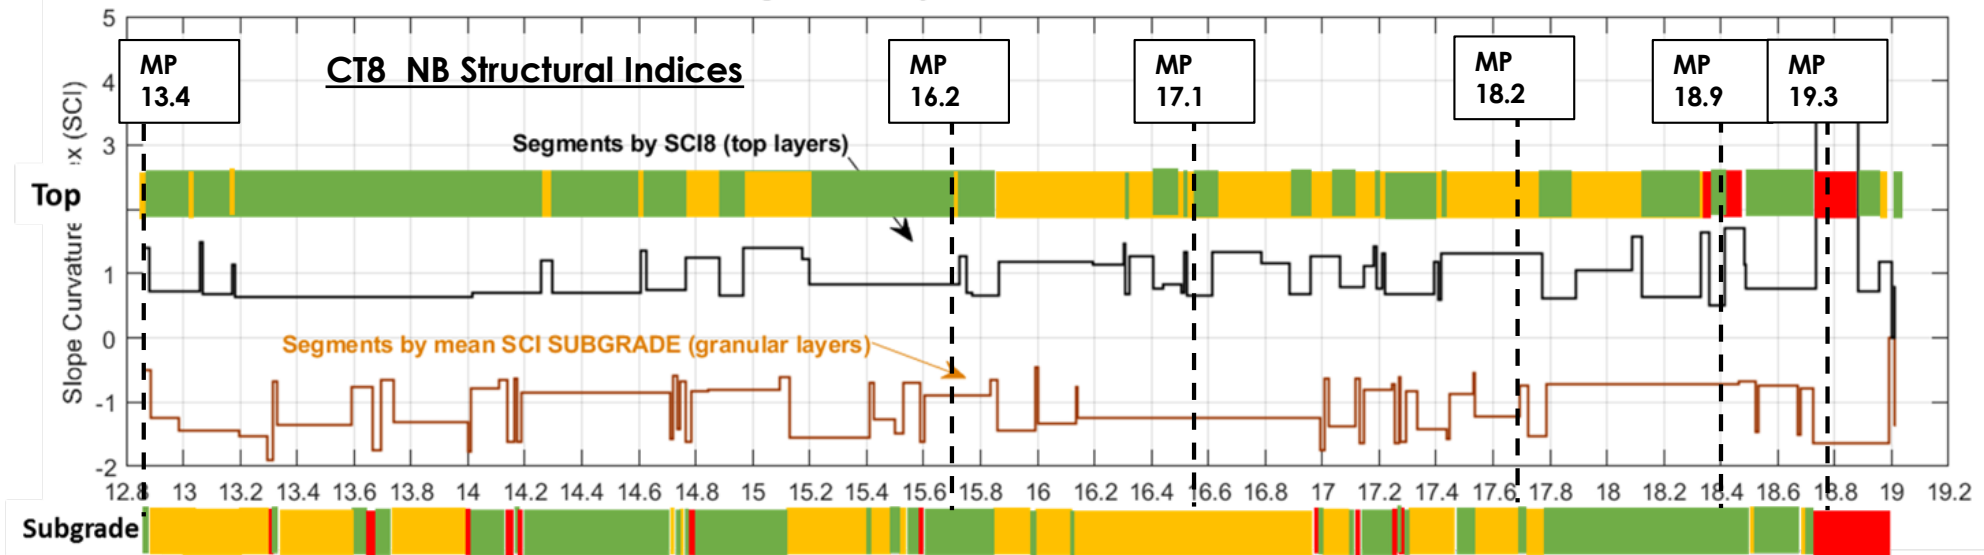
## Superposition of segments by structural and functional ratings

### CT8 NB Functional Indices

CT8NB Segmentation by Cumulative Difference in Structural Indices

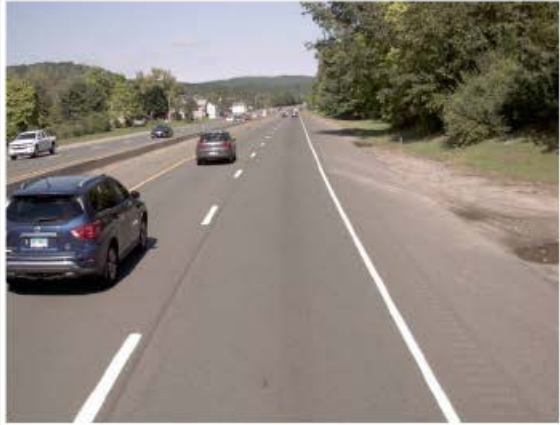
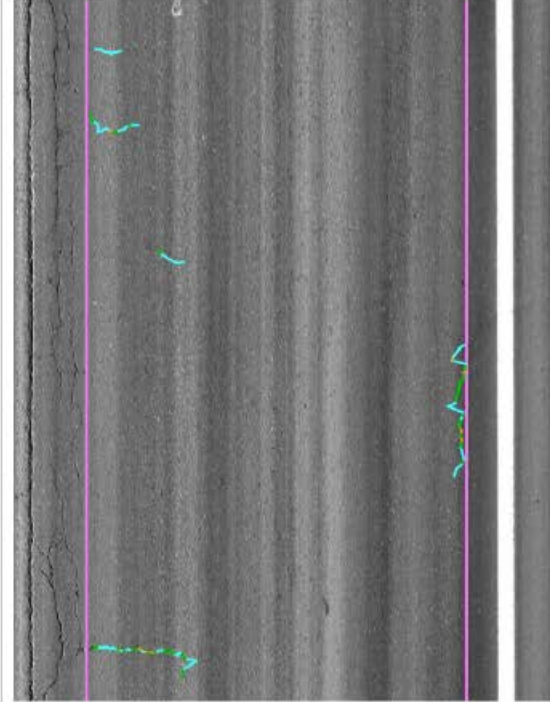
## Example of High SCISUBGRADE with no related surface distress

Road ID/Notes	Chainage	Forward Camera (-1)	Pavement Camera
<p data-bbox="239 574 352 630">CT-8 NB/ Forward</p> <p data-bbox="239 662 415 834">Joints not fully reflected to surface, TSD data may be indicative of poor LTE.</p> <p data-bbox="239 867 428 889">SCISUBGRADE: -4.3</p>	<p data-bbox="464 574 562 597">18.9624</p>	<p data-bbox="600 574 877 597">2018 - Road ID: CT-8 CT Route 8 Forward 18.962mi L0 [Front Center]</p> <p data-bbox="600 597 806 613">Lat/Lon: 41.40724, -73.96946 Collected: 29 Sep. 2018 11:56:32 am</p>

<p data-bbox="1188 574 1598 597">2018 - Road ID: CT-8 CT Route 8 Forward 18.962mi L0 [ACD]</p> <p data-bbox="1188 597 1528 613">Lat/Lon: 41.40724, -73.96946 Collected: 29 Sep. 2018 11:56:32 am</p>

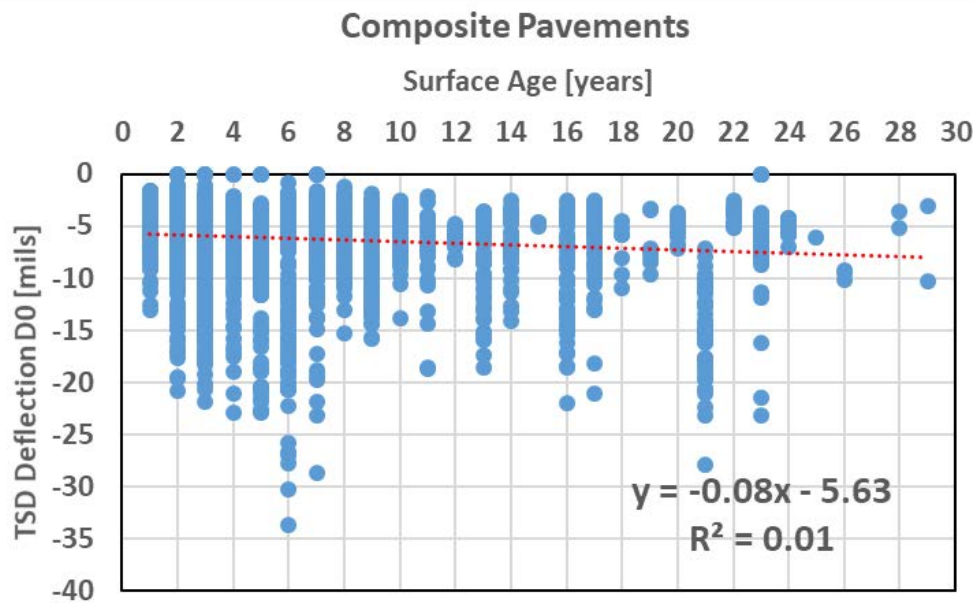
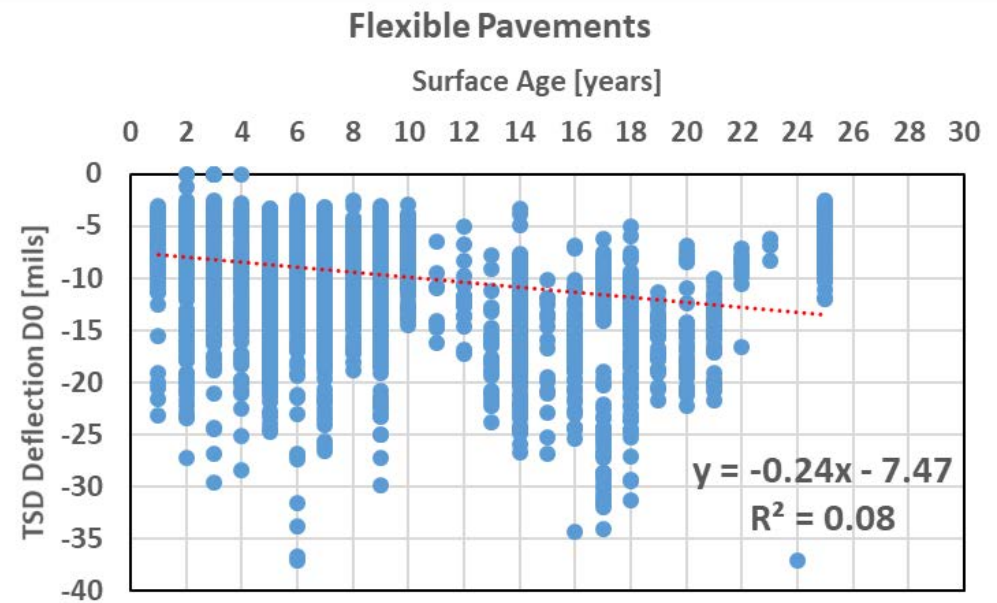
## Deflection (D0) vs. Age

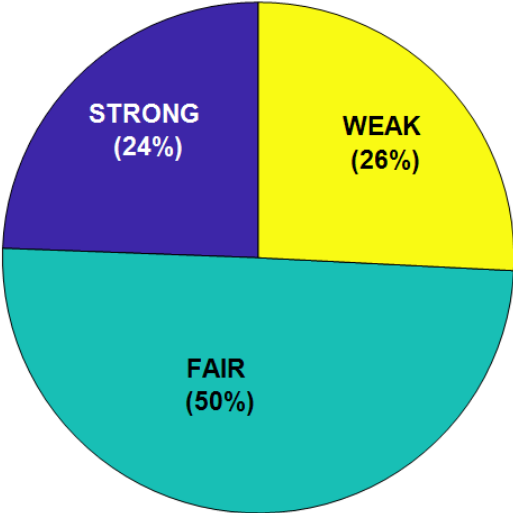
Composite

Rating	Criteria
STRONG	$D0 < 4.2$ (25 <sup>th</sup> percentile)
FAIR	$4.2 \leq D0 \leq 7.0$ (75 <sup>th</sup> percentile)
WEAK	$D0 > 7.0$

Rating by Percentile of D0

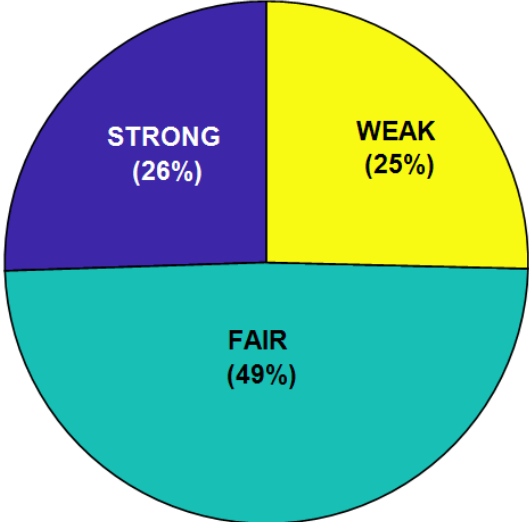
Flexible

Rating	Criteria
STRONG	$D0 < 6.0$ (25 <sup>th</sup> percentile)
FAIR	$6.0 \leq D0 \leq 11.8$ (75 <sup>th</sup> percentile)
WEAK	$D0 > 11.8$

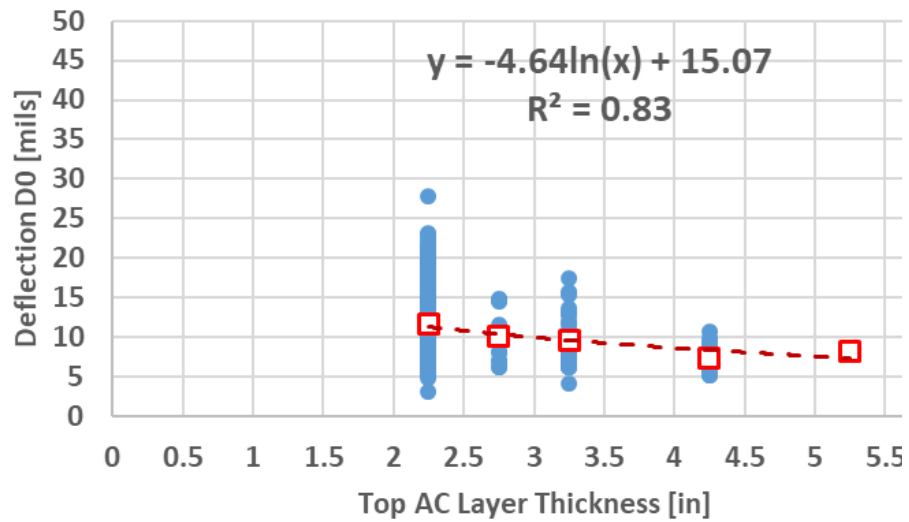
Composite Pavements

## Estimating Pavement Thickness
