Superpave In-Situ Stress/Strain Investigation (SISSI)

AN OVERVIEW AND A LOOK AT RESULTS

Mansour Solaimanian, Ph.D., P.E.
Pennsylvania Transportation Institute
The Pennsylvania State University

NESMEA Meeting
Burlington, Vermont
October 19, 2005

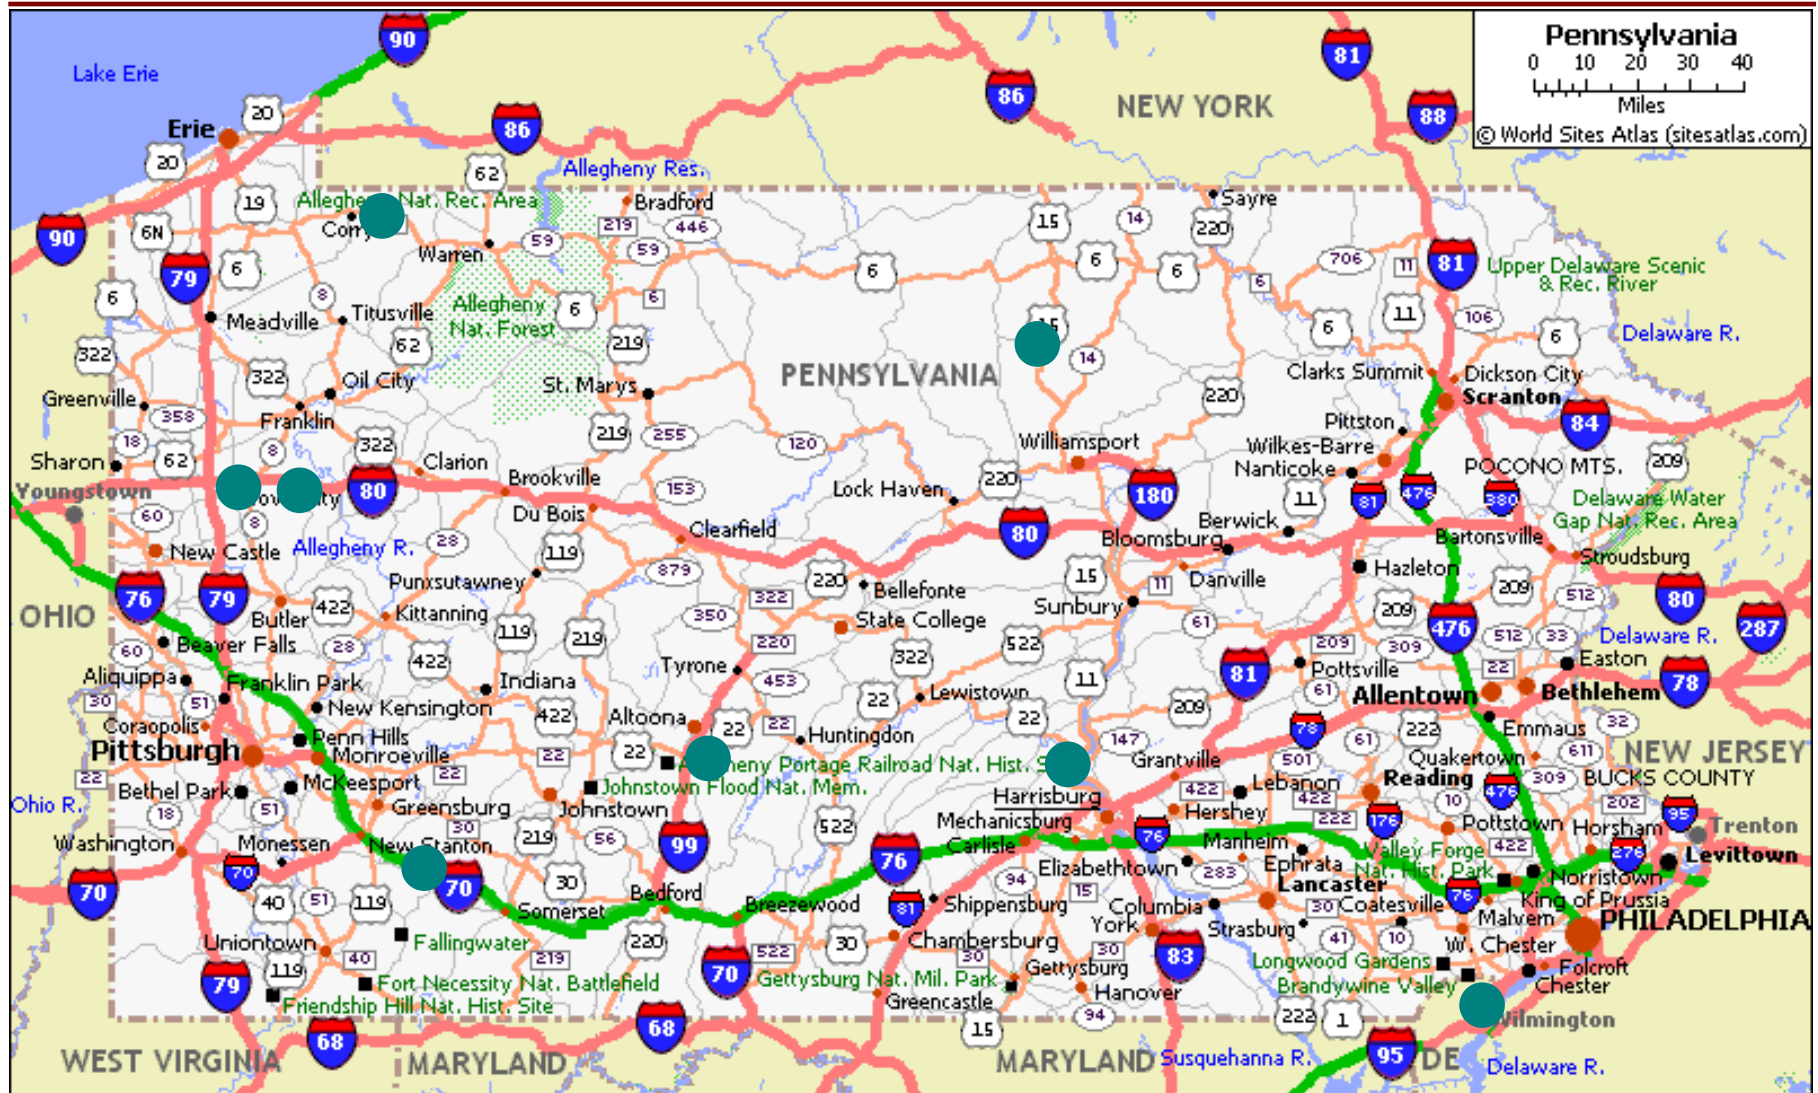
Location of Sites

- Eight sites
- Two pavement types
 - ✓ Structural overlays
 - ✓ New full-depth asphalt construction
- Two traffic levels
 - ✓ Under 30 million ESAL's
 - ✓ Over 30 million ESAL's
- Two climatic zones
 - ✓ North and south of I-80

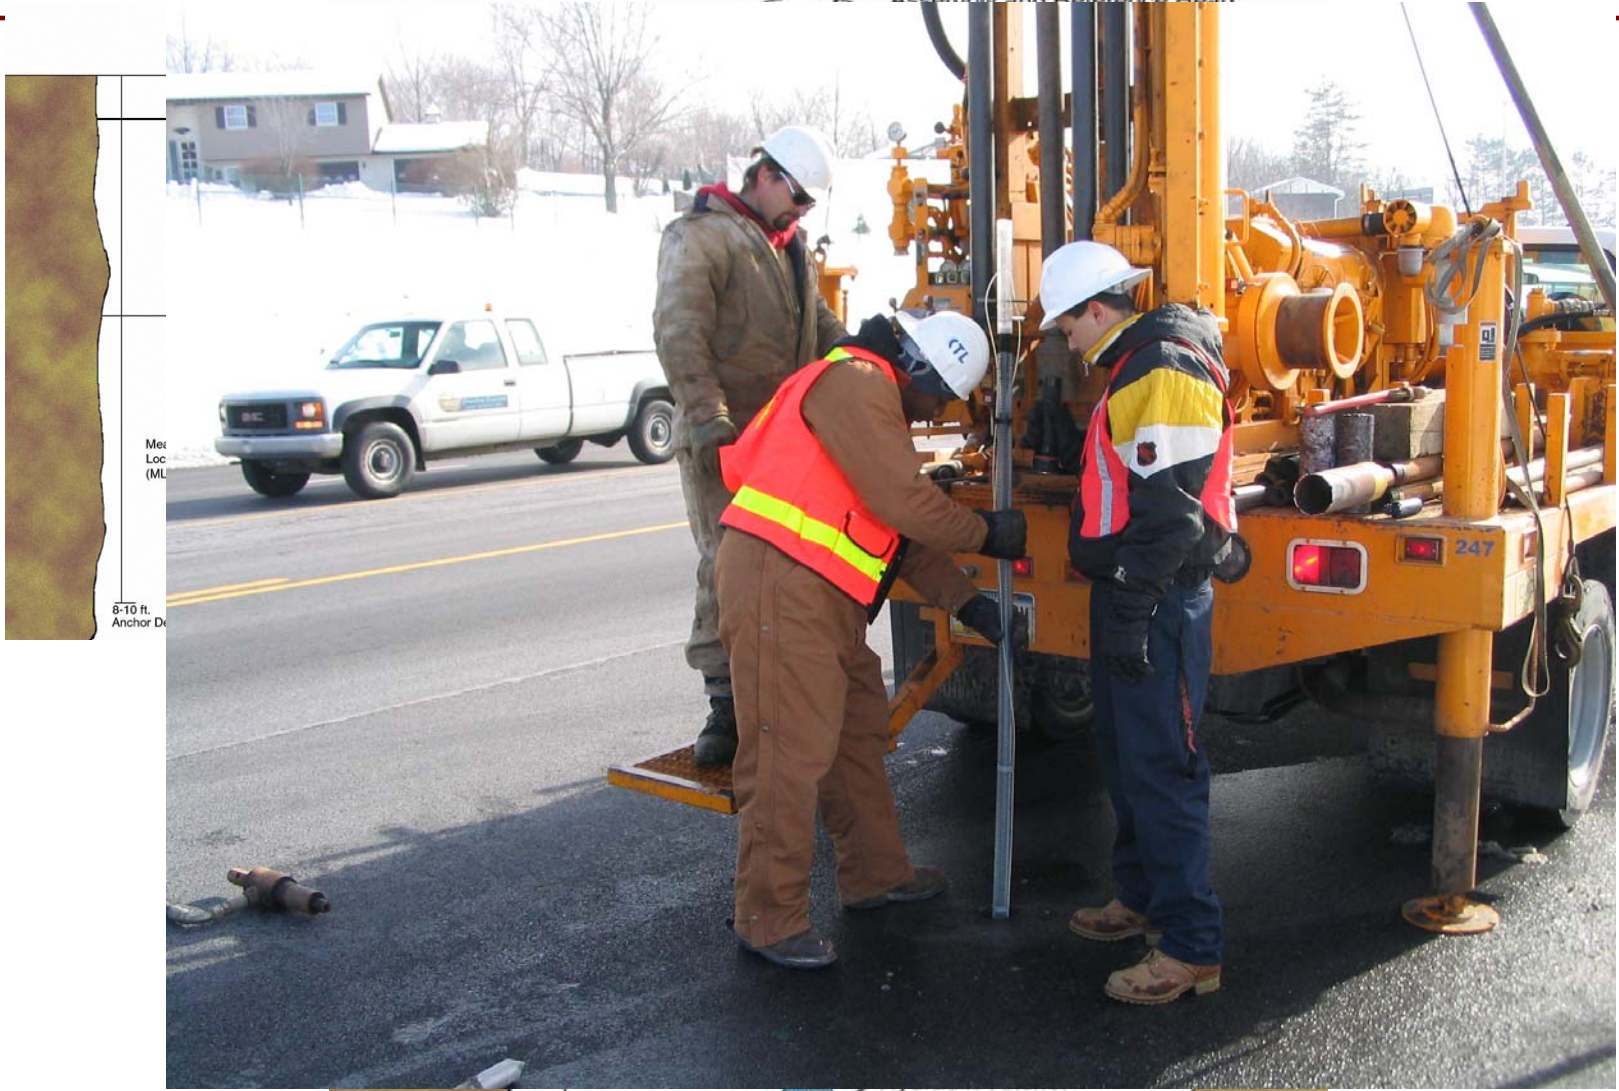
Multi-Depth Deflectometer (MDD)

Road Box for
Displacement Transducer
Assembly and Reference Head

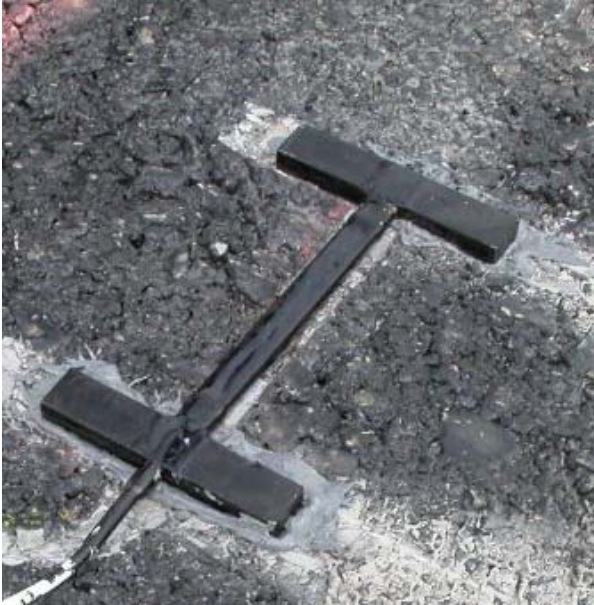
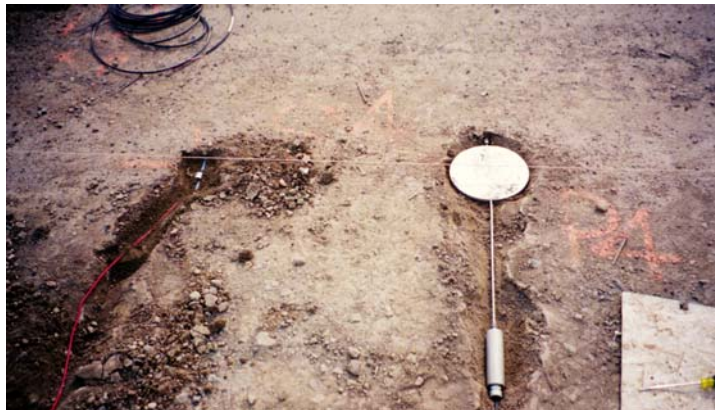
Strain Gage and Pressure Cell

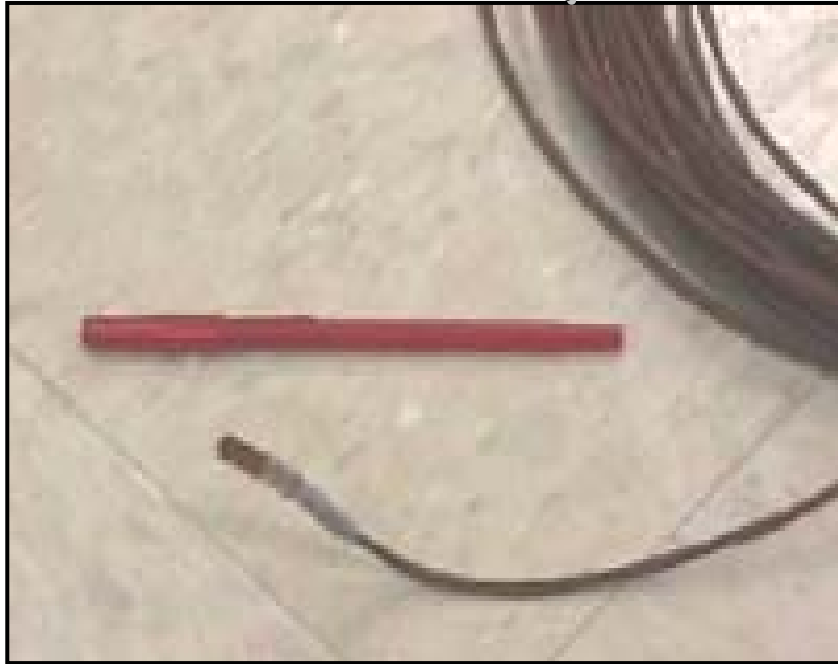
Thermocouples

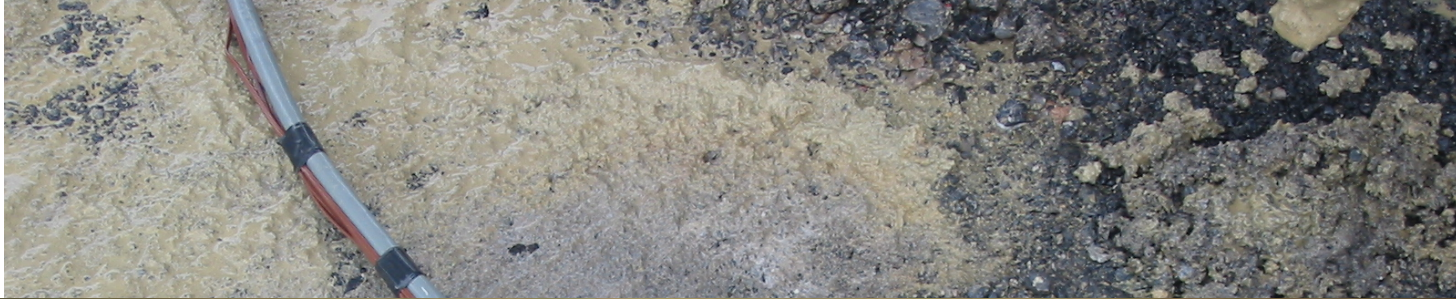
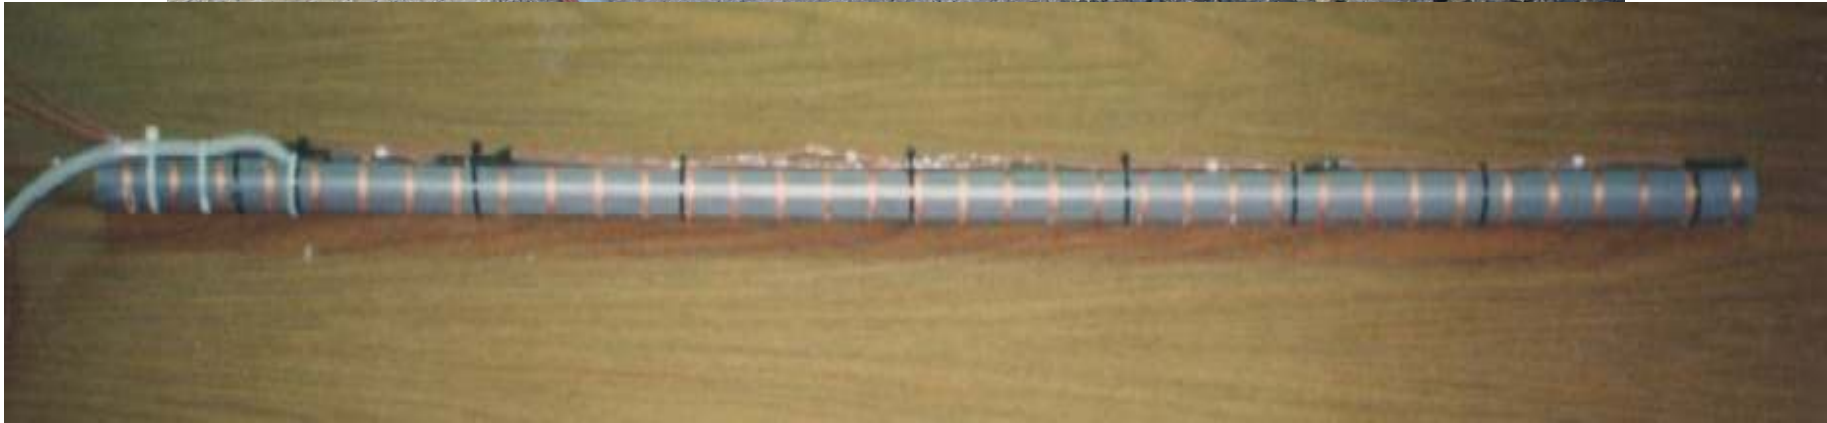
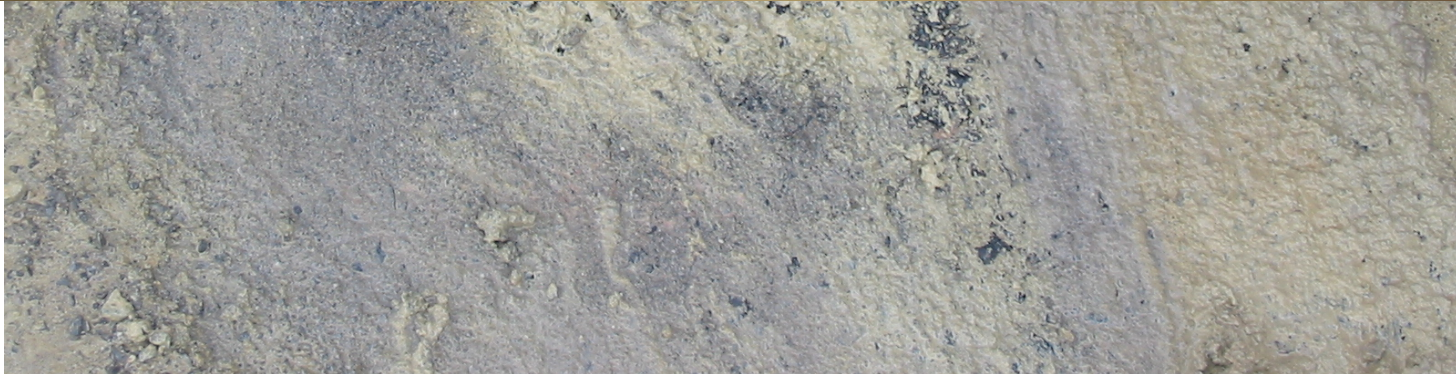
Frost Gage (Resistivity Probe)

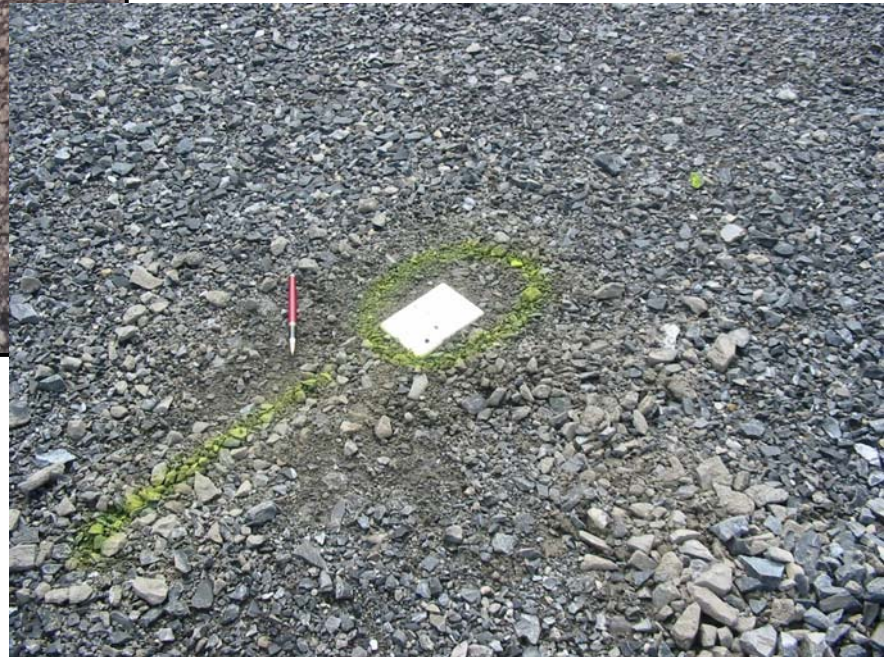
Moisture Content Measurement

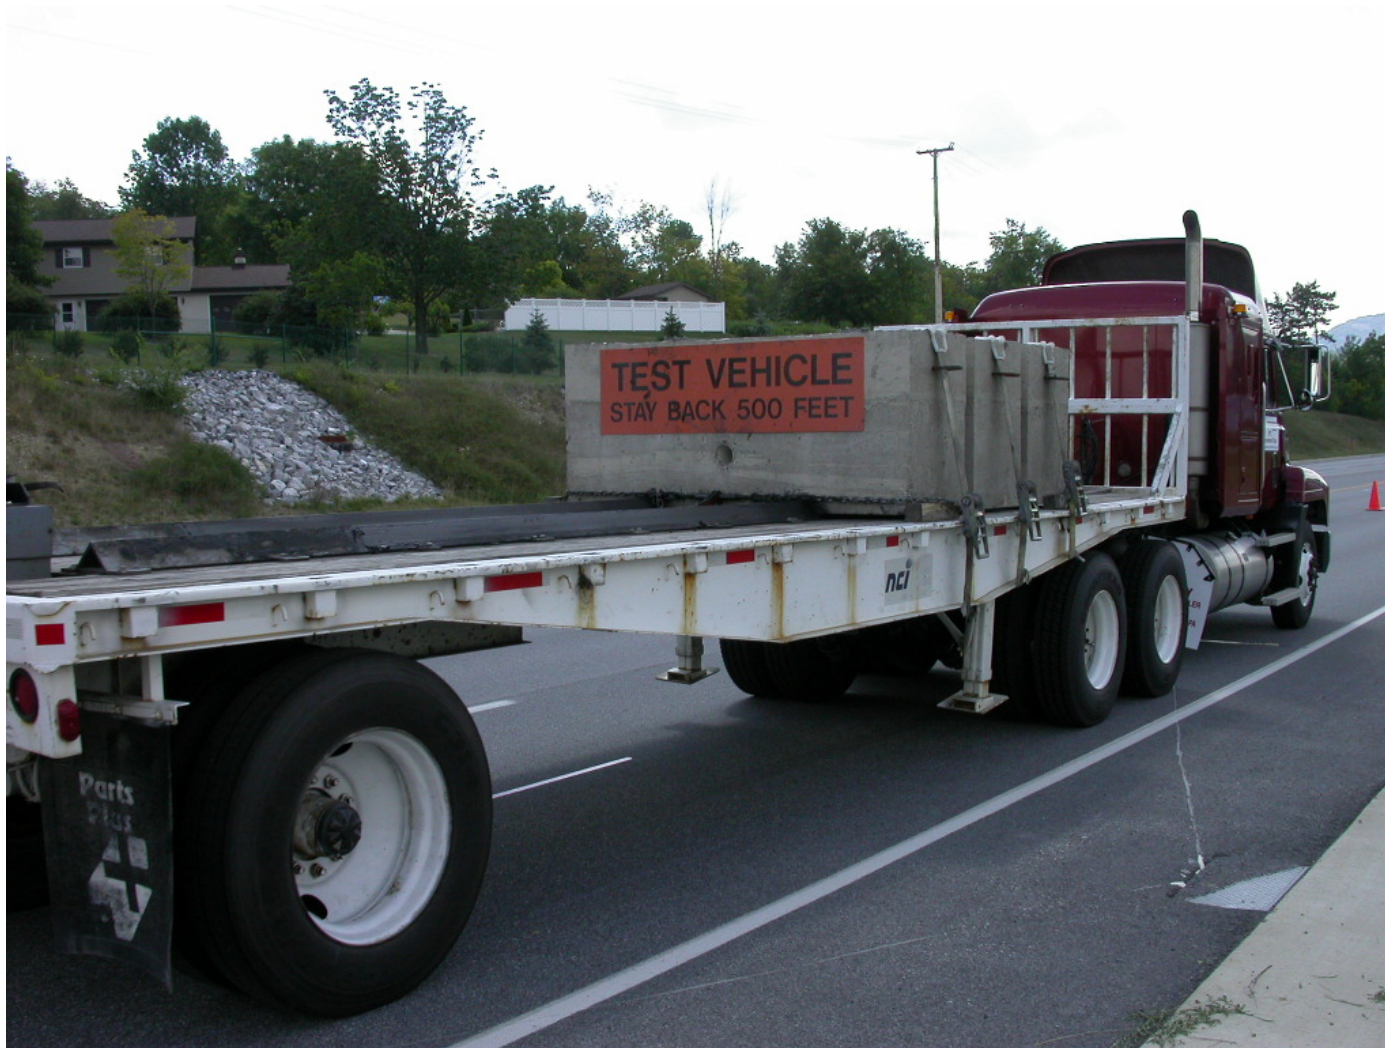
Truck for Pavement Loading

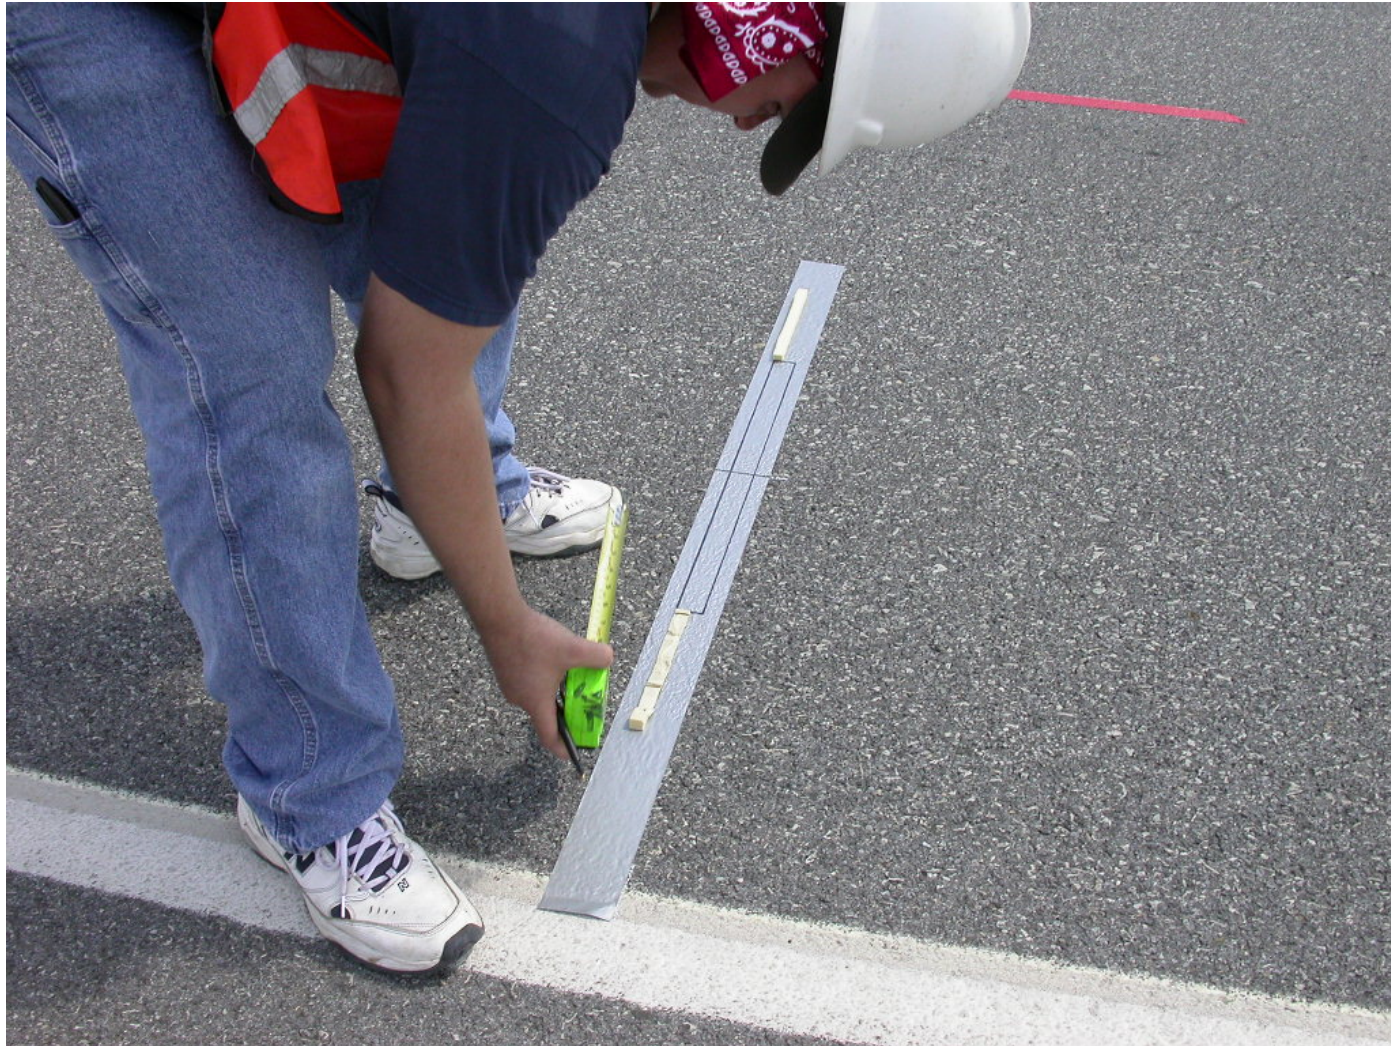
Wander Measurement

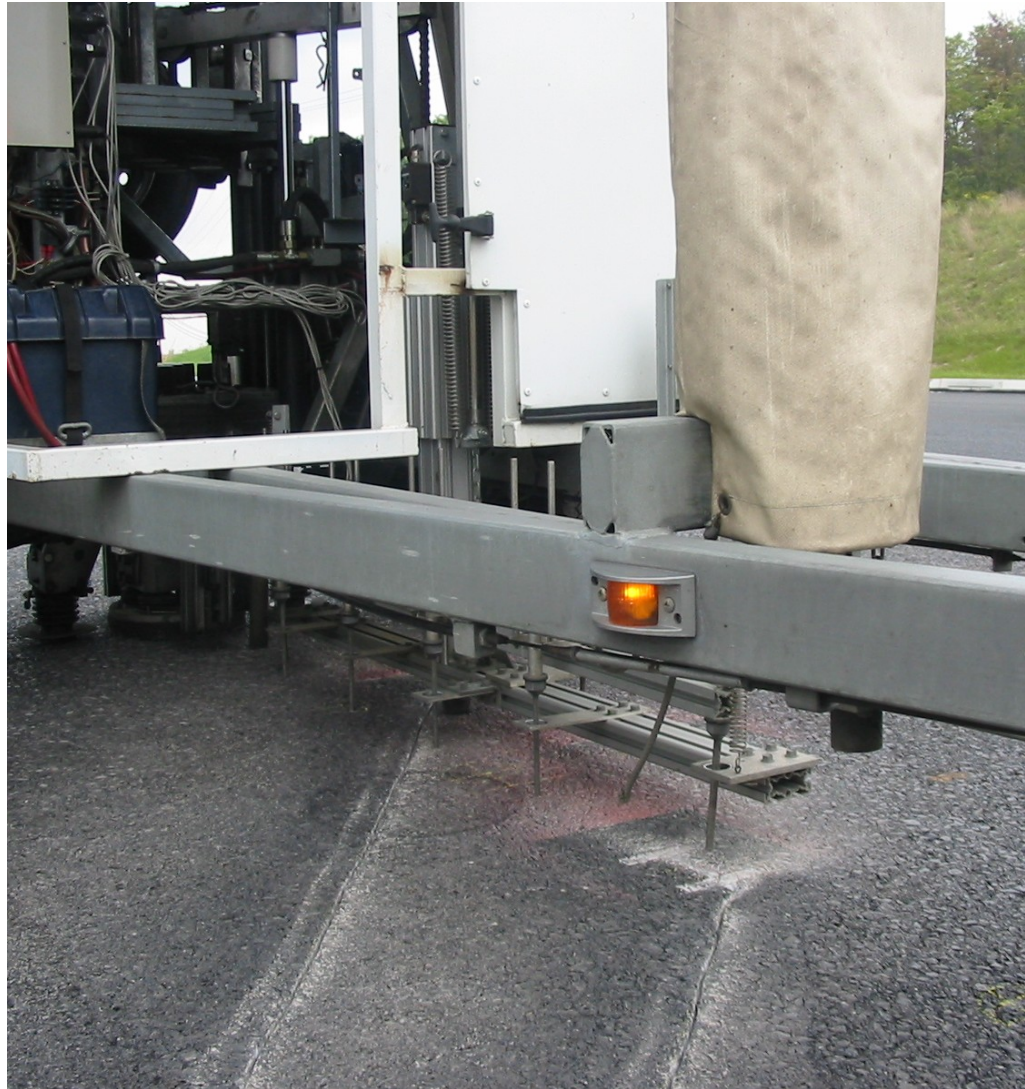
Falling Weight Deflectometer

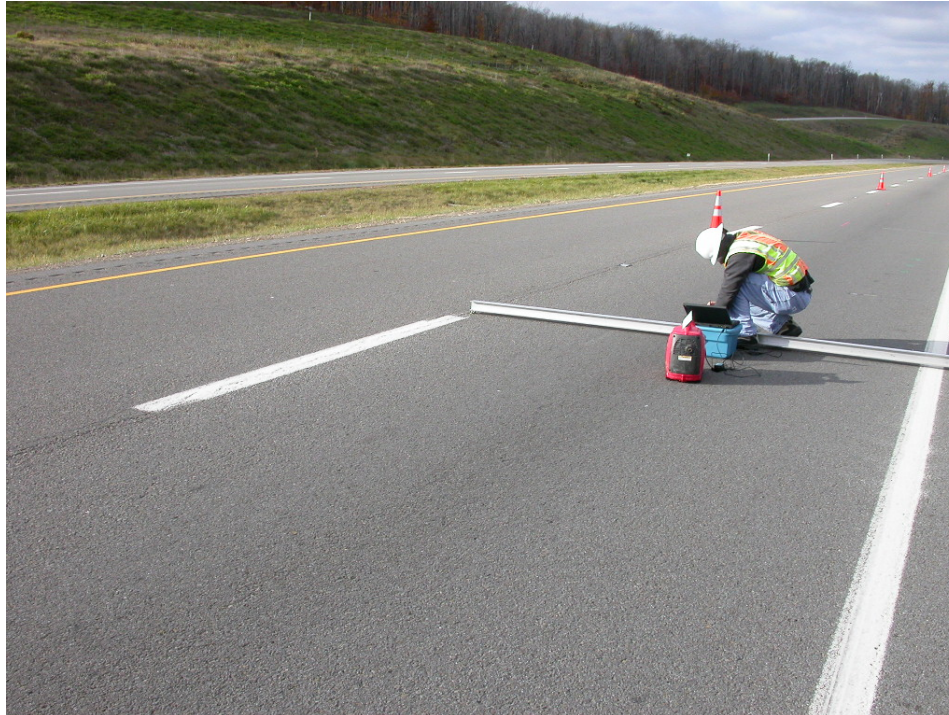
Transverse Profile

- Simple, low cost
- Easily transportable
- Measurements each time dynamic test conducted

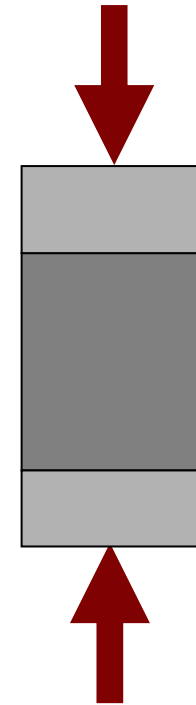
Dynamic Modulus Test

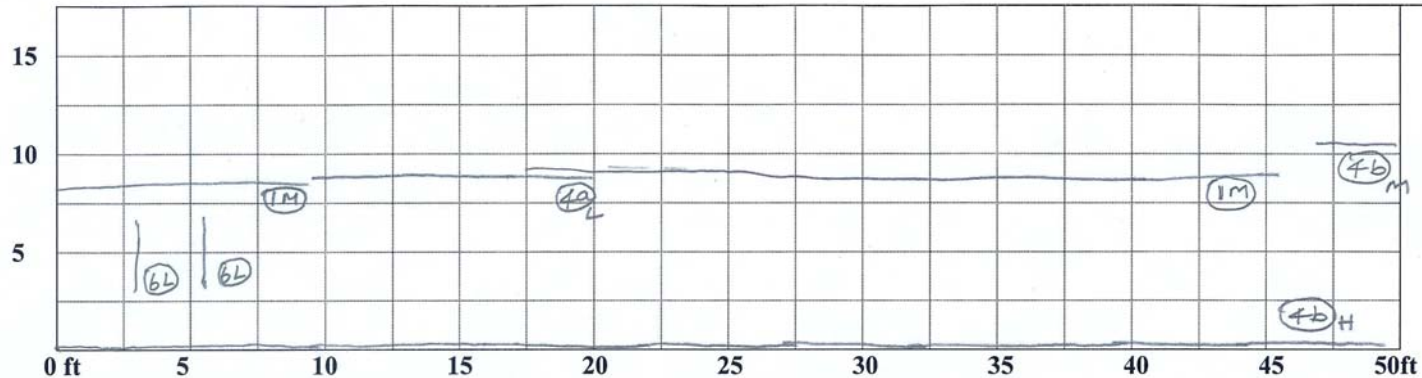
FIGURE 2 Instrumentation Location Distress Map

SITE: **Warren** Instrumentation Location: ONE Surveyed By: VENKY
 Date/Time: 08/07/03 8:30 AM Surface Temperature (°C) Before Survey: _____ After Survey: _____

1 – Fatigue Cracking 4 a- Longitudinal Cracking – Wheel path 4 b- Longitudinal Cracking – Non-wheel path
 6 L – Transverse Cracking (Low) M – Medium H-High

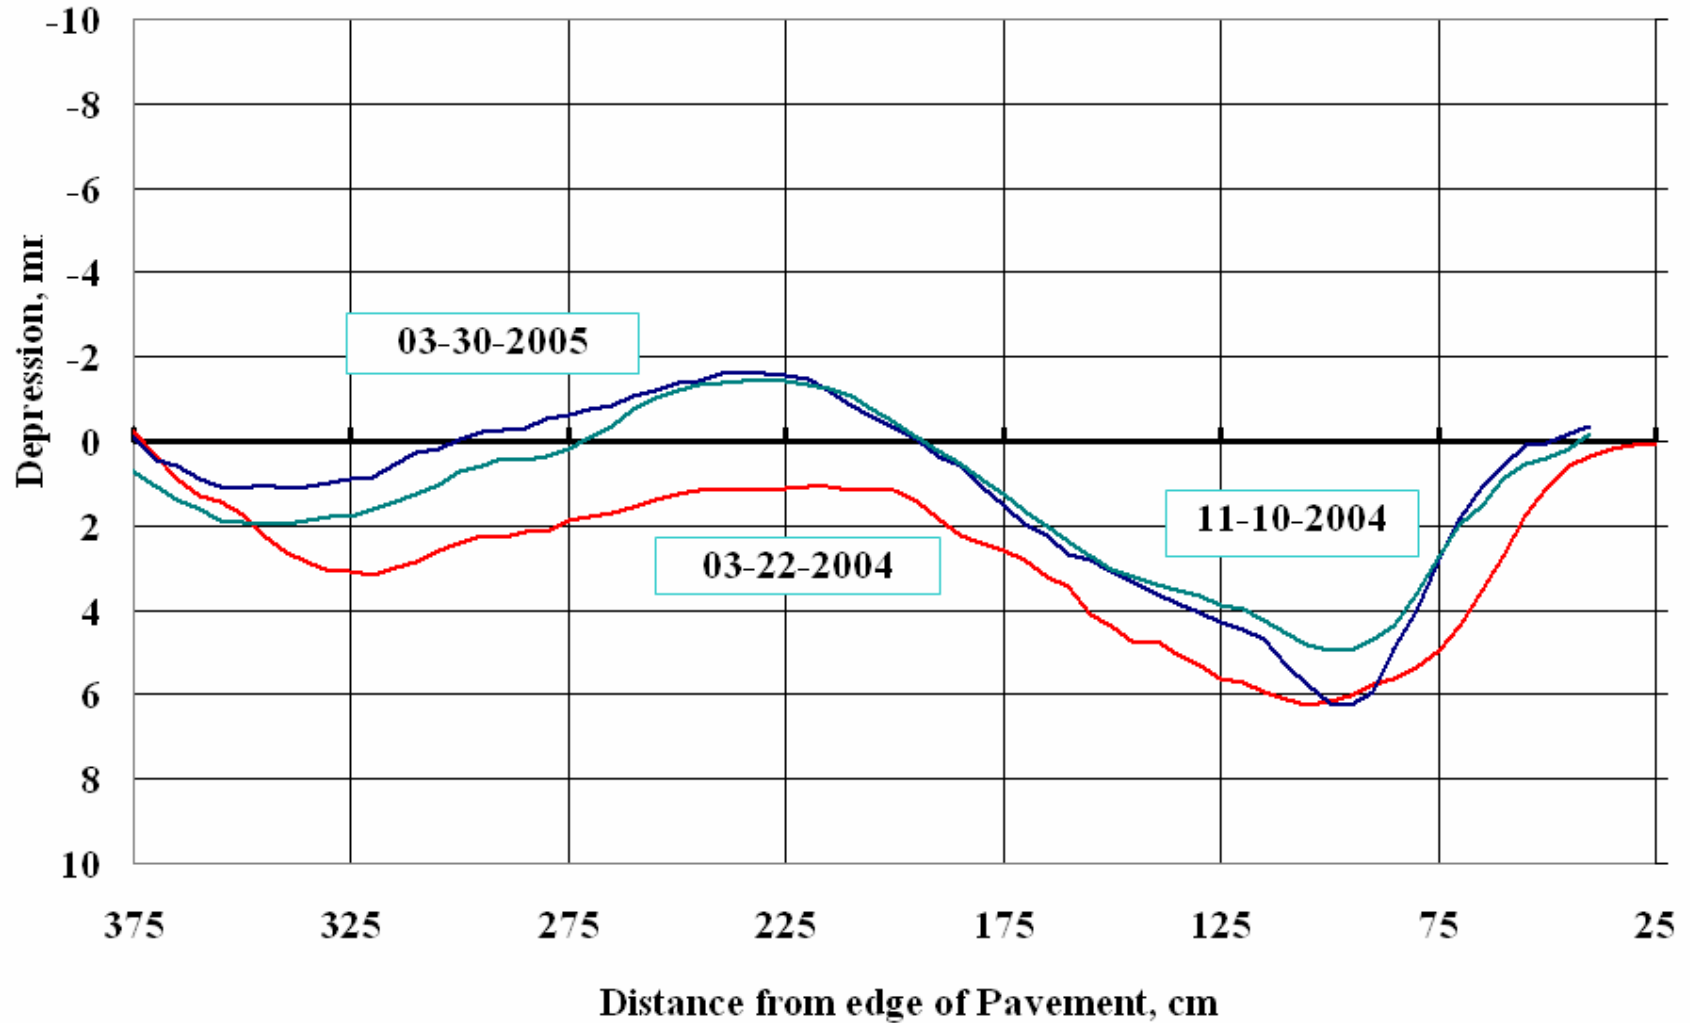
Distress Analysis

County: Delaware Highway: SR202 Location: 1 - 24 feet

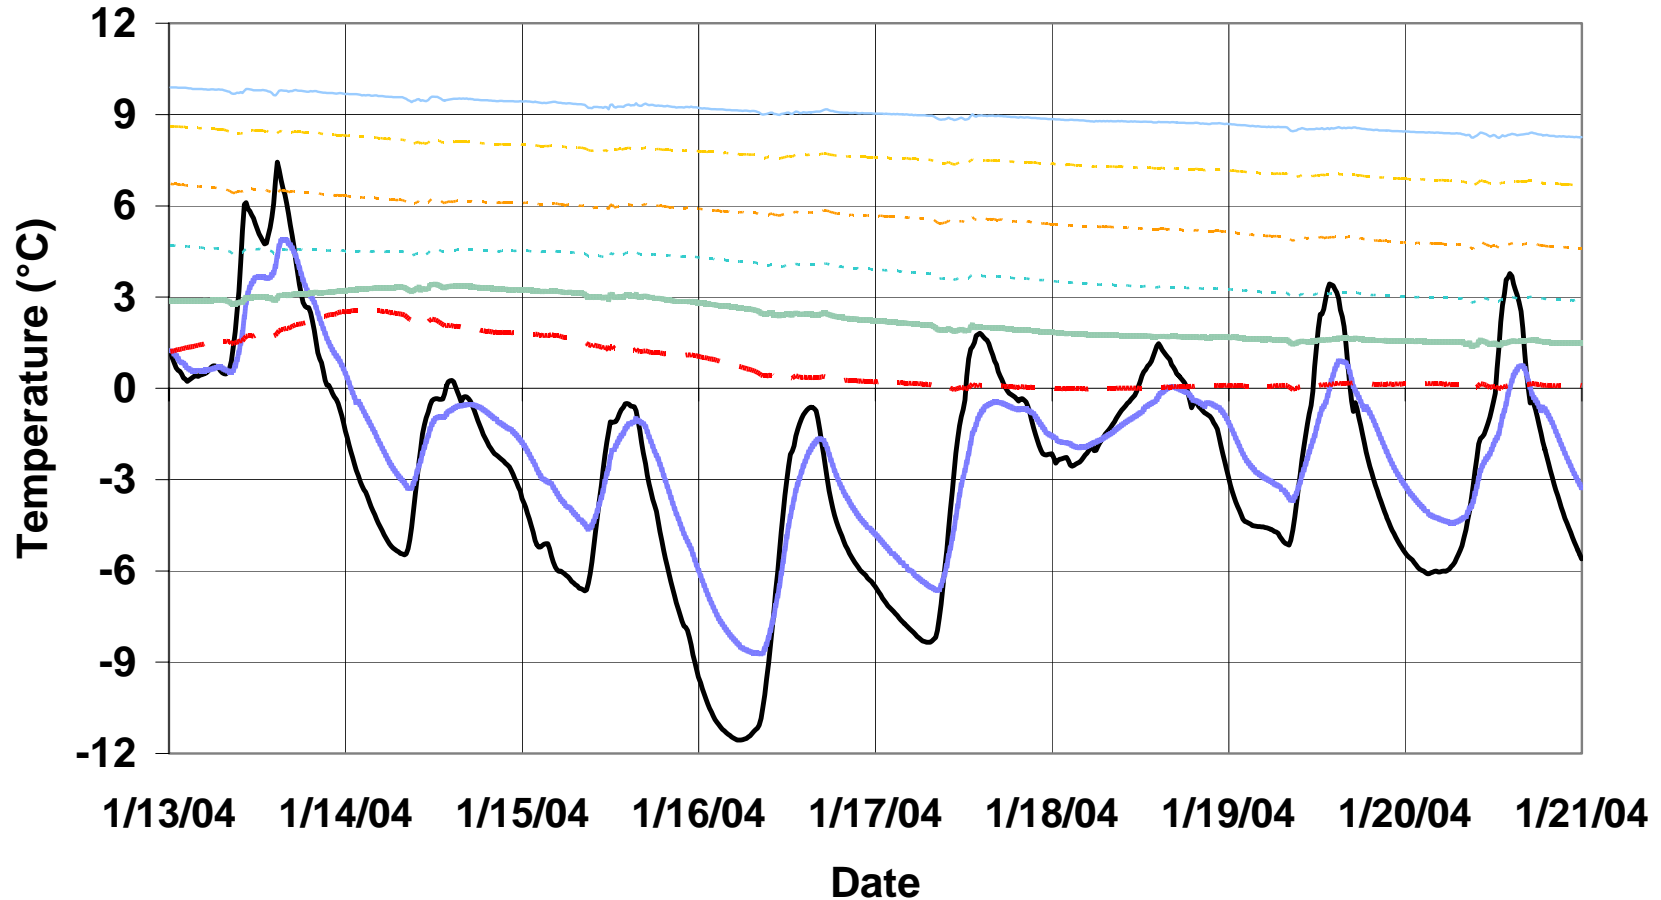
Temperature Variation – Freeze Cycles

County: Delaware

Highway: SR202

Location: 1

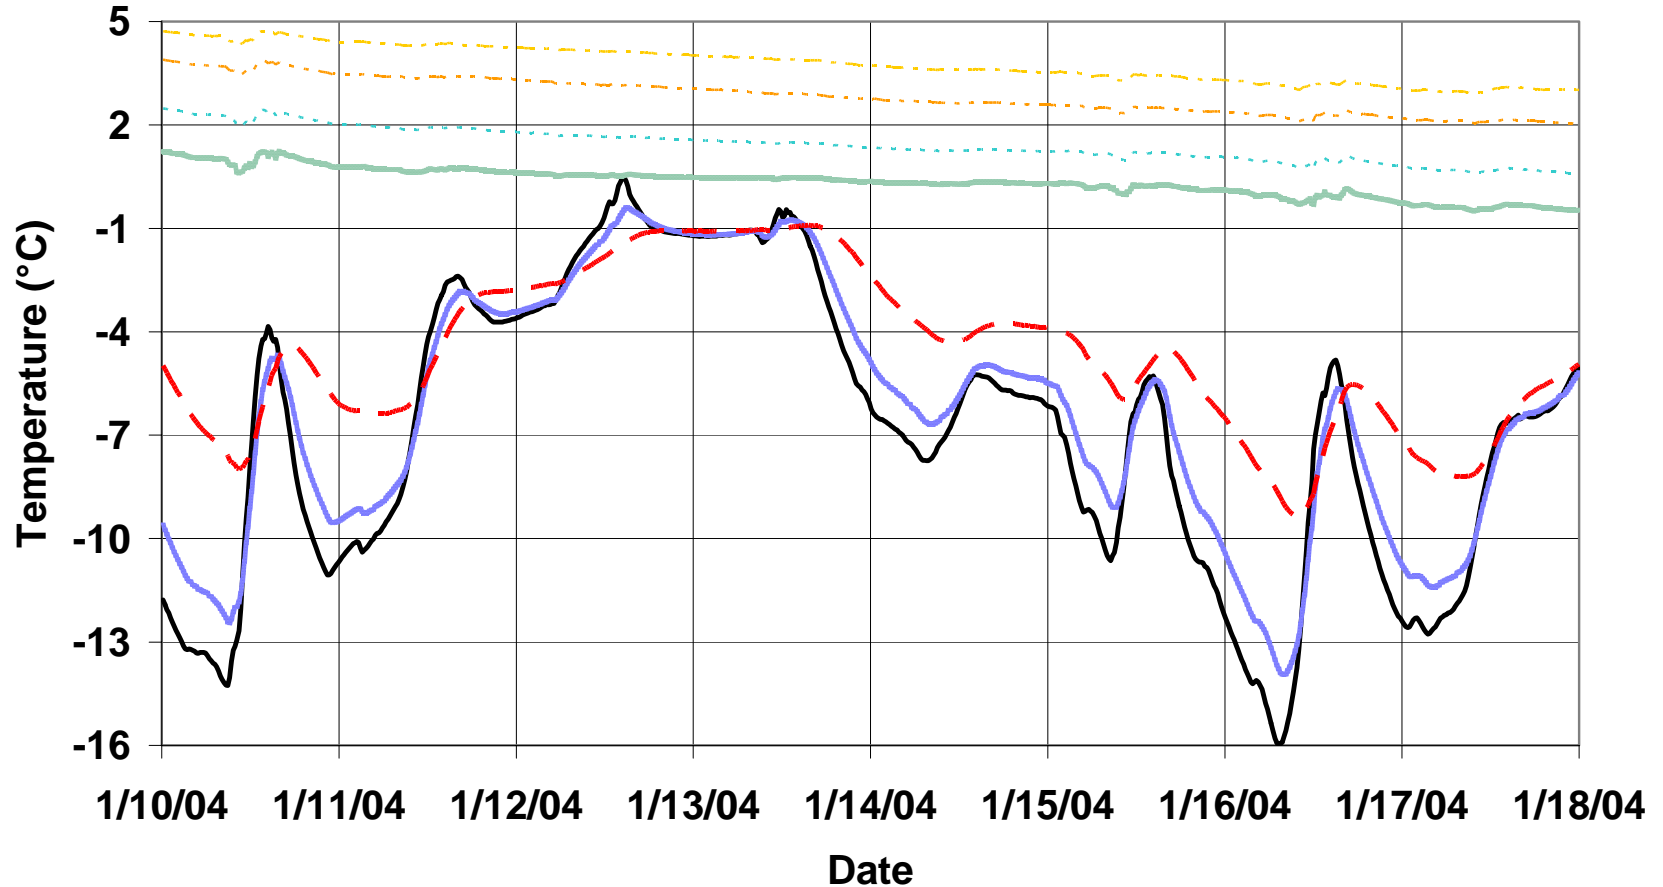
Temperature Variation – Freeze Cycles

County: Warren

Highway: SR 6

Location: 2

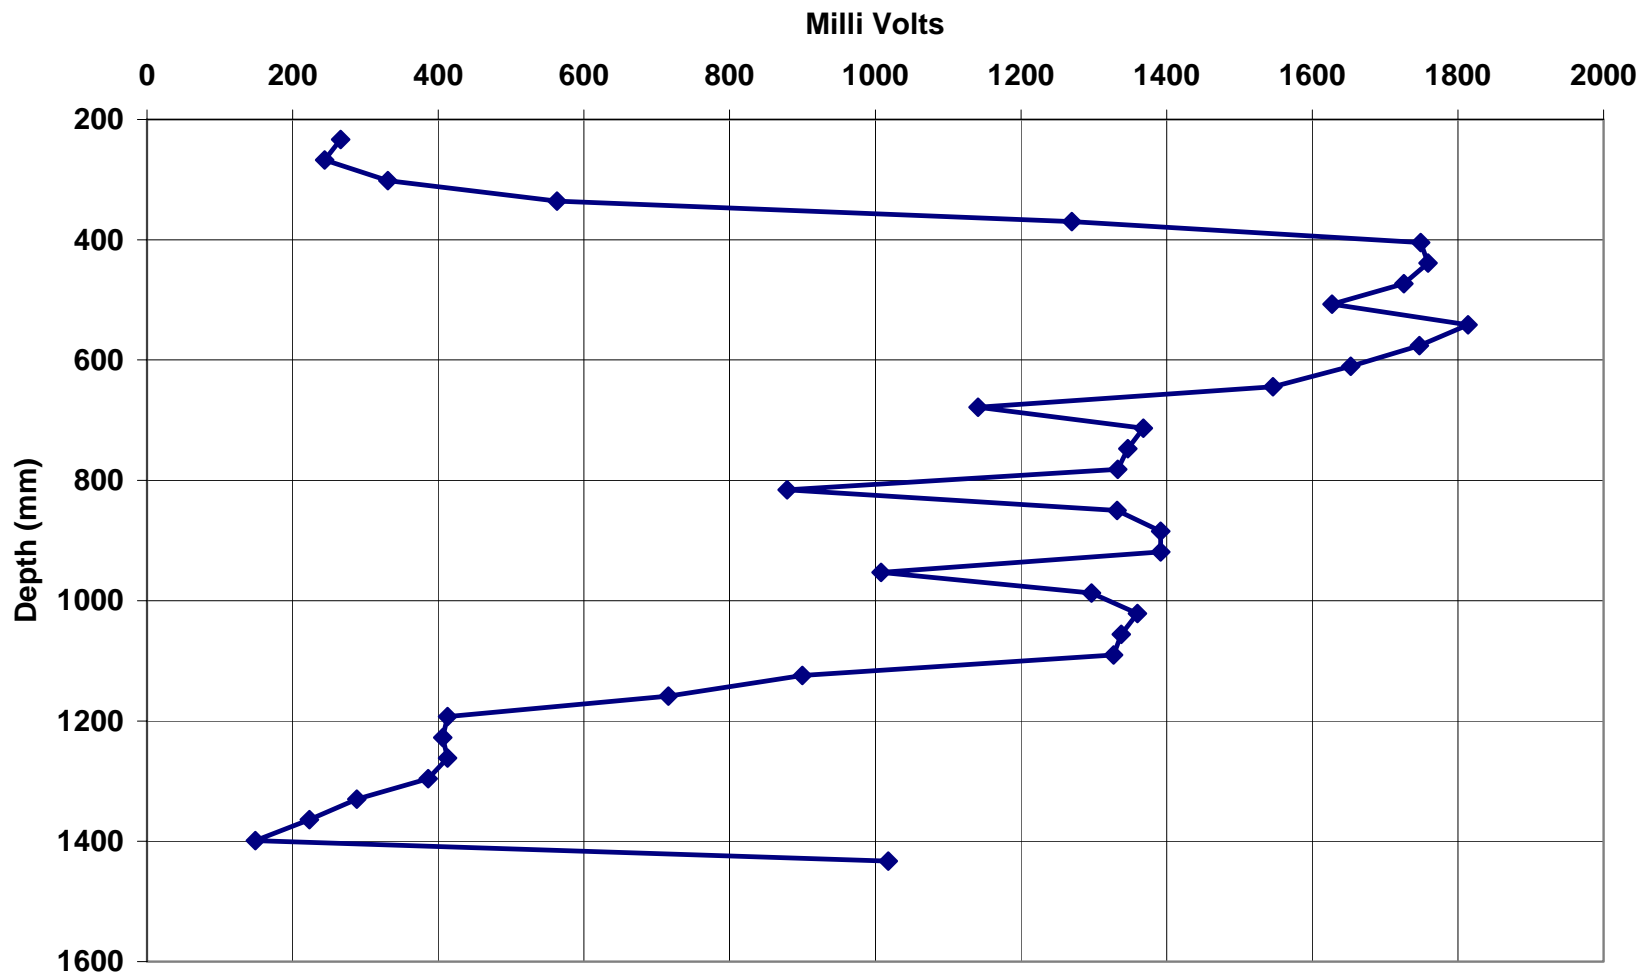
Pavement Freezing Depth

County:Perry

Highway:SR 322

Location:2

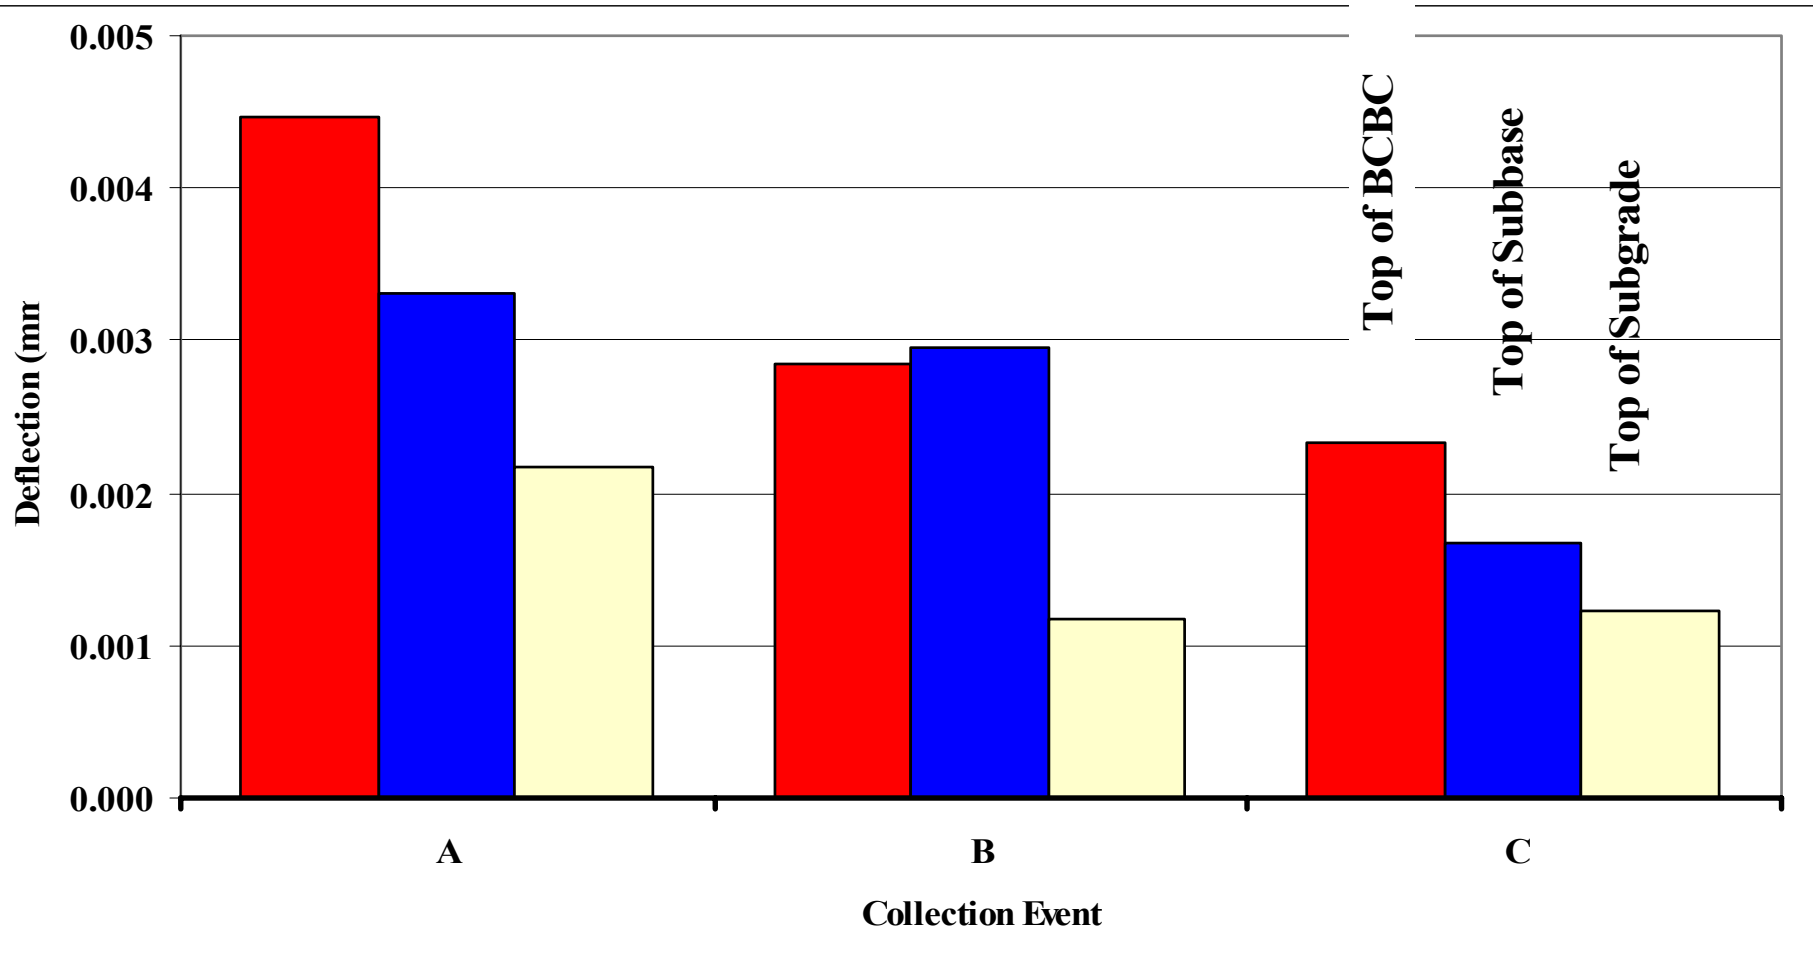
Pavement Response to Load – Position Effect

Vertical Deflection (MDD)

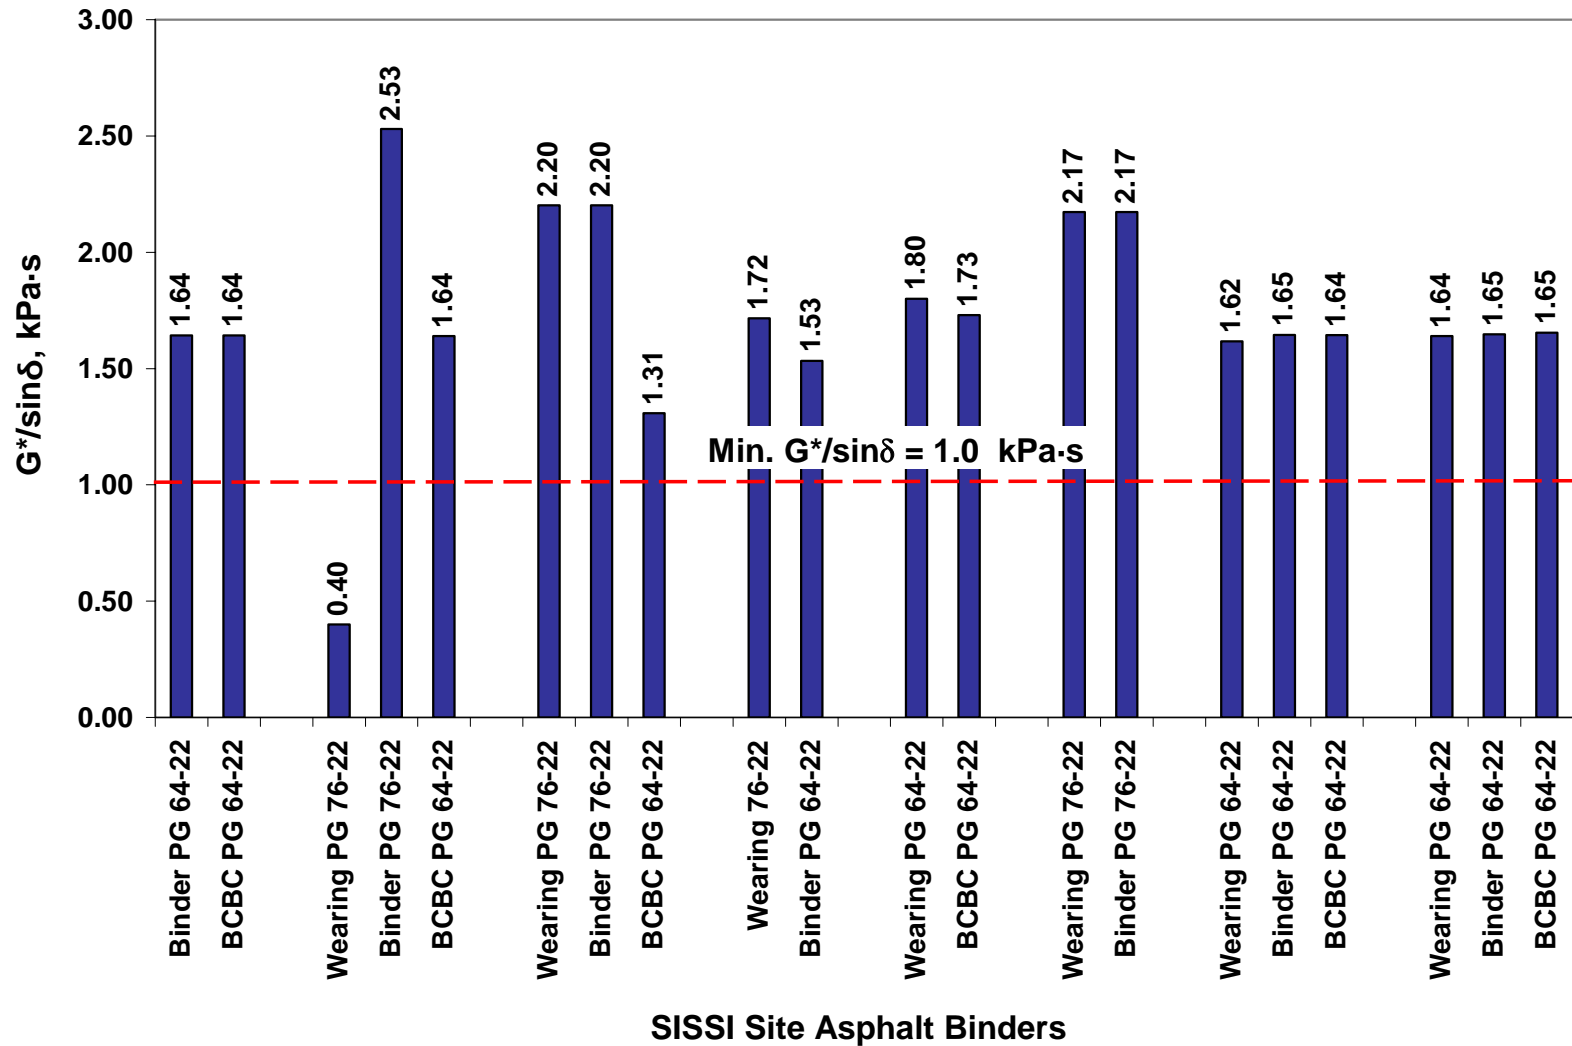
Laboratory Testing - Binders
