Superpave In-Situ Stress/Strain Investigation (SISSI)

AN OVERVIEW AND A LOOK AT RESULTS

Mansour Solaimanian, Ph.D., P.E.
Pennsylvania Transportation Institute
The Pennsylvania State University

NESMEA Meeting
Burlington, Vermont
October 19, 2005

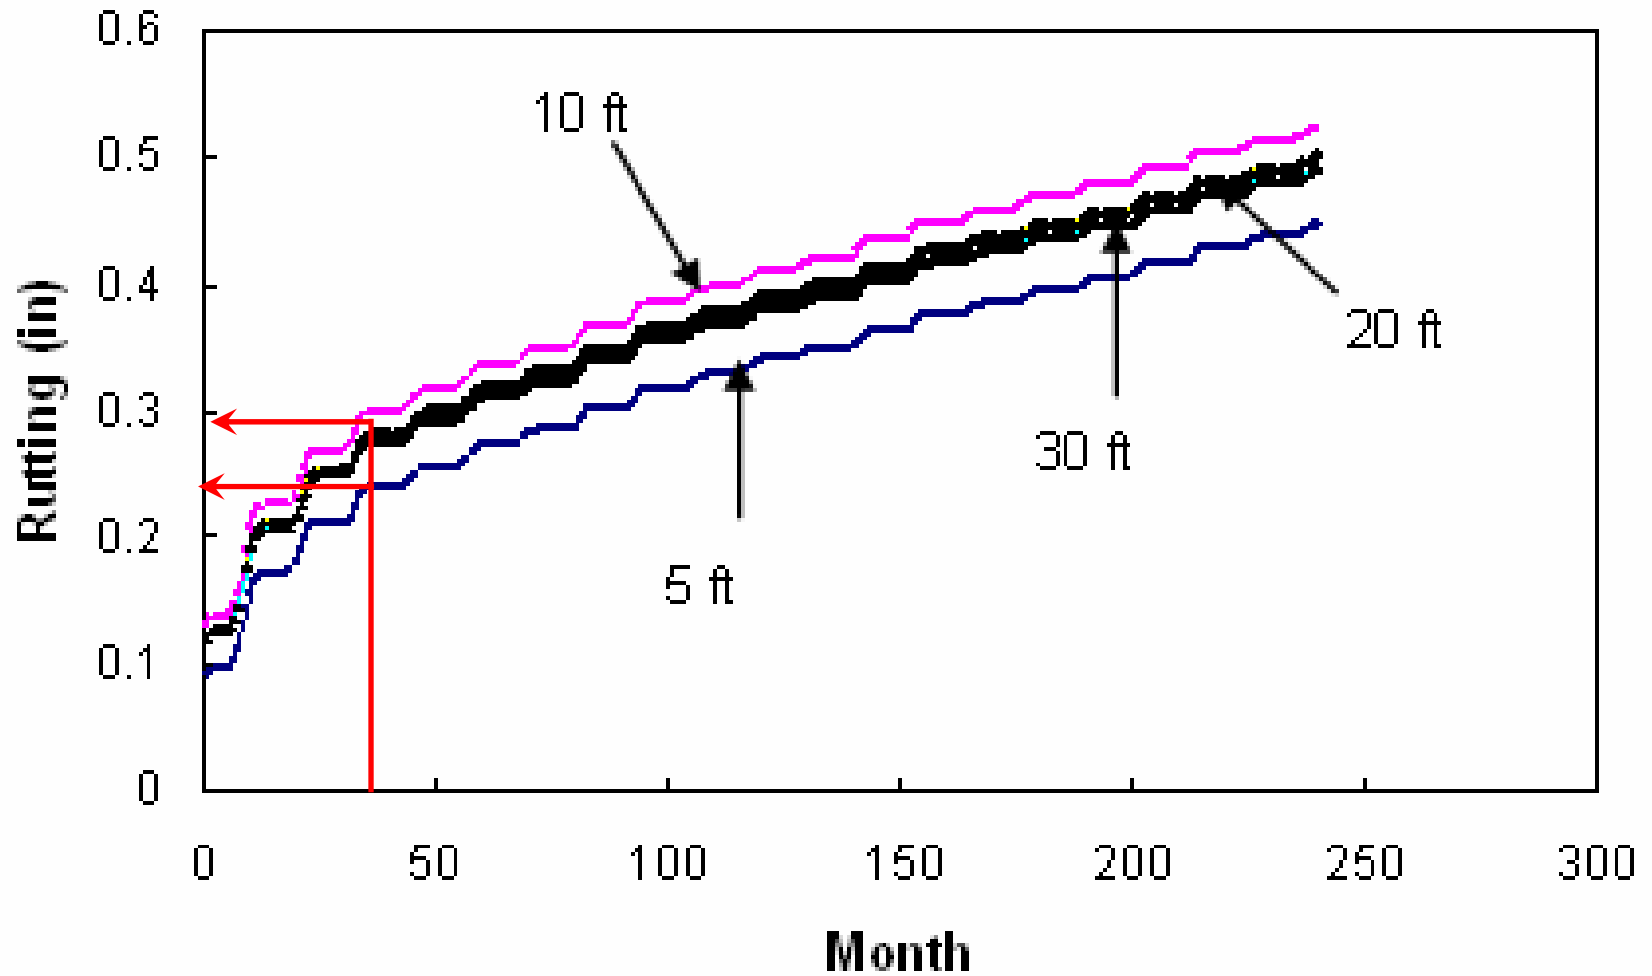
AASHTO Design Guide – Predicted Distress
