Update of Connecticut Advanced Pavement Laboratory Project SPR-2249

Comparison of the Use of a Notched Wedge Joint vs. Traditional Butt Joints in Connecticut

NESMEA, Mystic CT. Oct 17th, 2007

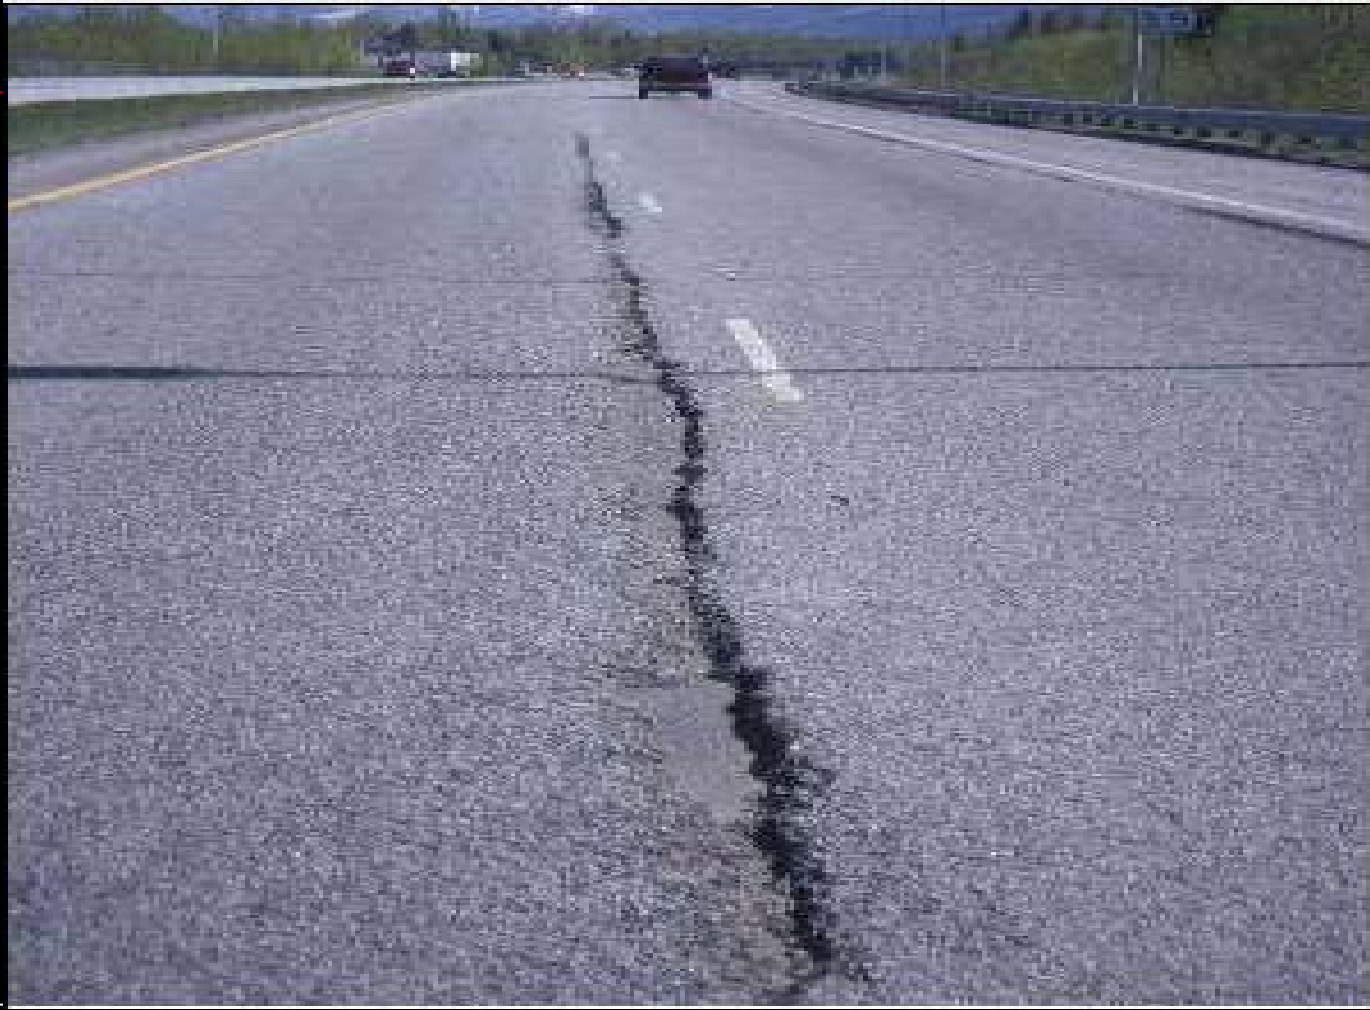
The Problem

- Insufficient material at the joint during construction
- Inadequate density at the joint
- Lack of confined edge during 1st pass
- Inadequately compacted edge material to compact against during second pass

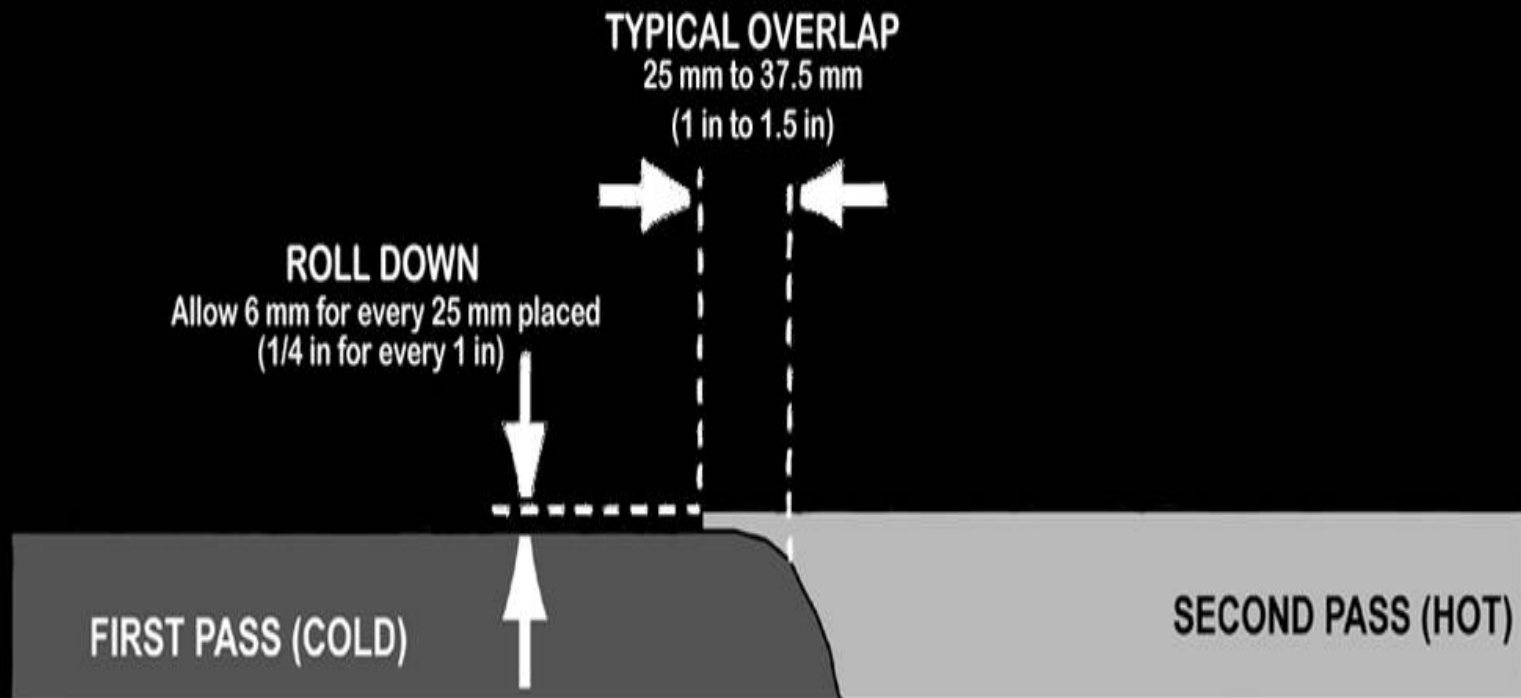
- Connecticut traditionally uses the vertical or “Butt” Joint

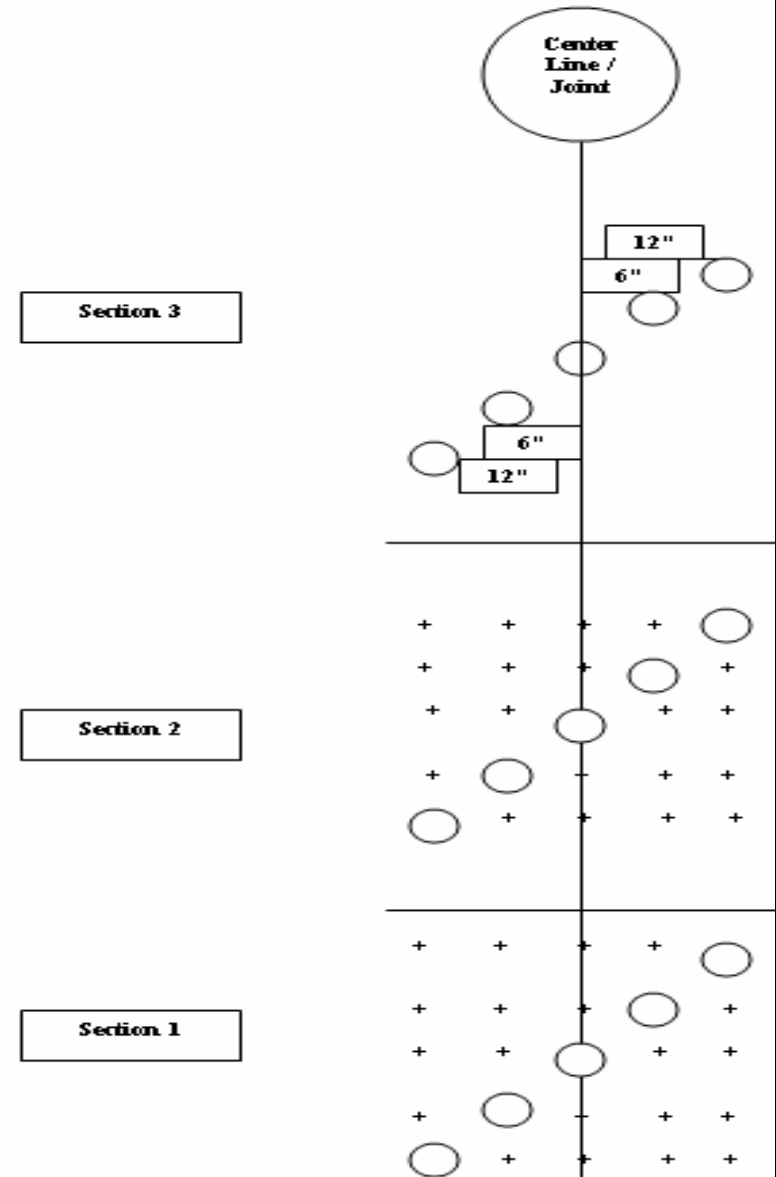
Measurement & Evaluation of Longitudinal Joints (Plan View)

- ~ 2-3 sections per day
- 25 Nuclear measurement locations per section (60 sec counts) avg. of 2 readings
- Rotate gauge 180 degrees between readings
- 5 cores per section
- Cores at 1', 6", 0, 6", 1'
- 5 longitudinal feet between cores

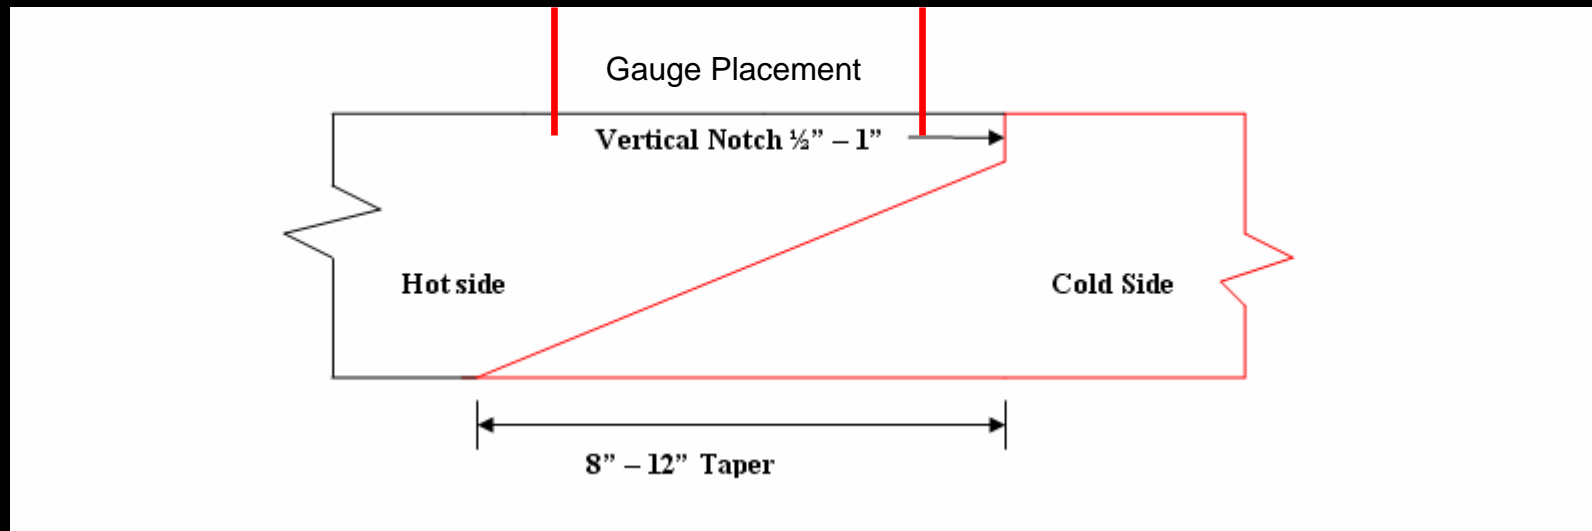
Defining the Joint Location on Notched Wedge Projects

Gauge was placed directly over the wedge portion of the notched wedge joint

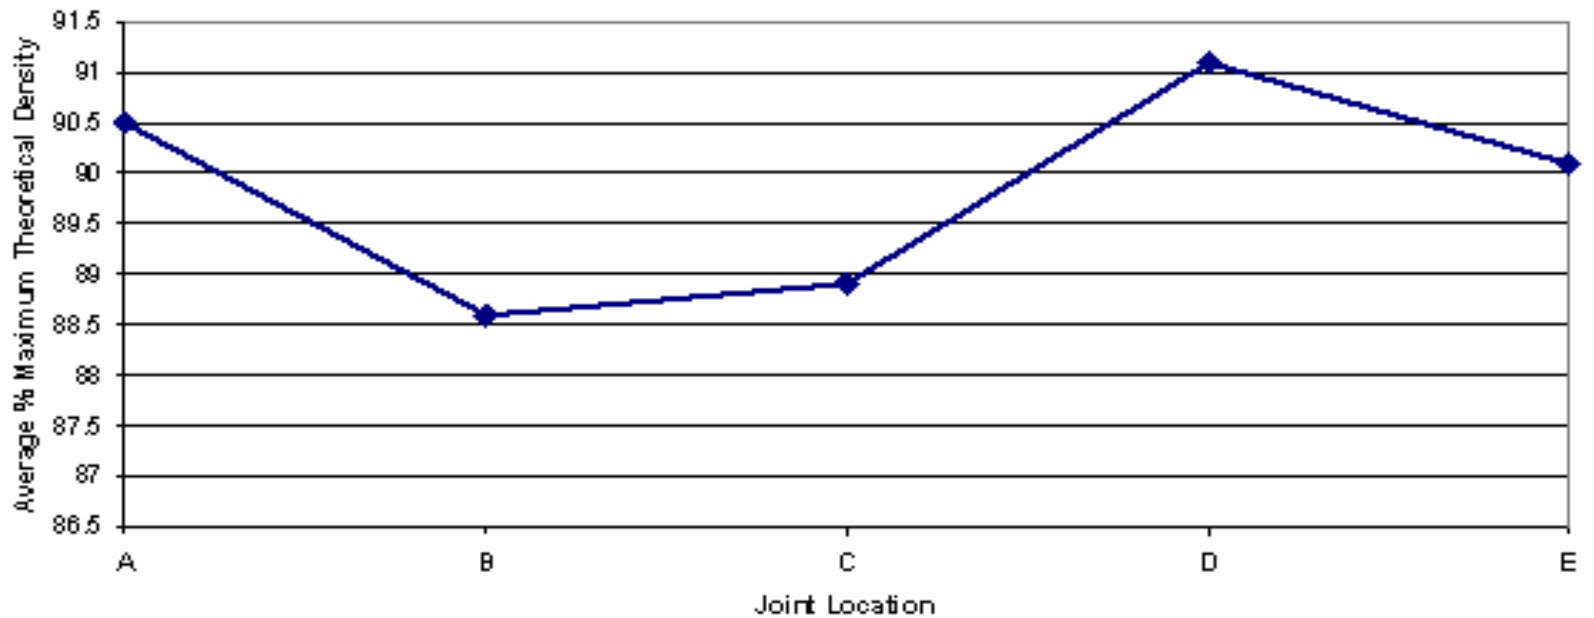
Nuclear Density by Profile Location (Notched Wedge Joint)

Average % Nuclear Density by Profile Location (Notched Wedge Joints)

A = 1 foot cold side B = 6 inches cold side C = joint location D = 6 inches hot side E = 1 foot hot side

- Cold side density seems to measure lower than warm side density
- There is a significantly steep jump in density from the joint location to six inches on the hot side
- Nuclear Gauge typically gave higher density than the core volumetric value on Notched wedge pilot projects

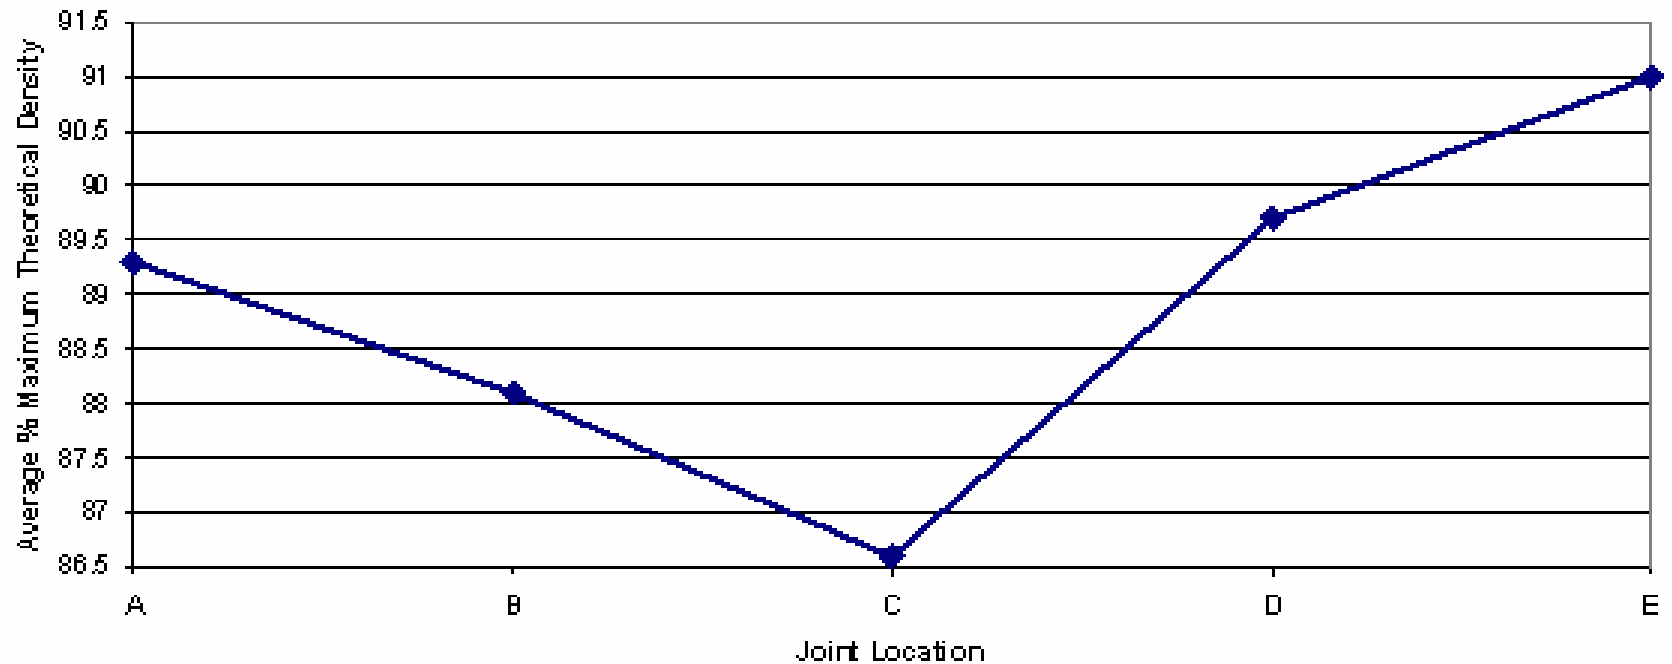
Volumetric Density by Profile Location (Notched Wedge Joint)

Average % Volumetric Core Density by Profile Location (Notched Wedge Joints)

A = 1 foot cold side B = 6 inches cold side C = joint location D = 4 inches hot side E = 1 foot hot side

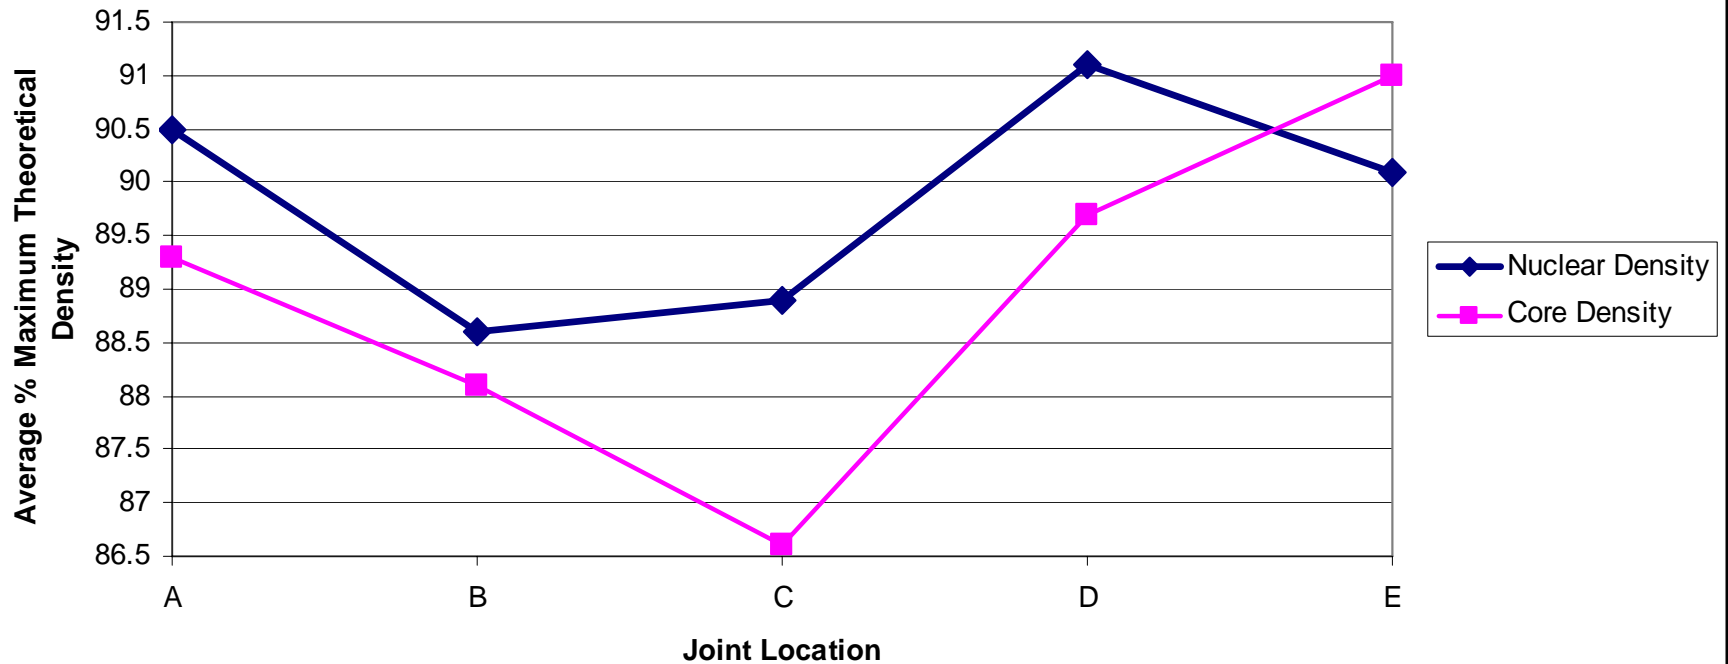
Notched Wedge Core Density vs. Nuclear Density

Average % Nuclear Density vs. Core Density by Profile Location (Notched Wedge Joints)

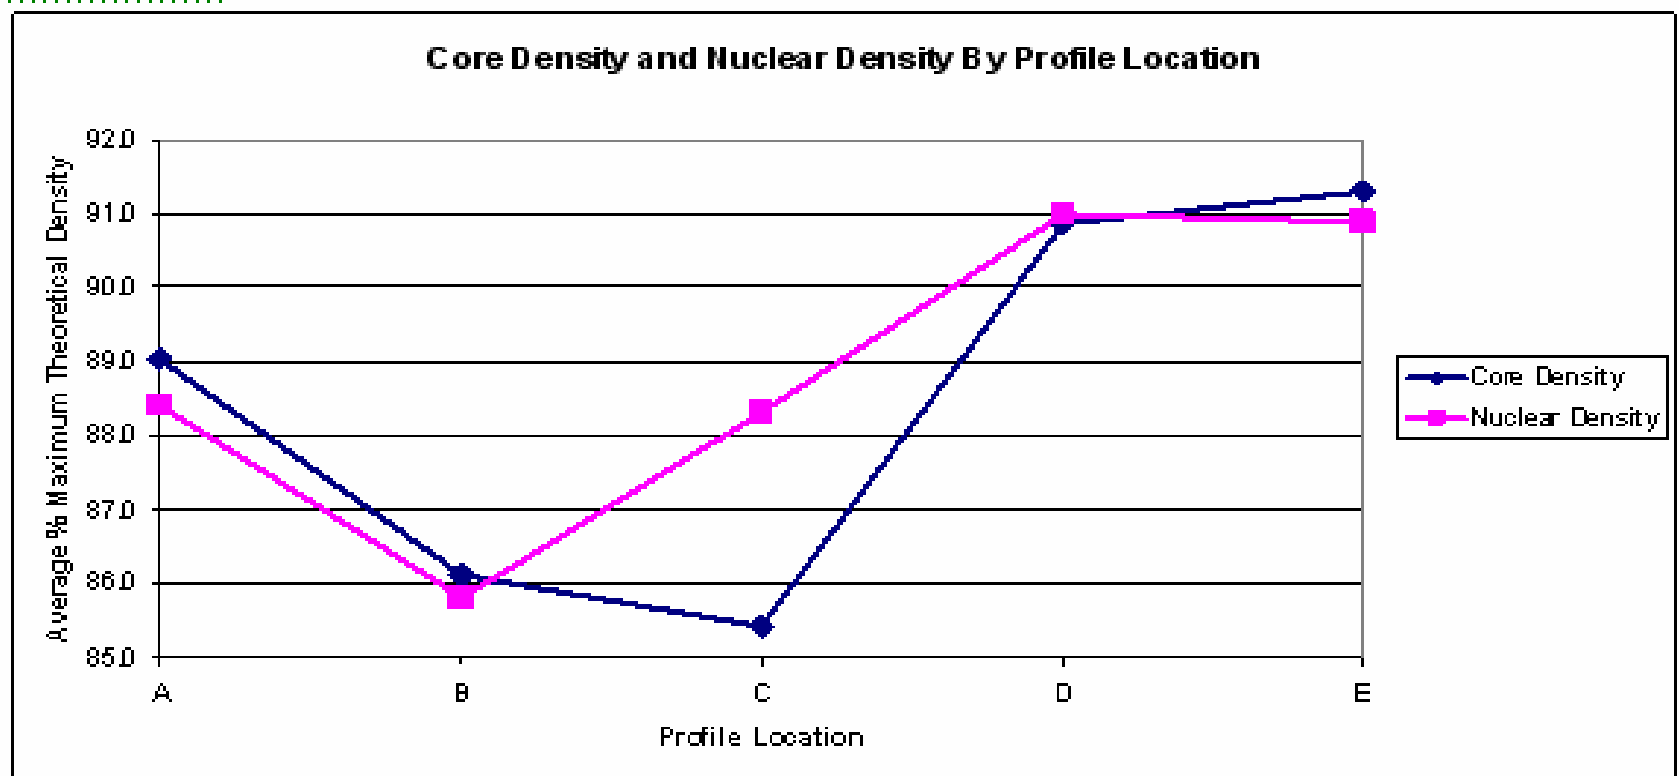
Nuclear and Volumetric Density by Profile Location (Butt Joint)

A = 1 foot cold side B = 6 inches cold side C = joint location D = 4 inches hot side E = 1 foot hot side

- Cold side density seems to measure lower than warm side density
- There is a significantly steep jump in density from the joint location to six inches on the hot side
- Current version of nuclear gauge correction procedure brought nuclear density values more in line with core density values

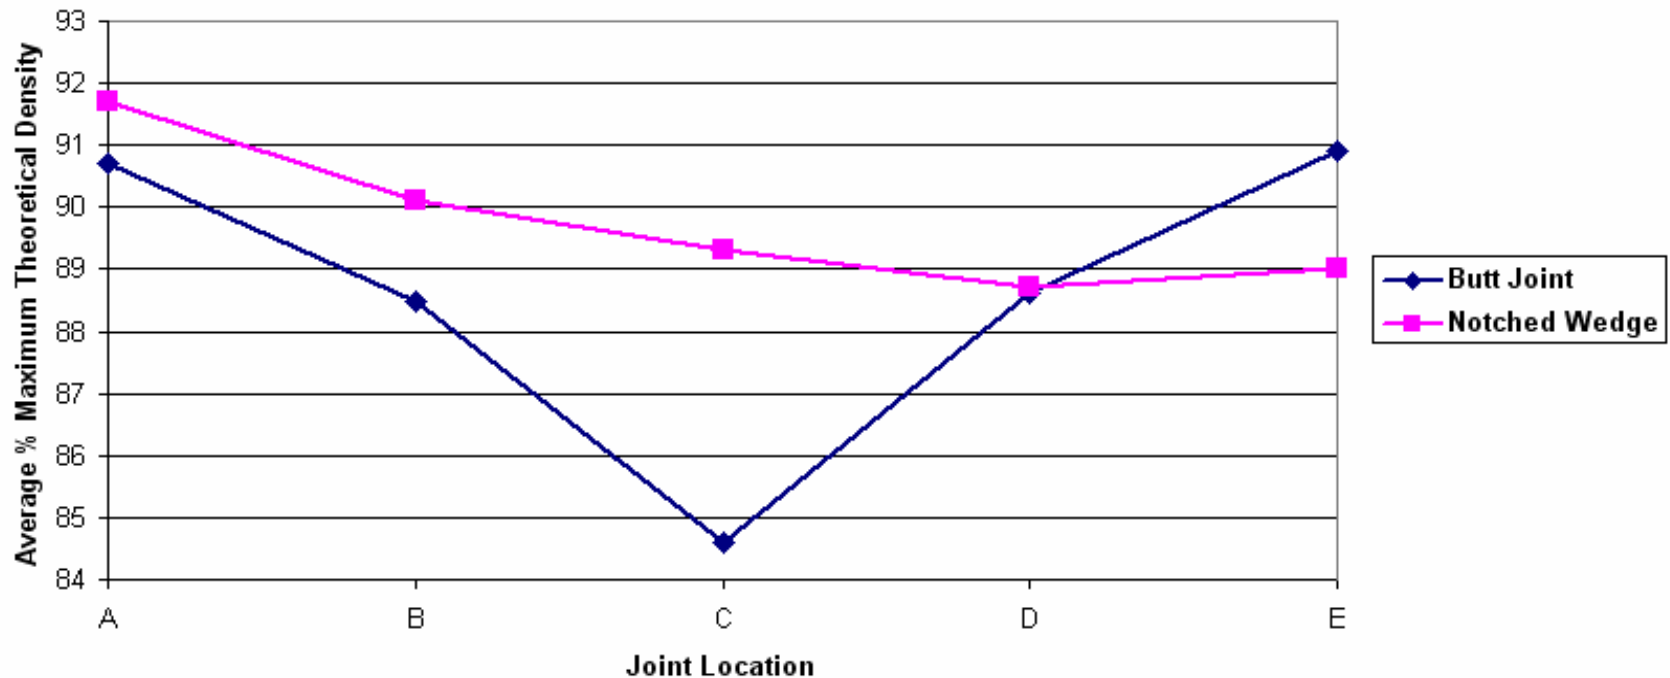
2007 Preliminary Analysis of Core Data

- Overall Average density is improved along the joint with the use of the notched wedge joint
- Density profile is more consistent and smooth with the notched wedge joint
- Major drop off in density at the joint location is virtually eliminated with the notched wedge joint

2007 Notched Wedge Density vs. Butt Joint Density. (Based on very limited data)

- All results are preliminary
- Still insufficient amount of data
- Correction factor has not yet been applied to 2007 nuclear density data – all 2007 data is based on core density
- All cores tested using AASHTO T 331 (Corelok®)

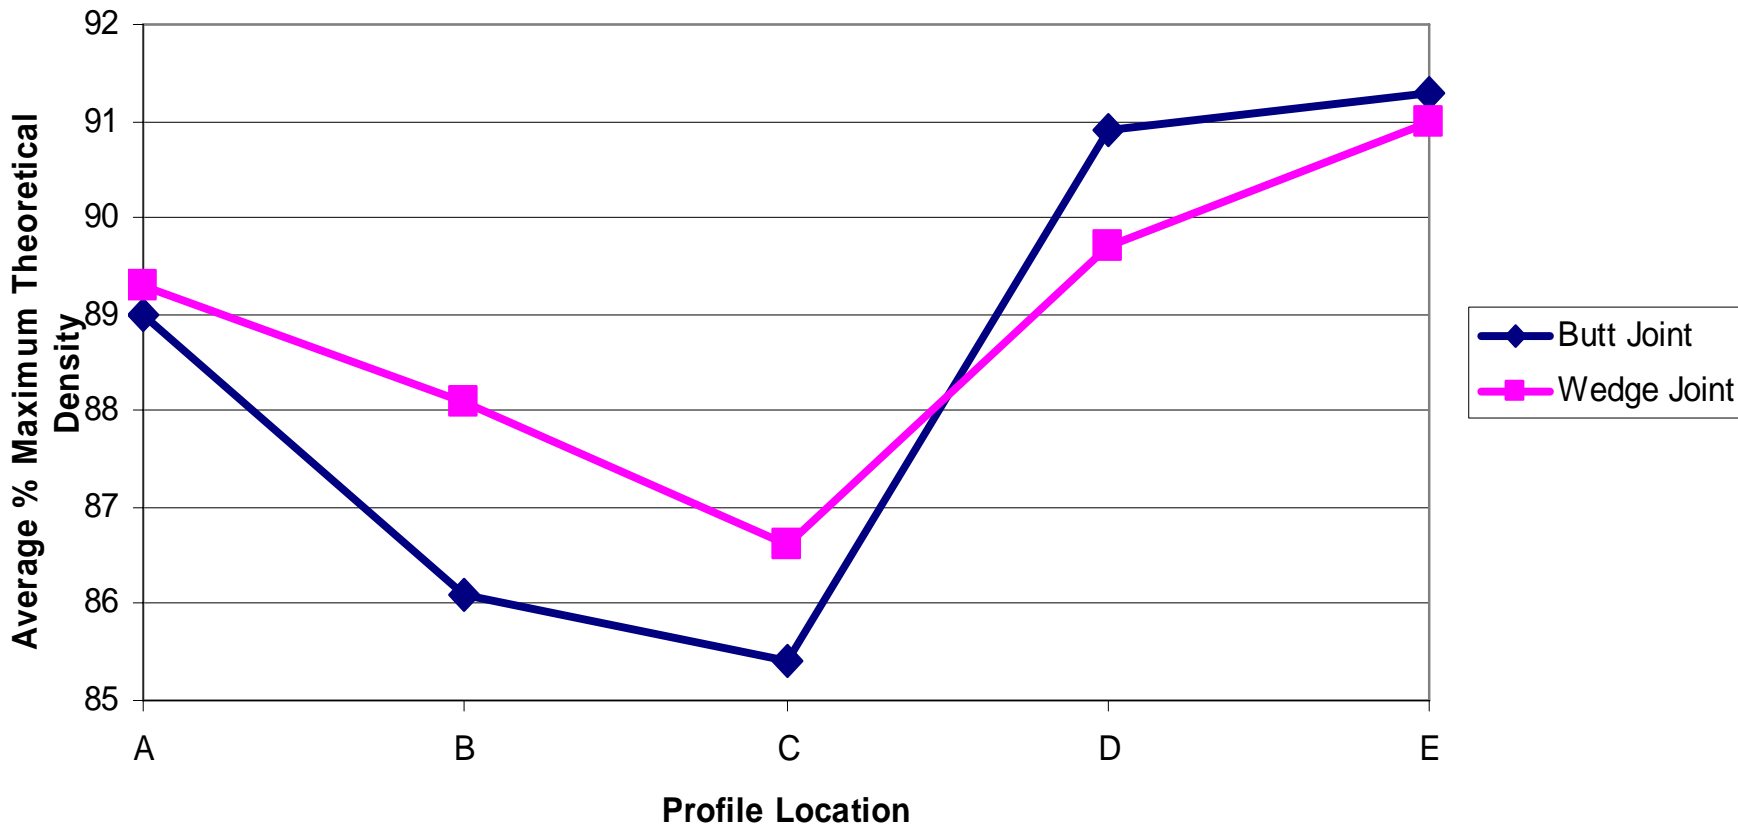
Comparison: Butt Joint Vs. Notched Wedge Joint (Volumetric Core Density)

- Less variability in density moving across the notched wedge joint than butt joint
