# A comparative study of bridge deck condition assessment by high frequency GPR antennas

**NESMEA 2008**

Center for Advanced Infrastructure and  
Transportation (CAIT)

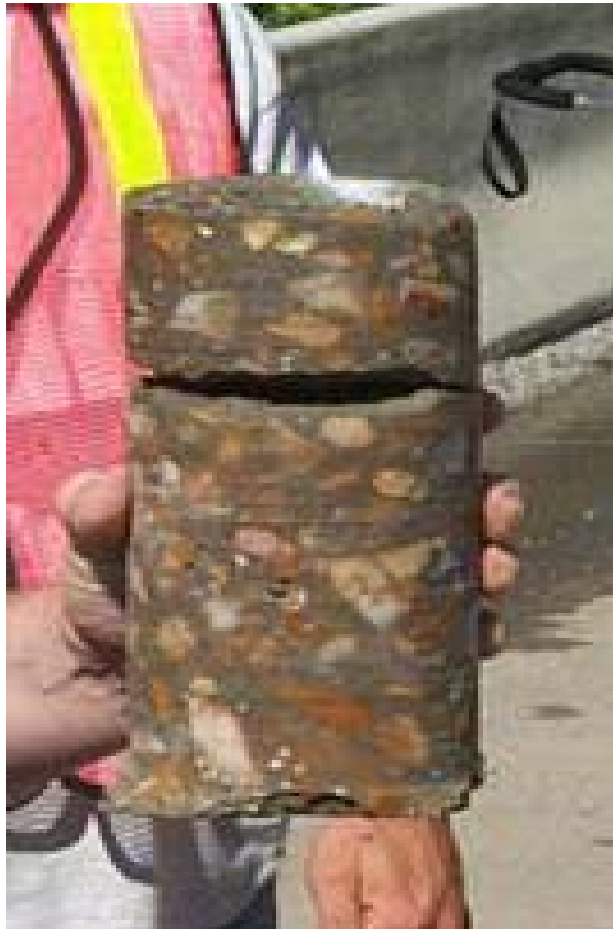
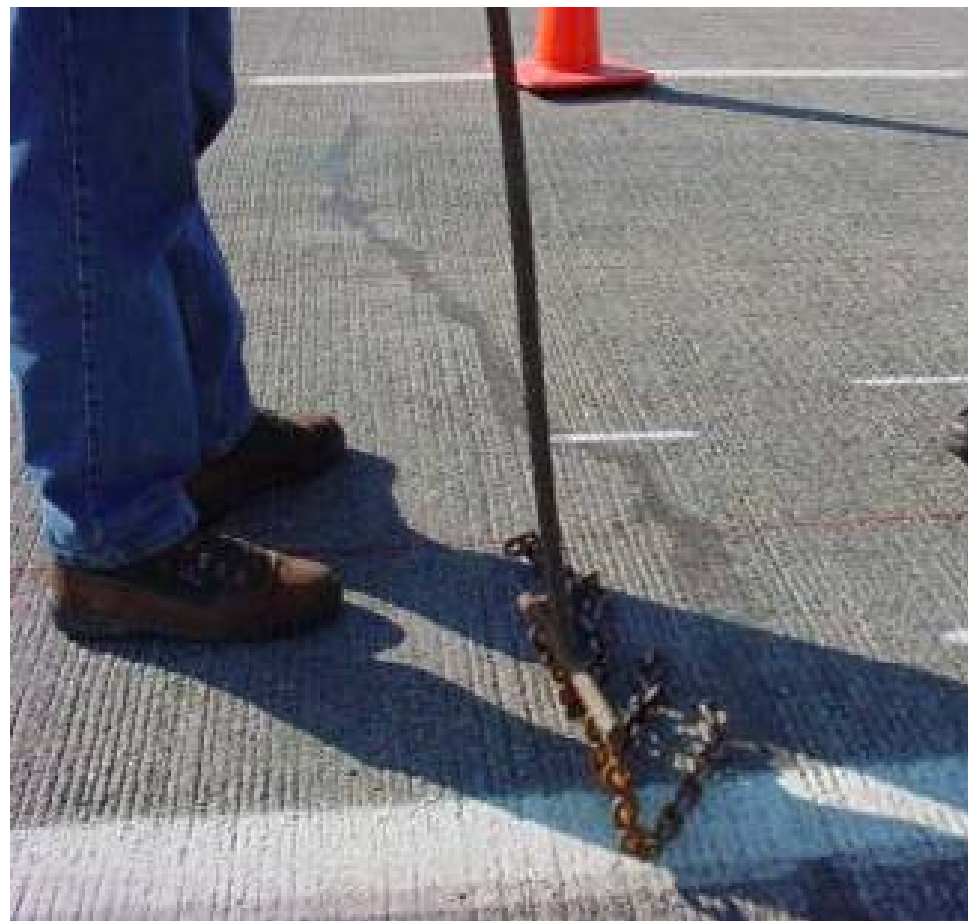
# DELAMINATED DECK AND CHAIN DRAG

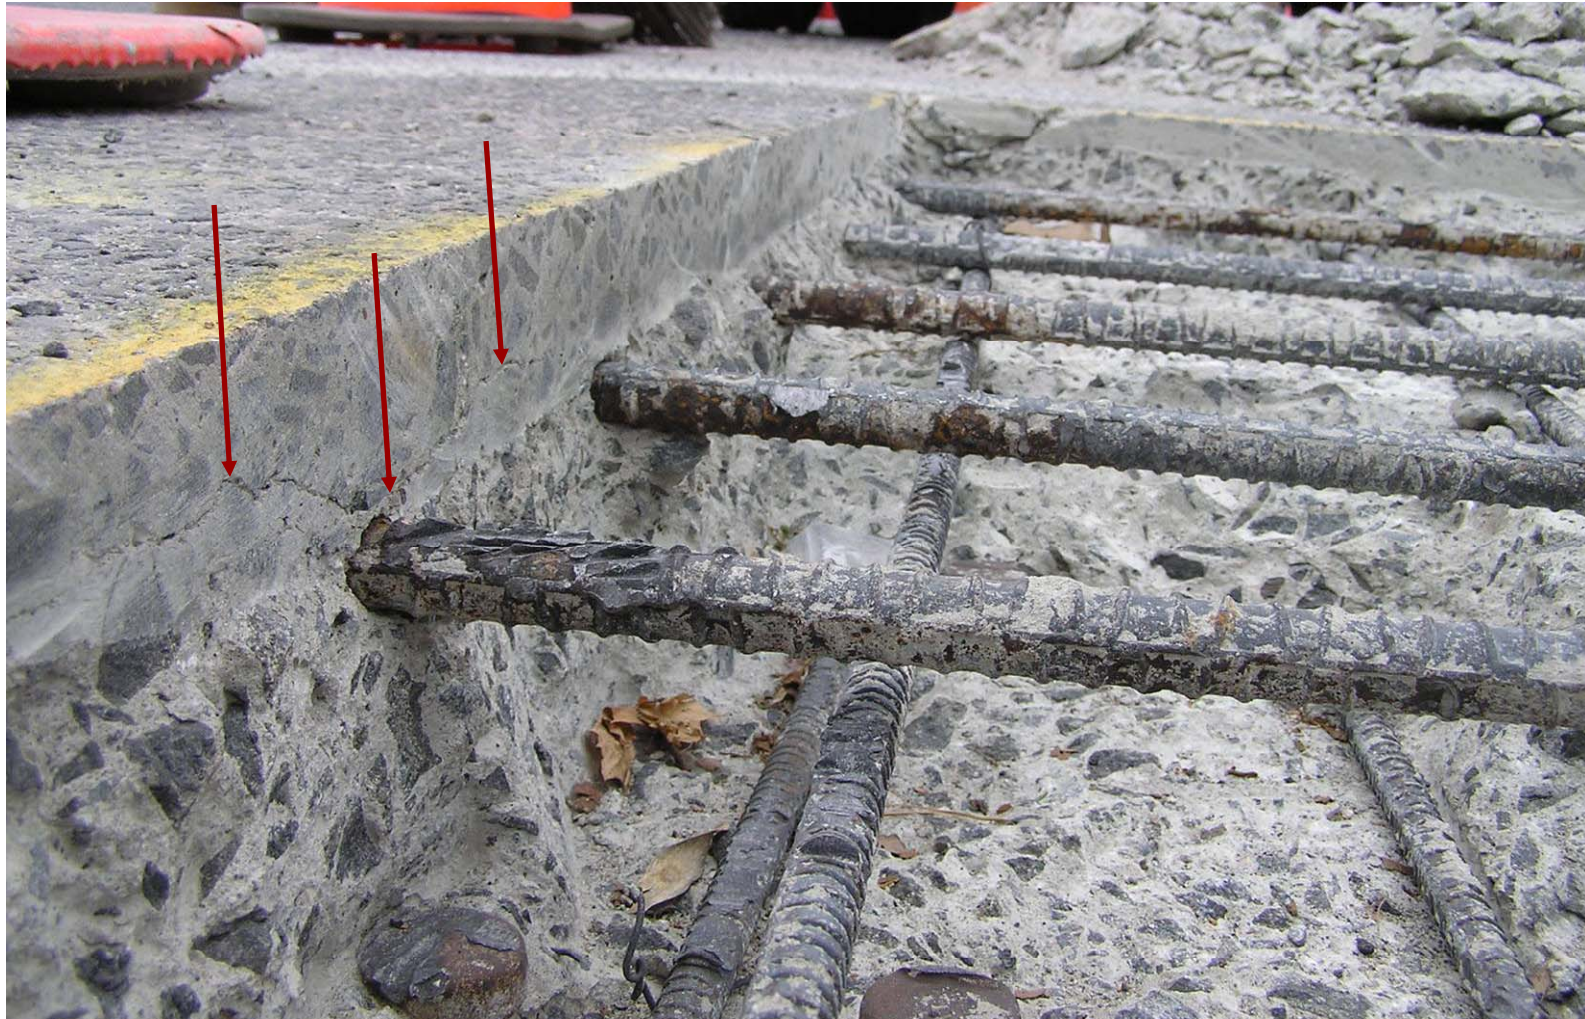
# DECK DELAMINATION

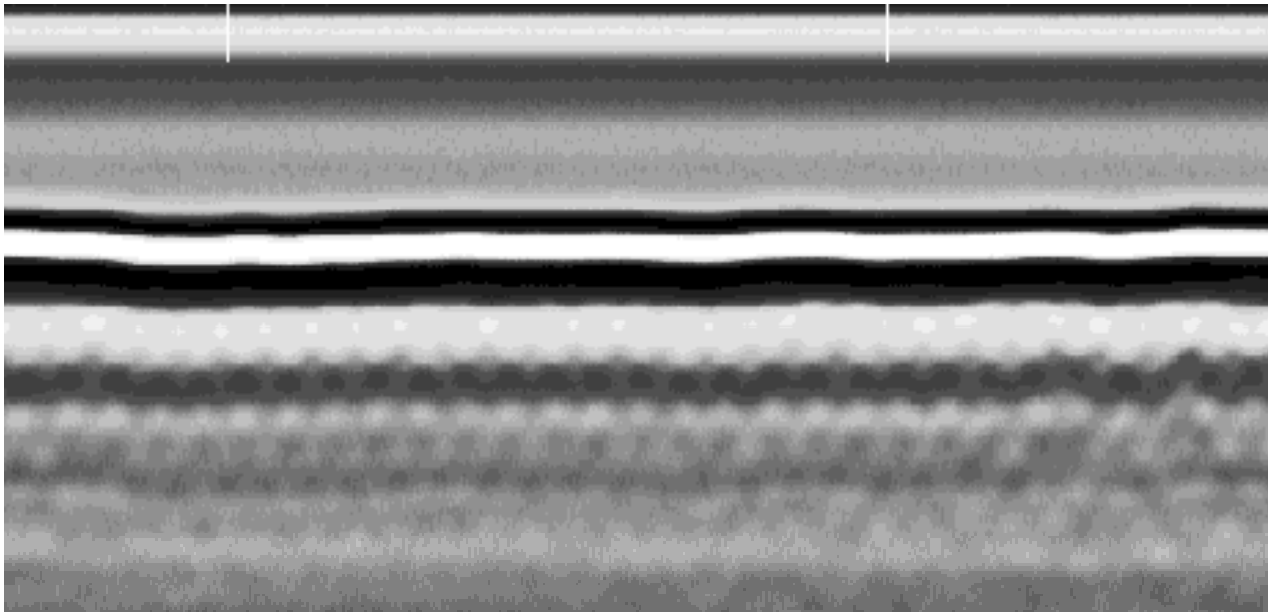
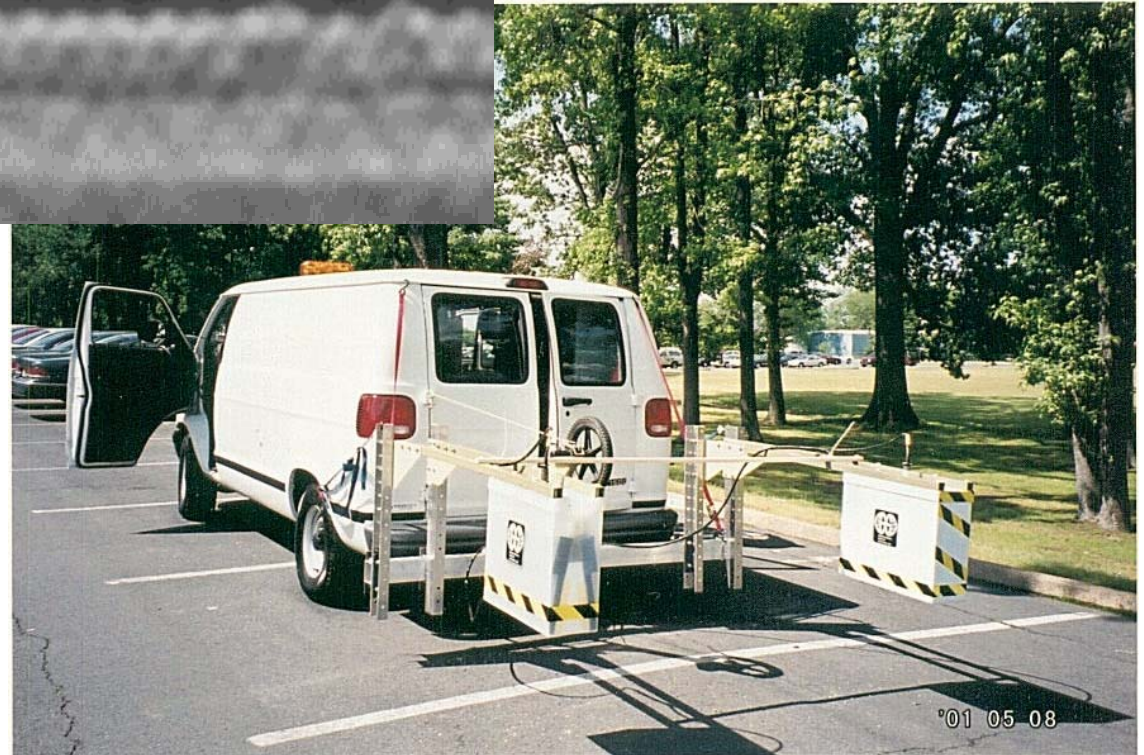
Air Launched: **Fast Overview**

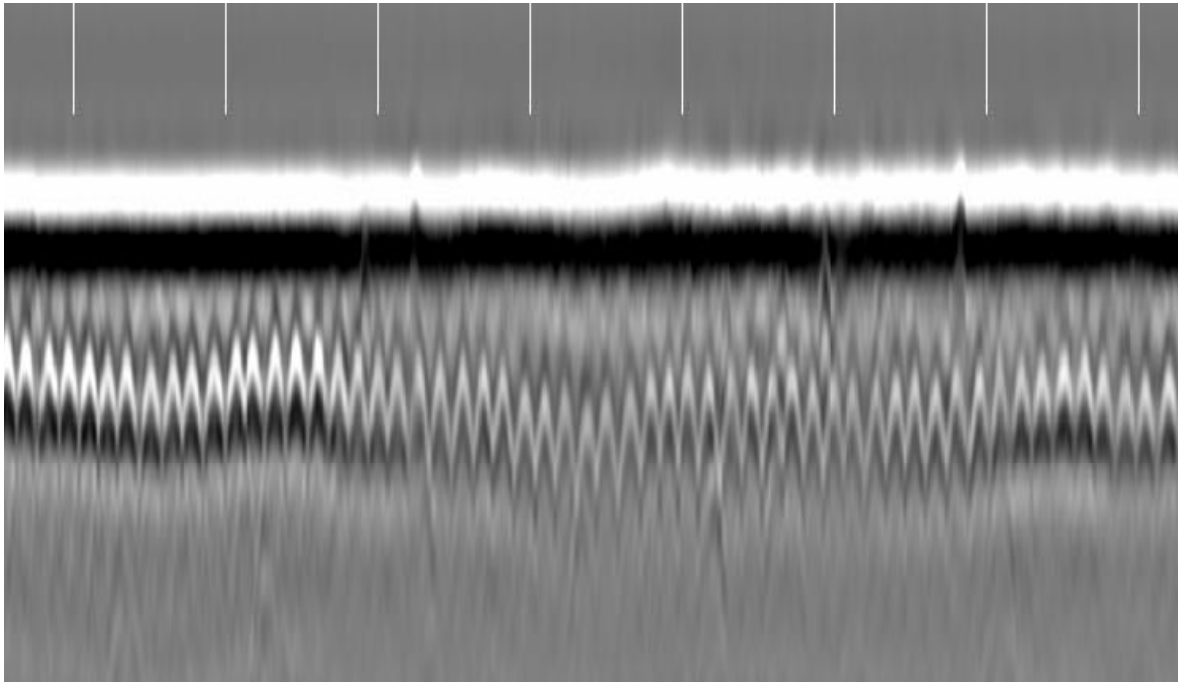
# Ground Coupled: **Detailed Imaging**

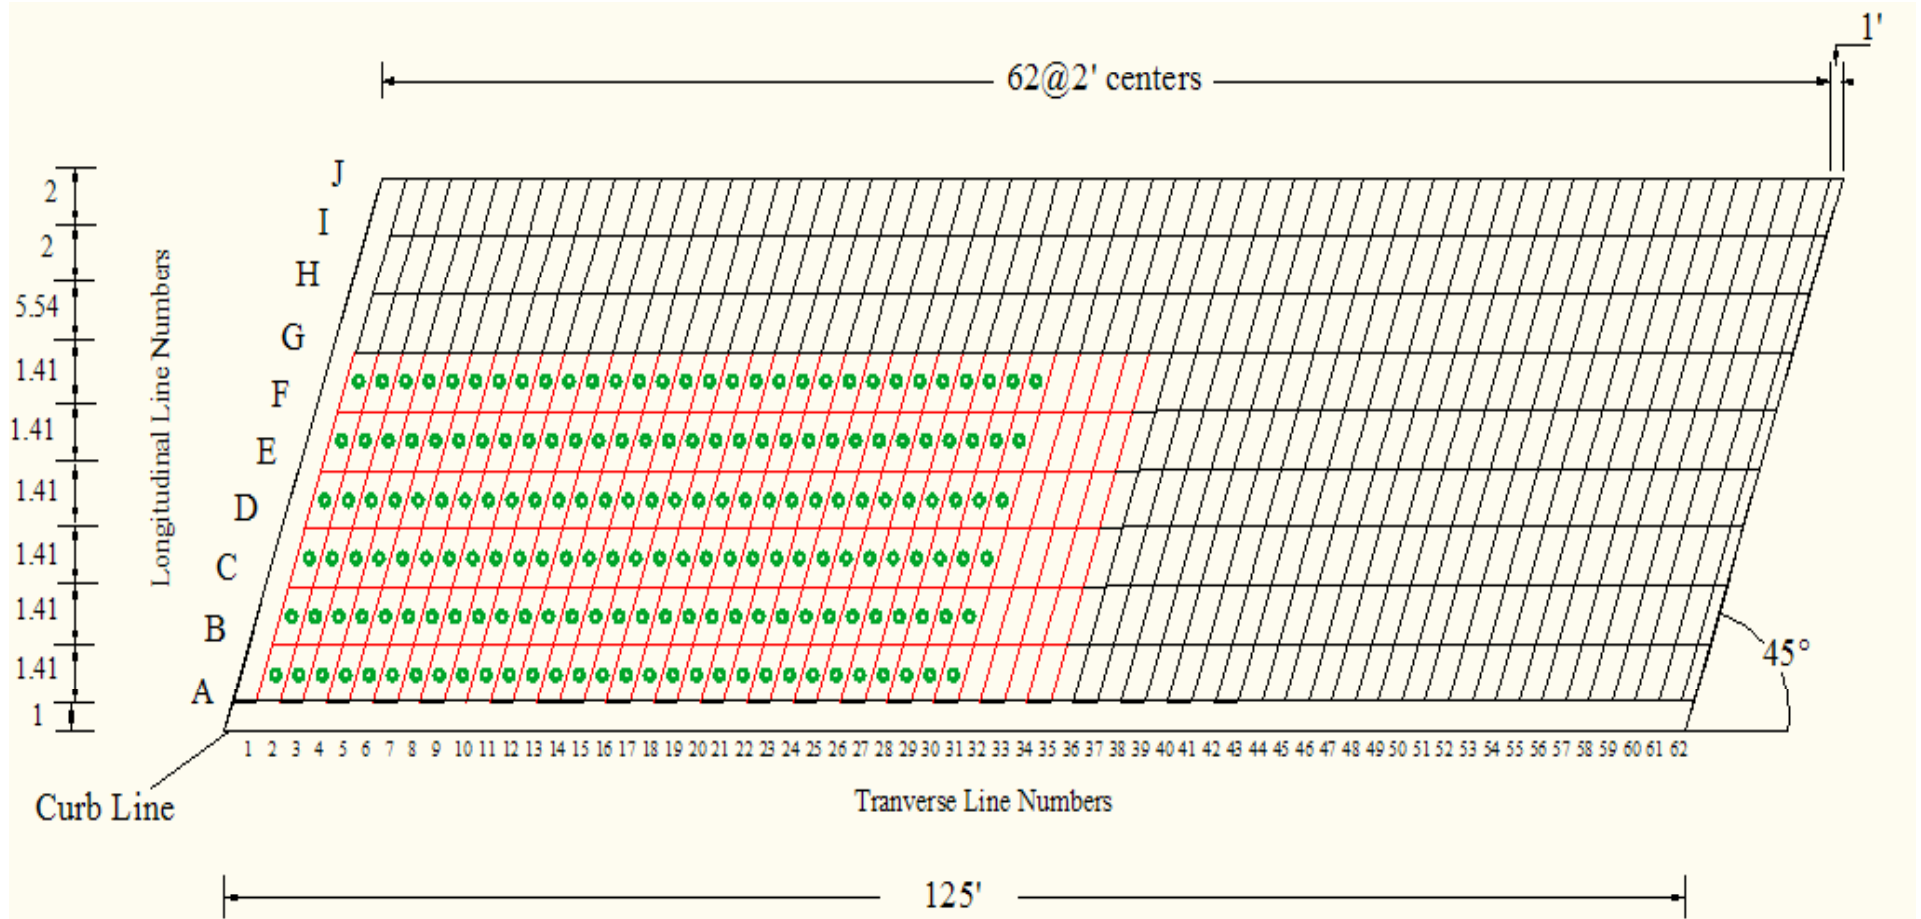
# Municipal Drive Bridge

\* West Bound Not Tested

Red Lines Indicate Completed Impact Echo Tests

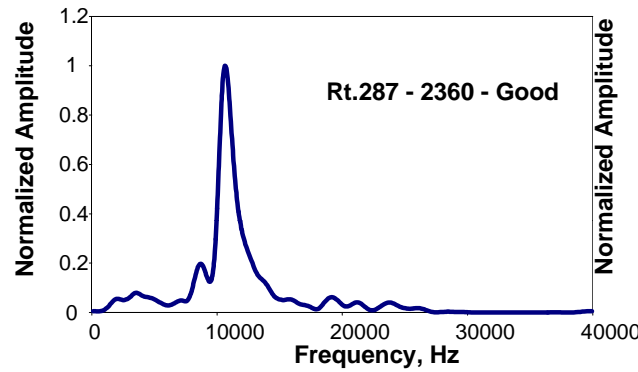
## GOOD (INTACT) CONDITION

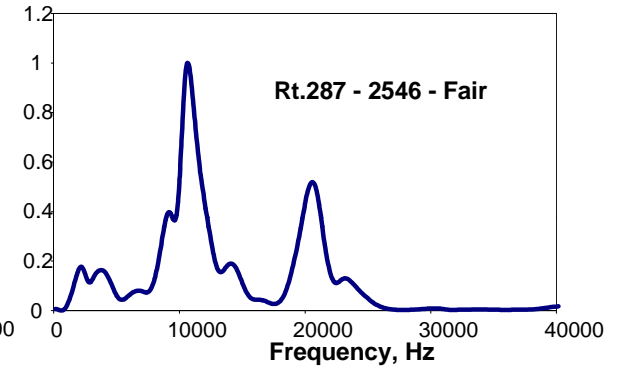
## FAIR CONDITION

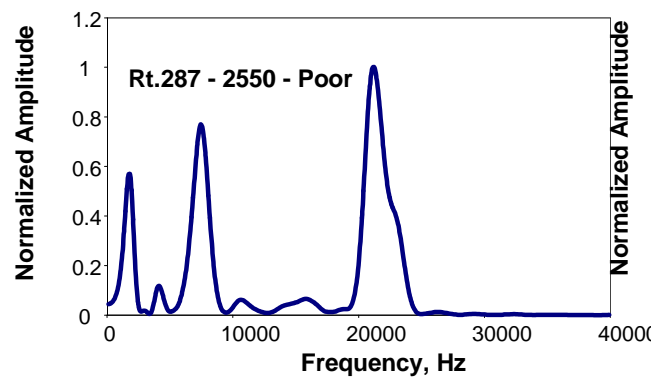
## POOR CONDITION

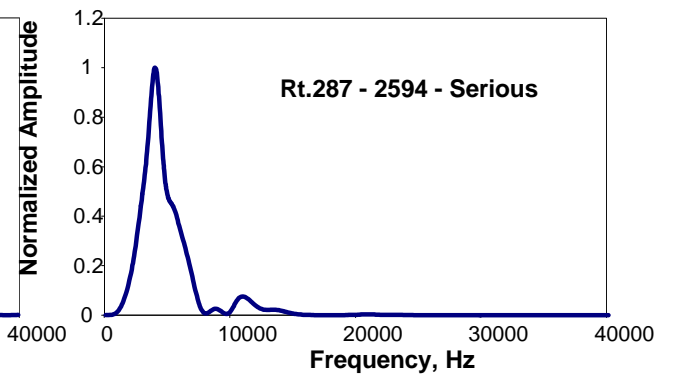
## SERIOUS CONDITION
