84th Annual NESMEA Conference

Urethane Foam in Highway Construction and Maintenance

Steven Tartabini

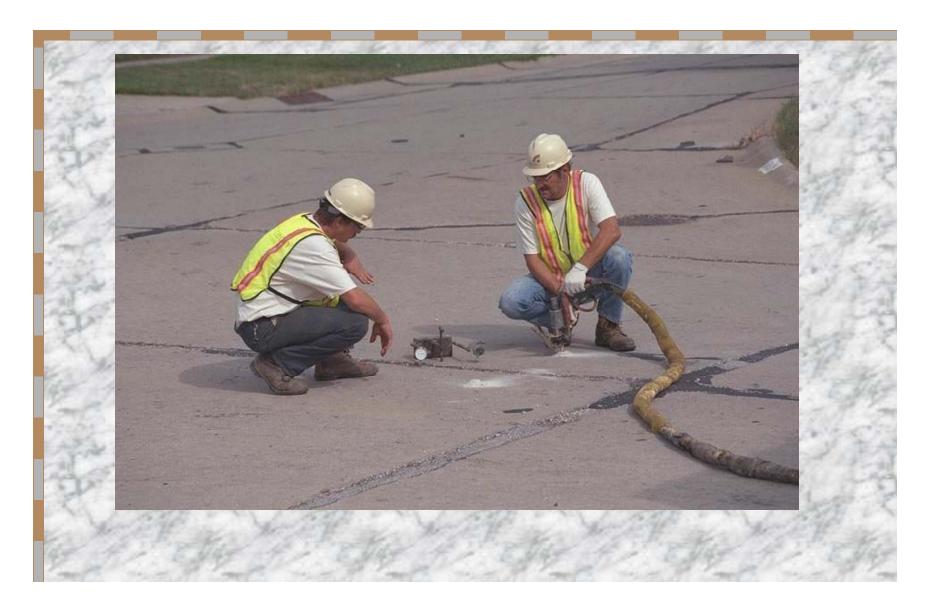
THE HDP PROCESS INVOLVES:

- Providing a flowable, foamable, curable composition which cures to a flexible and resilient foam
- Injecting the above composition under a slab to completely fill any void located between slabs and/or sub-base
- Allowing the composition to foam and cure

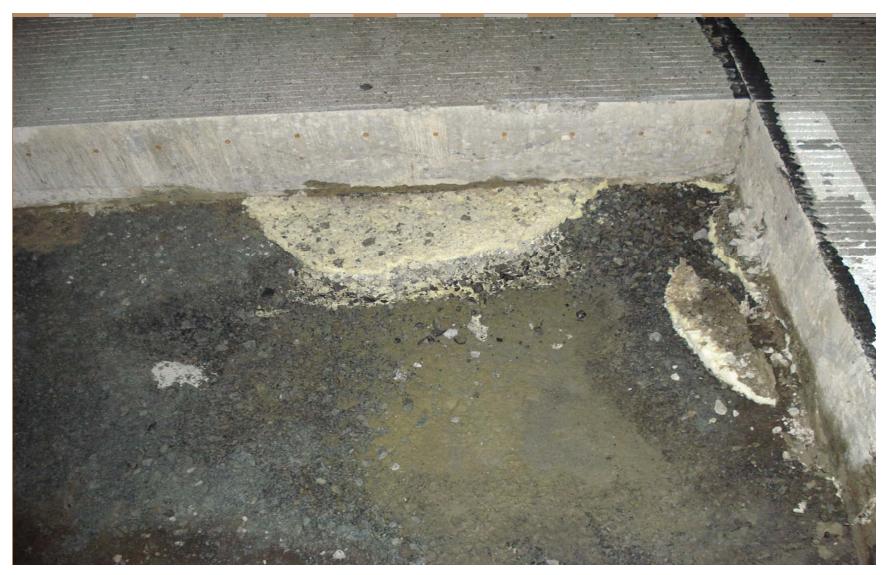
The concrete slabs also curl due to temperature differences between the top and bottom of the slab, as can occur at the beginning or end of the day. When concrete slabs are in a concave configuration (i.e., the ends of the slabs are curled up), a void is created between the bottom of the slab and the sub-base.

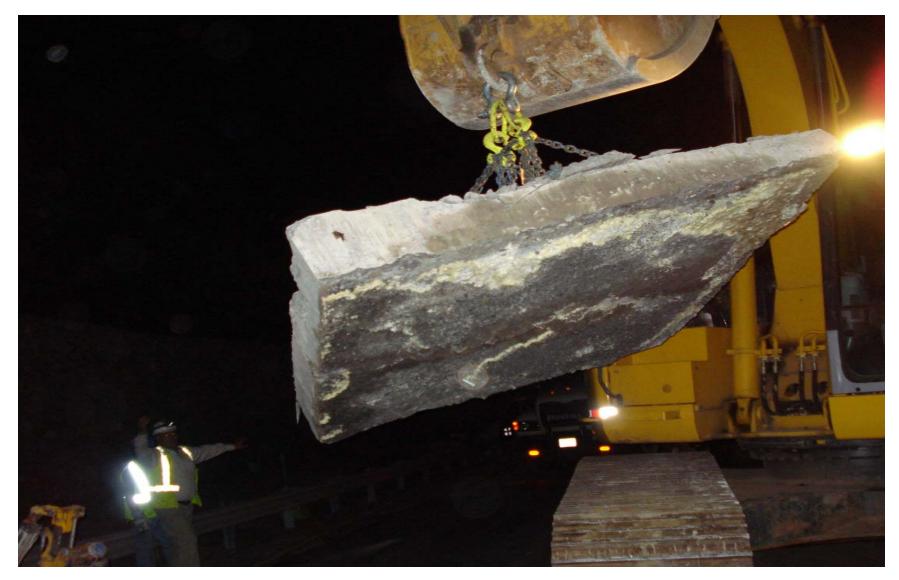
The diminished sub-base support at the joints causes a pumping action when traffic passes over the distorted slabs, which can lead to loose incompressible fines underneath the ends, a rough ride for vehicular traffic and eventual cracking at the slab ends.

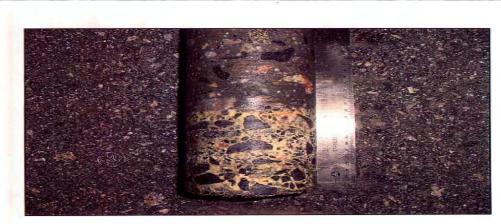
STABILIZED SECTION OF N.S.O.G. PAVEMENT

Photo No. 1: Photo of pavement core with grouted 4" NSOG layer, taken 6" from grout hole.

The results of the test grouting programs indicate that the HDP grout will penetrate and fill the voids within the NSOG and bind the aggregate together to form a solid mass. Alternately, the cement grout will not substantially penetrate the NSOG drainage layer and the grout quantities will be limited to the amount of grout required to fill voids immediately beneath the pavement.

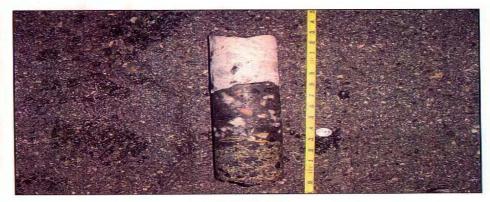
Photo No. 2: Photo of pavement core with grouted 4" NSOG layer, taken 1" from grout hole.
