Development of High Friction Surface Treatment (HFST) Prescreening Protocols and an Alternative Friction Application

**Thomas Bennert, Drew Tulanowski & Chris Ericson, Rutgers University
Robert Blight & Susan Gresavage, NJDOT
Vahid Ganji, Michael Baker International**

**Northeastern States Materials Engineers Association (NEAMEA)
October 27th 2020
(Somewhere from my house)**

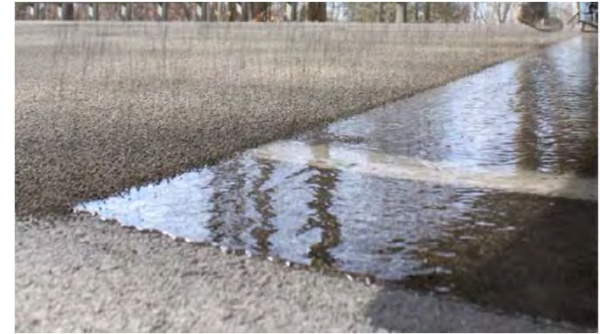
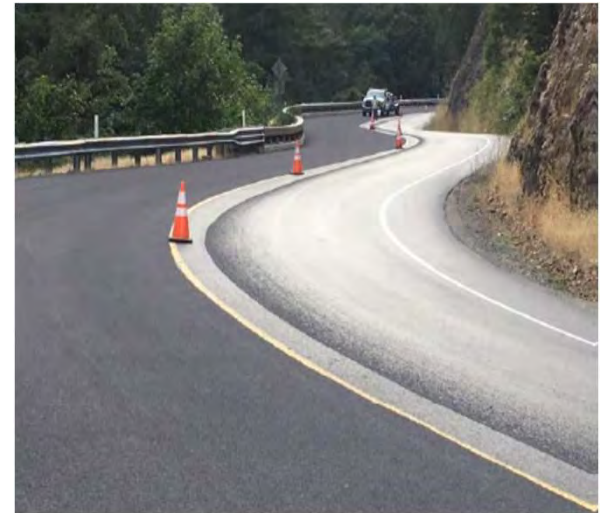
High Friction Surface Treatment (HFST)

- Typically consists of calcined bauxite (polish resistant) bonded to pavement with polymer resin
- HFST installed as a thin overlay ($< \frac{1}{2}$ inch)
- Applied as a single “surface”
- Used to improve frictional characteristics of pavement surfaces

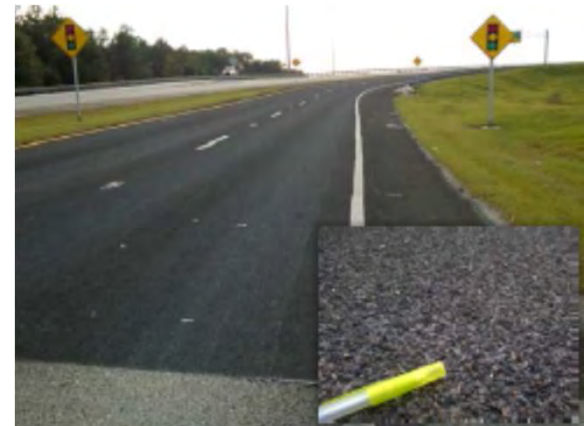
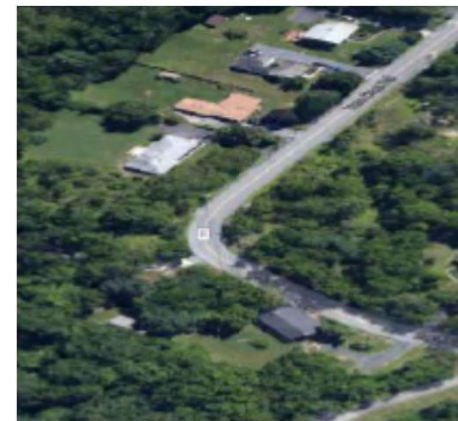
Recommended Locations of HFST

- Horizontal curves*
- Intersections
- On and Off Ramps*
 - Elevation changes (loops ramps)
- Steep grades
- Line of Sight problem locations
- High speed connectors/merge locations
- High crash clusters, roadway departures or poor roadway friction conditions

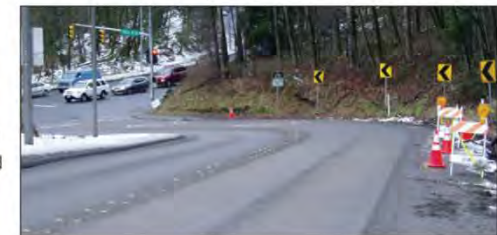
HFST at the intersection of Forest Drive and Cole Creek Parkway in Bellevue, Washington results in 78 percent fewer accidents per year
Associated accident costs dropped by 83 percent

The City of Bellevue in Washington State installed the HFST 'Tyre-grip' on the westbound approach of Forest Drive at its intersection with Cole Creek Parkway in Bellevue in October 2004 (resurfaced again in May 2007 due to a surface water issue). This is a downgrade intersection approach often affected by icy weather conditions. Approximately 35,000 vehicles use the westbound approach weekly. Bellevue tried several countermeasures, including installing a large flashing warning sign at the bottom of the grade, additional road markers, new street lights, and raised pavement buttons, but did not achieve the desired result. After applying HFST, accidents at this intersection dropped 78% and costs associated with accidents declined by 83%.

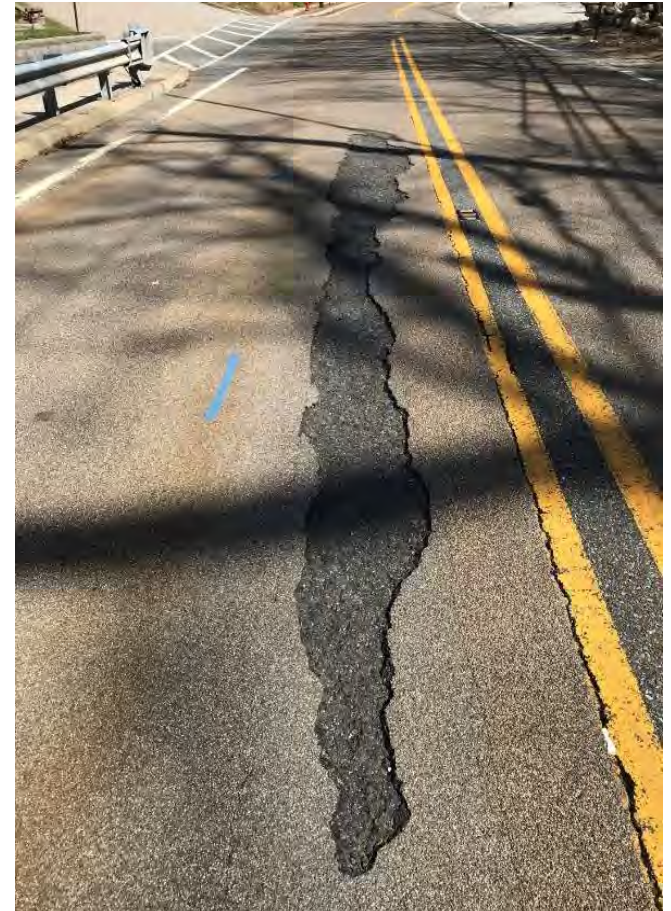
NJ County Roads SR511 & SR700

- Late Winter/early Spring 2018, pavement distress began showing up

- Both county roads received HFST application in 2017
 - CR511:
 - 8 to 13 inches of HMA over gravel base;
 - Recent HMA overlays from 2012 to 2015;
 - Visual distress survey showed pavement in “relatively good” condition (some deterioration near shoulder areas due to poor drainage)
 - CR700:
 - 8 to 9 inches of HMA over gravel base;
 - Recent HMA overlays from 2013 to 2015;
 - Visual distress survey showed pavement in “relatively good” condition

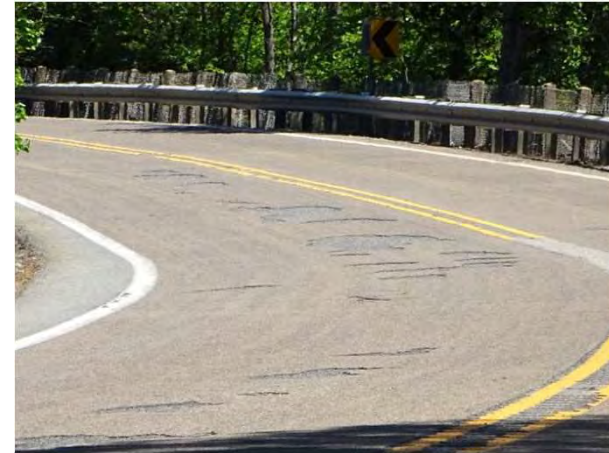
HFST Distresses and Possible Causes

- Substrate Failure – Top-down & Shallow Horizontal Cracking
 - Due to weak substrate
 - Areas of extreme stopping & slow turning
 - Thermally induced stress
 - Excessively thick & stiff HFST layer (epoxy)

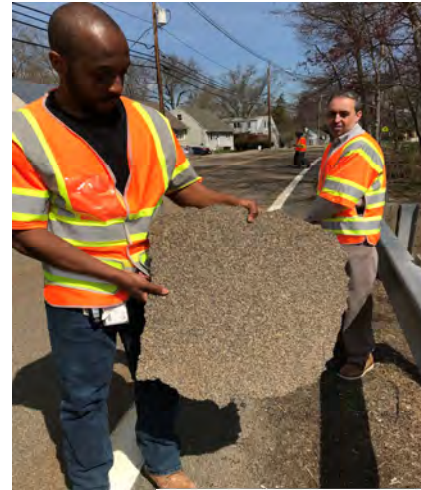
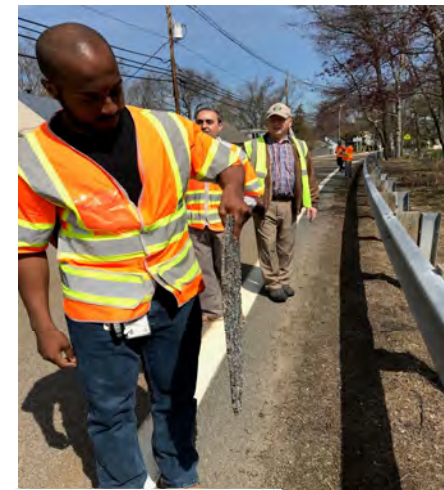
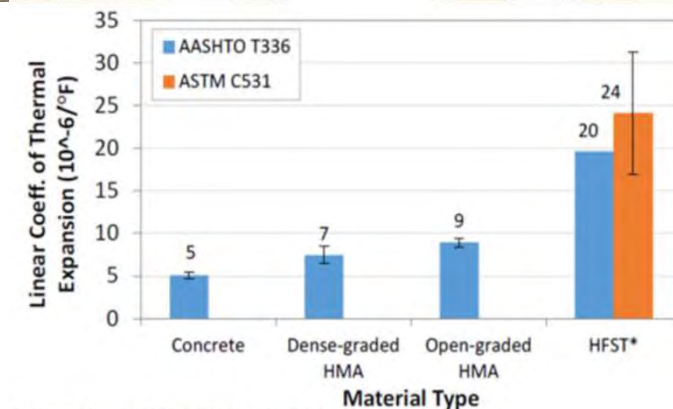
HFST Distresses and Possible Causes

- Substrate Failure – Top-down & Shallow Horizontal Cracking
 - Typically $\frac{1}{4}$ " to $\frac{1}{2}$ " deep
 - Epoxy and asphalt mixtures are thermally incompatible
 - Epoxy has an expansion/contraction rate 3 to 4 times greater than asphalt mixtures
 - Worst situation – cool/cold temperatures with a quick, large temperature decrease

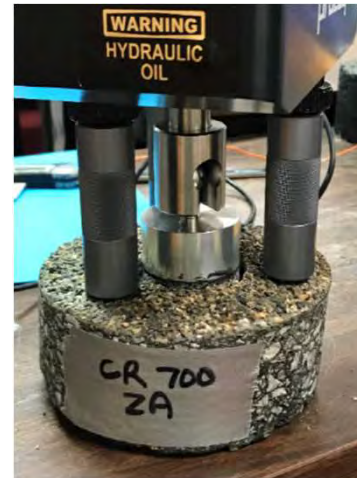
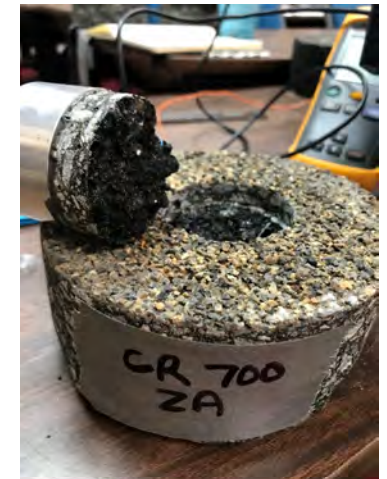
Proposed Prescreening Methods

- Test methods selected;
 - ASTM C1583 – testing pull-off strength of existing substrate tested at 25°C
 - 6 inch field cores work well
 - Asphalt binder characterization from upper 1/2" to 3/4" of existing asphalt pavement for "durability"
 - Glover-Rowe Parameter
 - ΔT_c (Difference in critical low temperature cracking)

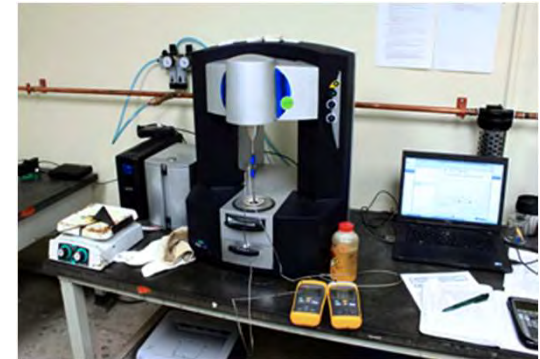
Glover-Rowe Parameter (G-R)

- Rowe (AAPT, 2011) proposed the DSR master curve analysis to calculate the “Glover-Rowe” parameter
 - As G-R parameter increases, the binder is more prone to fatigue cracking
 - Correlates very well to ductility of asphalt binder
 - G^* = shear modulus (stiffness of asphalt binder)
 - δ = phase angle (relaxation of asphalt binder)

$$\frac{|G^*|(\cos \delta)^2}{\sin \delta}$$

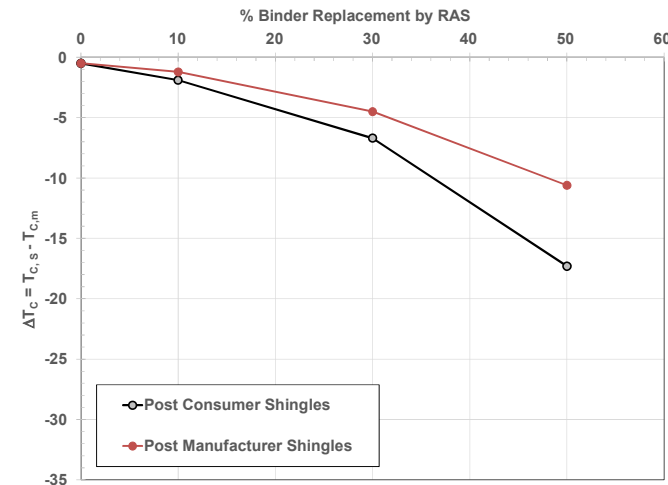
ΔT_c from BBR Testing

- As asphalt binders age, the relaxation properties (m-value) are negatively affected at greater rate than the stiffness (S)
- The difference between the low temperature cracking grade of m-value and S is defined as the ΔT_c

$$\Delta T_c = T_{c, S} - T_{c, m\text{-value}}$$

- Anderson et al. (2011) showed that the ΔT_c correlated to non-load associated cracking on airfields (i.e. – cracking due to lose of ductility from aging)
 - The more negative value, the more aged the asphalt binder

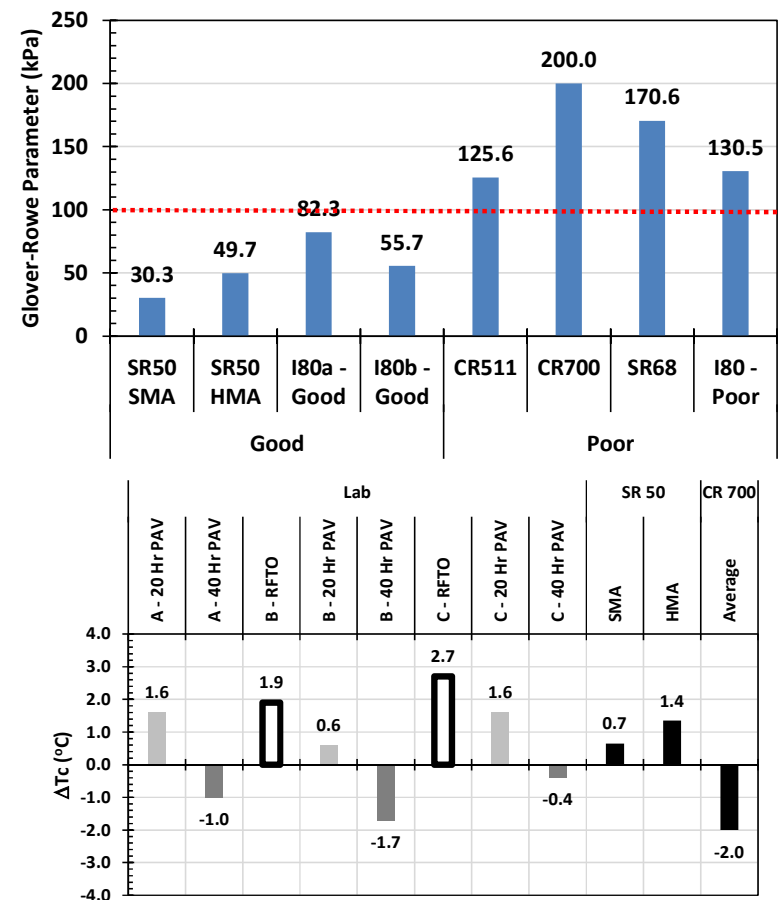
Failed HFST Sections – Asphalt Binder Characterization

- Recovered the asphalt binder for 1/2" to 3/4" of surface
 - "Good" HFST performance was identified with Glover-Rowe < 100 kPa
 - ΔT_c indicated values "warmer" than 0°C
 - Some projects not able to be tested due to limited material

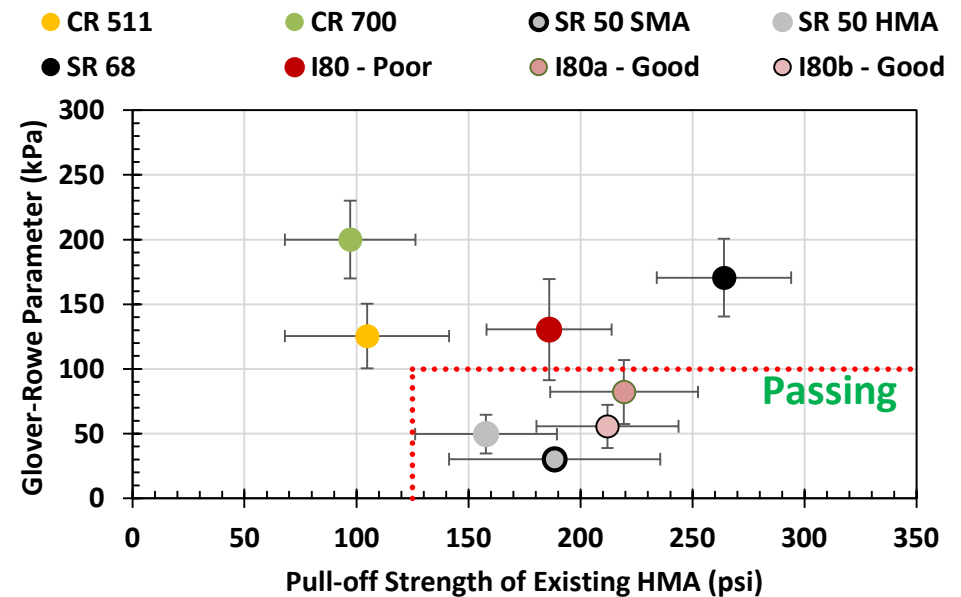
Preliminary HFST Prescreening Criteria

- Even though a pavement is visually in “good condition”, asphalt may still be prone to raveling/durability issues of “aged” asphalt
 - Binder testing to address quality of asphalt binder in existing pavement surface
 - Mix testing to address quality of mix strength properties in existing pavement surface

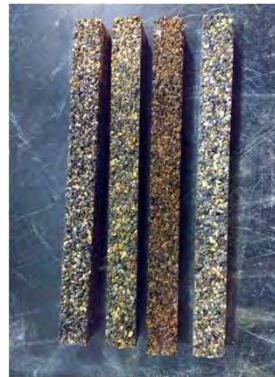
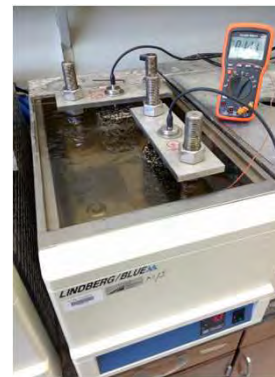
Route 68 High Friction Chip Seal (HFCS) Case Study

- What if we tried high friction aggregate with a highly modified asphalt binder?
 - Asphalt-based binding system more thermally compatible than epoxy resin
 - High PG to maintain stiffness in hot temperatures
 - Low PG properties to aid in thermal contraction movements

- Looked at using a chip seal process using hard, angular stone
- Evaluated different aggregate sources
 - Diabase (NJ) – Lane 1
 - Calcine Bauxite – Lane 2
 - Flint Rock (OK) - Shoulder
- Compared aggregate “polishing” resistance
 - Utilized micro-deval & Aggregate Imaging to assess polishing resistance (Masad et al., 2011)

- Asphalt binder met the requirements for FAA P₄₀₄, *Fuel Resistant (FR) Asphalt Mixture*
 - PG88-22 with Evotherm applied hot 0.3 to 0.38 gal/yd²
- Aggregate “chips” spread at 14 to 18 lb/yd²
- Rubber wheel rollers to seat aggregate & loose aggregate swept

- Looked at pull-off strength of HFCS applied to Rt. 68 surface
 - Could aggregate get pulled out of HFCS binder?
- Results were consistent for aggregate (Average ≈ 118 psi) and failures occurred between binder and pavement surface
 - Pull-off strength statistically greater than adjacent asphalt rubber chip seal

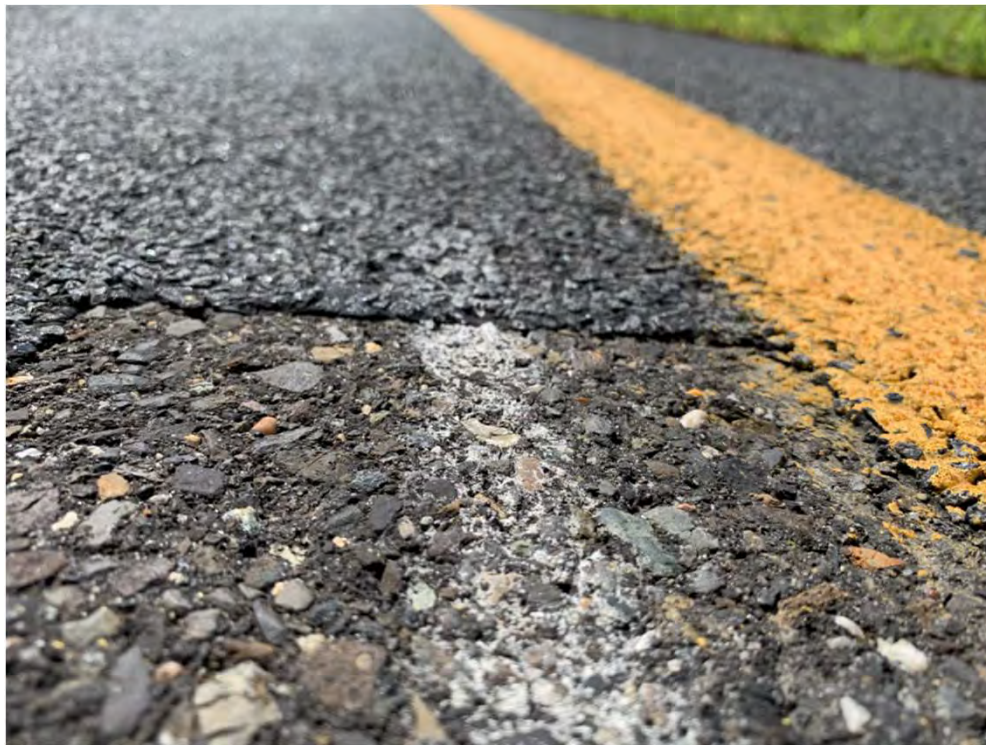
Diabase Aggregate

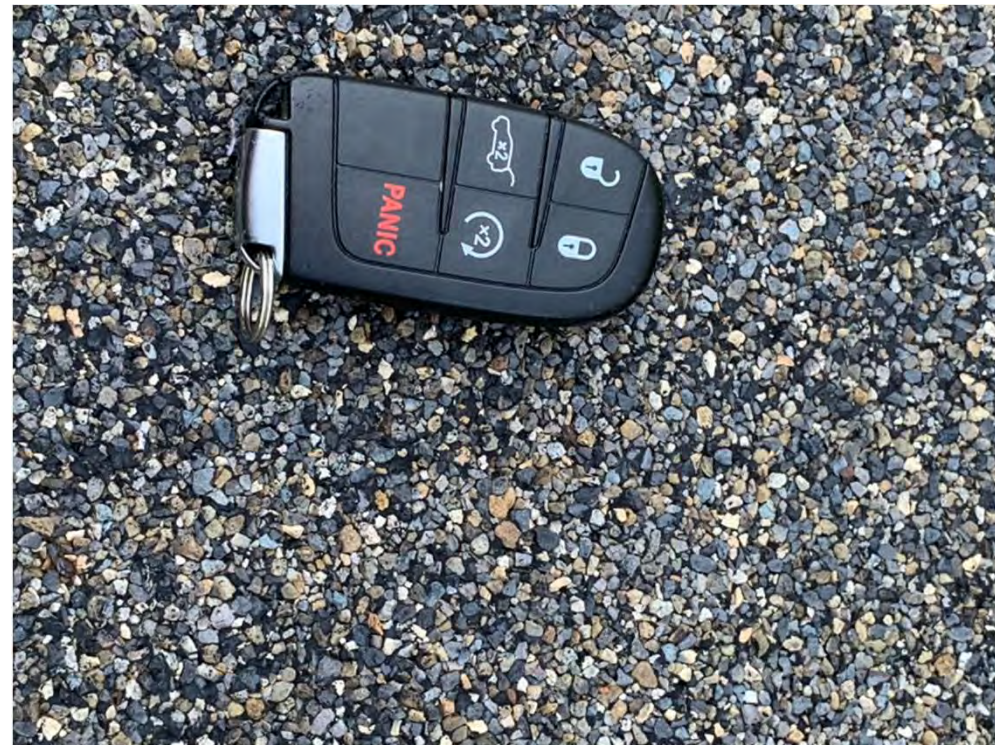
Calcine Bauxite

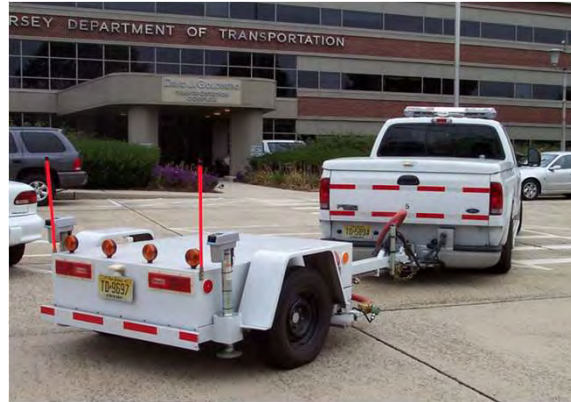
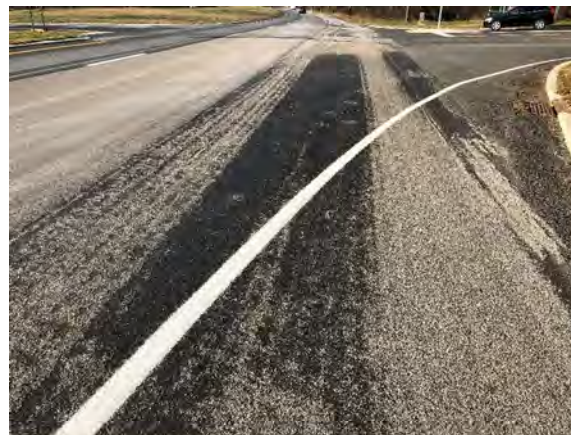
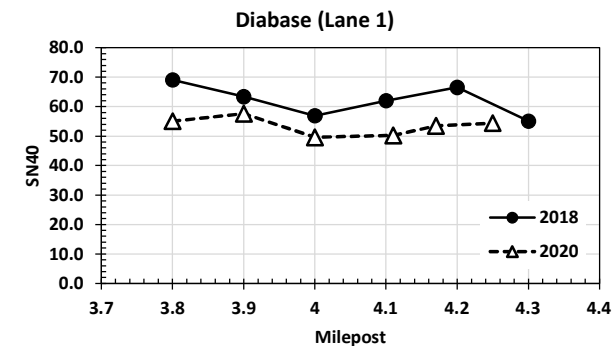
Skid Resistance, SN₄₀ (ASTM E274)

- Skid Testing was conducted in accordance to ASTM E274
 - Initial results looked good (SN₄₀ Ave > 60)
 - After 2 years, values dropped around 10 to 20%
 - Skid friction influenced by bleeding of adjacent asphalt rubber chip seal major issue
