Project-Level Analysis of Composite Pavements Using Ground Penetrating Radar

Online
Alex Bernier
Program Director
Connecticut Advanced Pavement Laboratory
Connecticut Transportation Institute
University of Connecticut

October 26, 2021

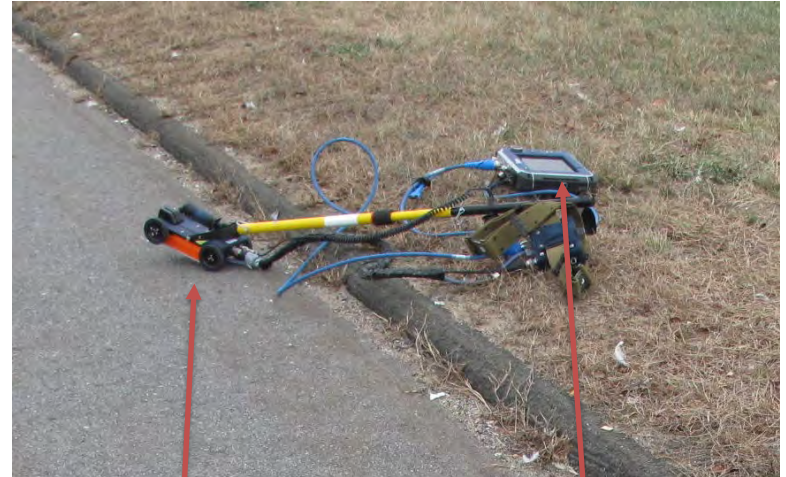
- Ground-Penetrating RADAR
 - RAdio Detection And Ranging
- Generate wide-frequency pulse, interpret difference in waves as they return to the device.
- Applications in roadways back many decades, however technologic limits existed on data collection rate and frequency of antenna

Antenna

Data Acquisition
System

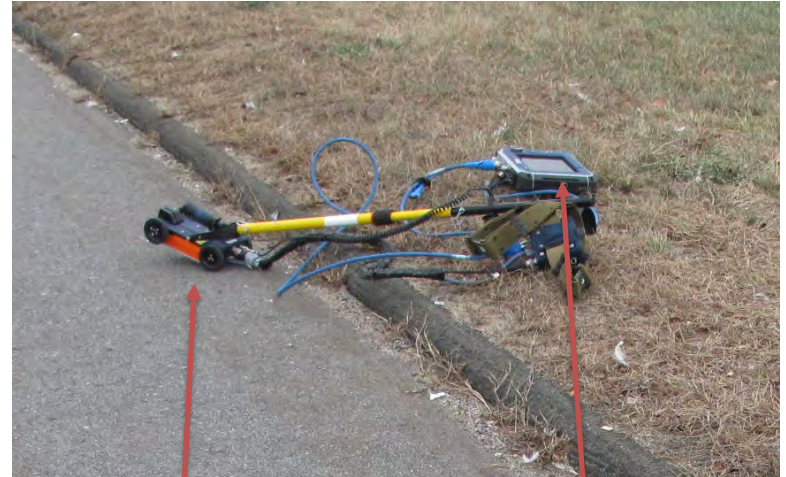
- Case Study No. 1 & 3 Utilized
 - 1.6 GHz (No. 1 only)
 - 2.6 GHz
- Ground-coupled, analog antennas
- 2mm scan spacing/0.0174 nano-seconds

Antenna

Data Acquisition System

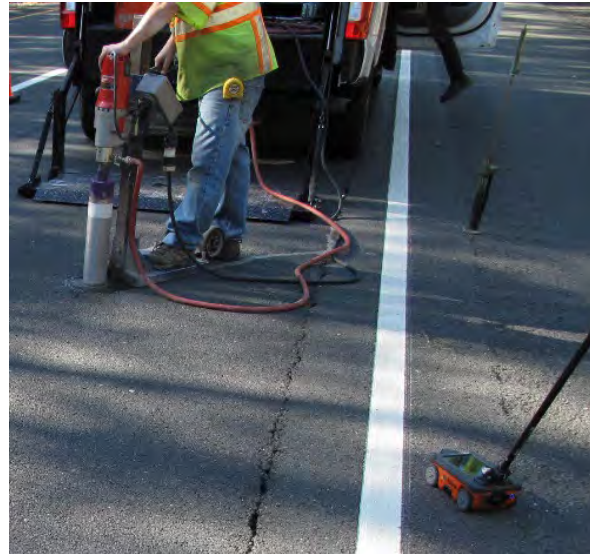
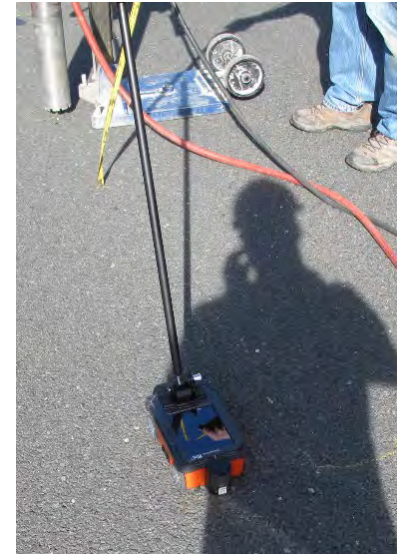
- Case Study No. 2 Utilized
 - 2.6 GHz
- Ground-coupled, analog, all-in-one concrete scanning device

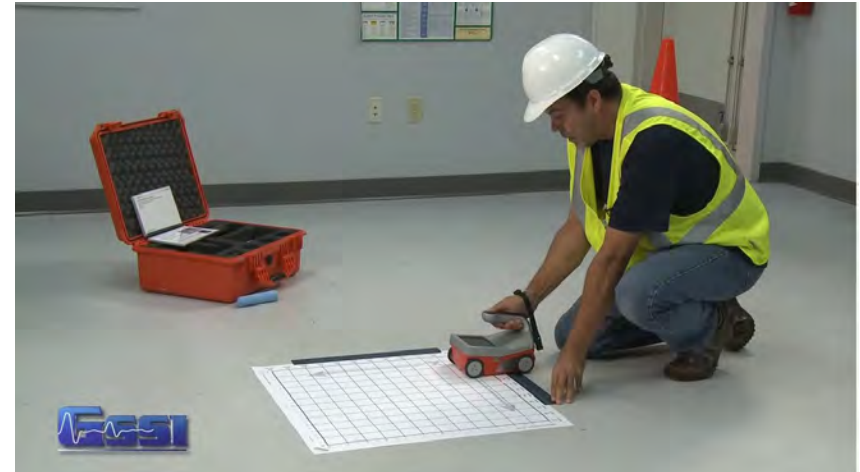
- Adapting a 3D Concrete Survey to Composite Pavements (Adding a layer to penetrate and interpret)

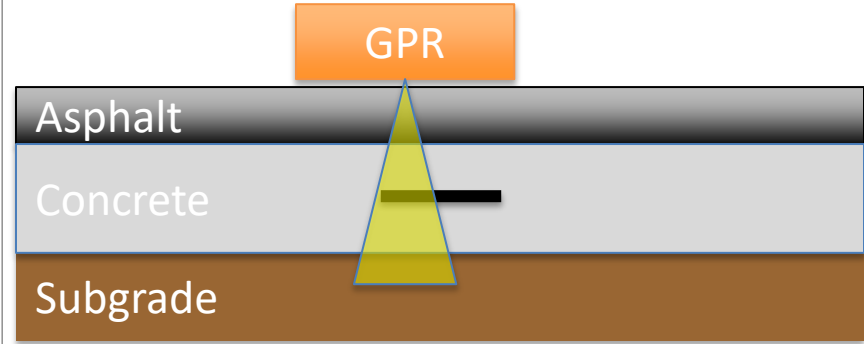
File024

- Lower frequencies → deeper penetration, but limited clarity at shallow depths
- Higher frequencies → shallower penetration, but higher clarity
- Ground-Coupled systems are slower to use
 - can't operate at highway speed
 - preserve energy lost at air/surface interface

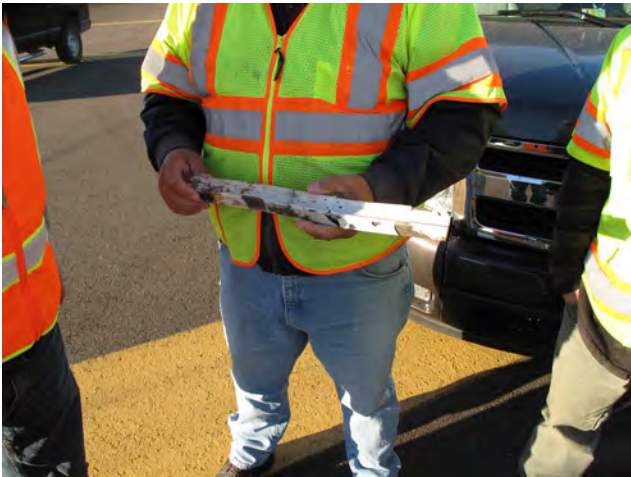
**DETAILS OF
LOAD TRANSFER UNIT
TYPE "A-1"**

- For a period of time, CT DOT permitted the use of i-beam style load transfer devices (LTDs) on Jointed Concrete pavements.
- It is unknown where these load transfer devices remain across the state, but the state desires to replace with modern dowels when encountered.

**CONNECTICUT
STATE HIGHWAY DEPARTMENT**

**FOR 9" & 10" REINFORCED
CONCRETE PAVEMENT**

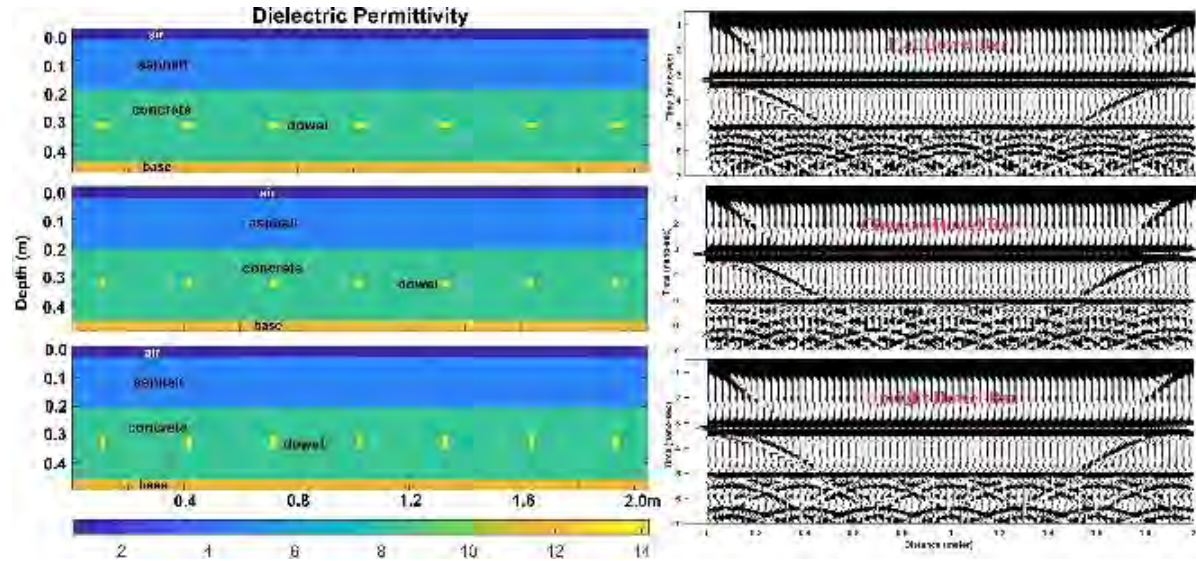
- Pseudo-Spectral Time Domain simulation performed to determine whether dowels vs. i-beams may be differentiated.

Lanbo Liu, Alexander Bernier, and James Mahoney, (2020), "Push the resolution limit: Can we differentiate the cross-section shape of dowel bars in the concrete with GPR?," *SEG Global Meeting Abstracts* : 180-183.

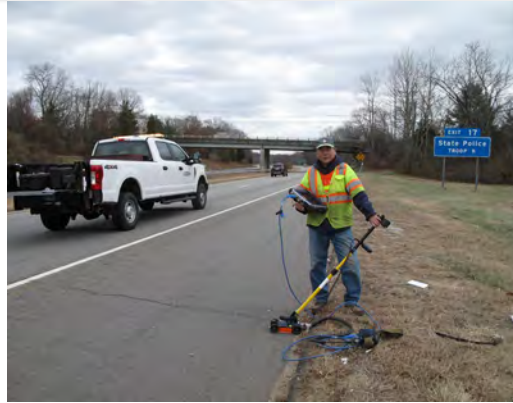
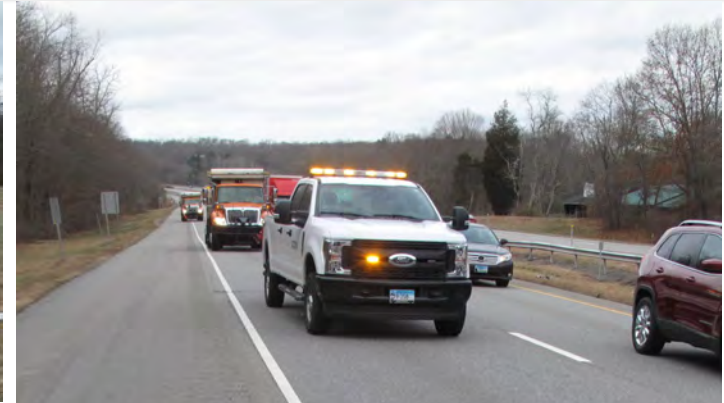
- Success!
- Field-confirmed
 - length of LTDs
 - spacing of LTDs
 - structure layer thicknesses
- Hypothesize we did encounter i-beam LTDs at some locations

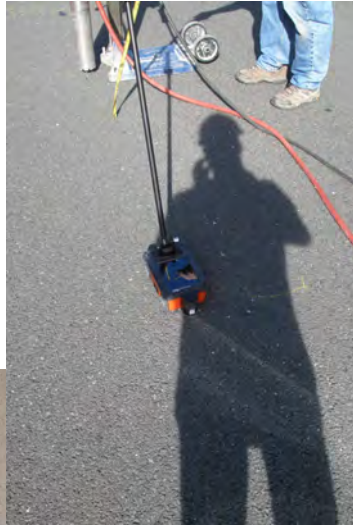
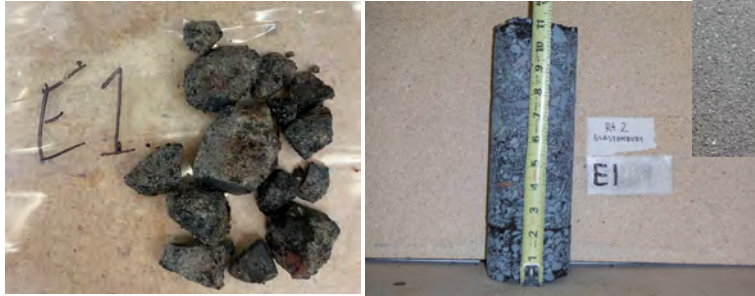
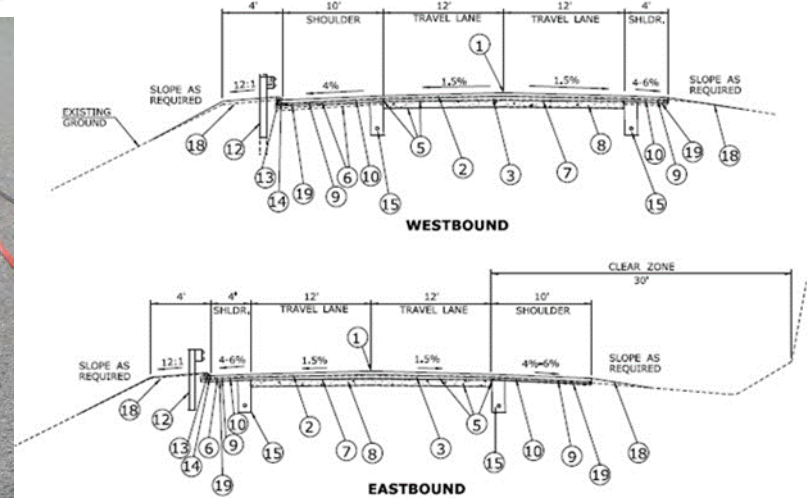
TYPICAL SECTION NUMBERING KEY

- 7-9 inches HMA over PCC in design
- 2.6 GHz all-in-one Ground-Coupled GPR unit
- Surface Distresses prompted investigation

1. APPLICATION OF GRADE
2. 4" PMA 50.5 (2 EQUAL LIFTS) ON TOP OF 1 1/4" TO 2 1/2" HMA 50.375 CURB TO CURB
3. 3.5" TO 5" HMA S1 (2 LIFTS) ON TRAVEL LANES
4. 2" HMA 50.5 ON TOP OF 1 1/4" HMA 50.375

5. APPROXIMATE LIMITS OF EXISTING CONCRETE PAVEMENT
6. APPROXIMATE LOCATION OF EXISTING BITUMINOUS CONCRETE PAVEMENT
7. MILL TO TOP OF CONCRETE PAVEMENT
8. RUBBLIZATION OF EXISTING CONCRETE PAVEMENT

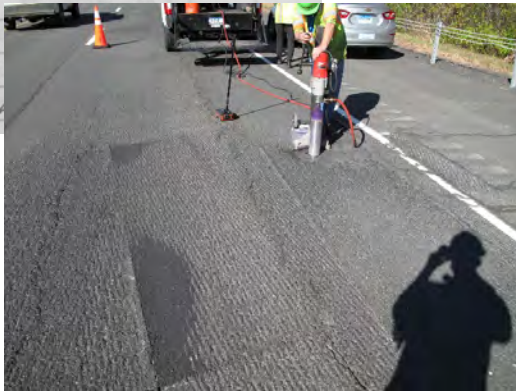
Case Study No. 2: Deleterious Material on Rubbleized PCC

- Asphalt layer found to be thicker than original design
- 'Pasty' Effluent and light colored material indicative of a deleterious patch material

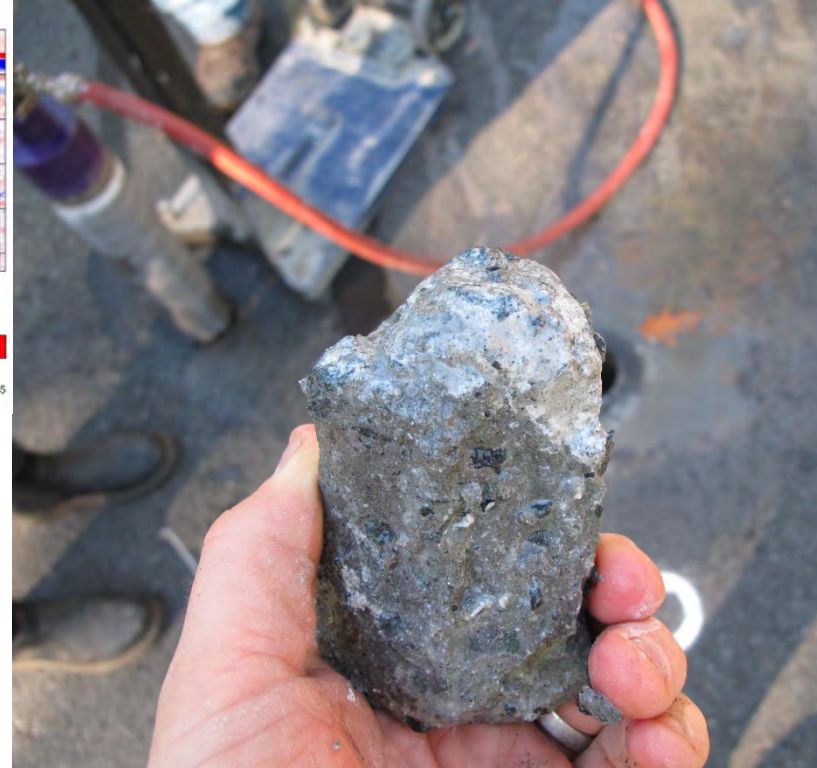
- In the field, wavy subgrade signals from GPR seemed to relate to presence of patch material

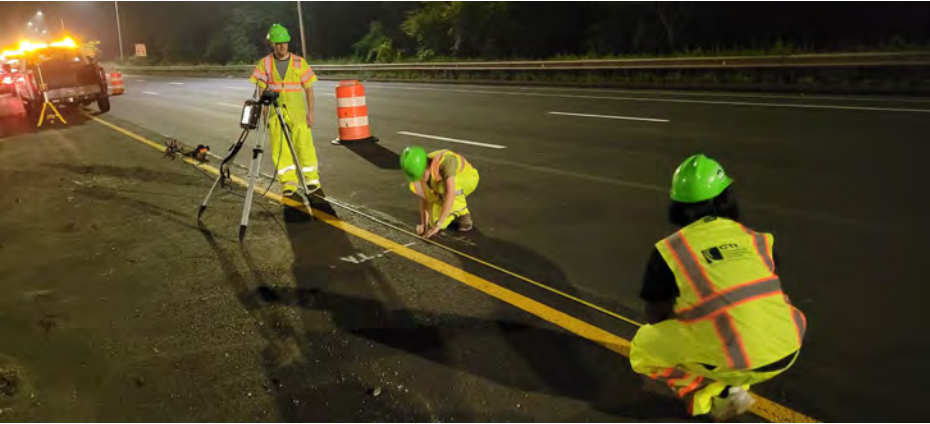
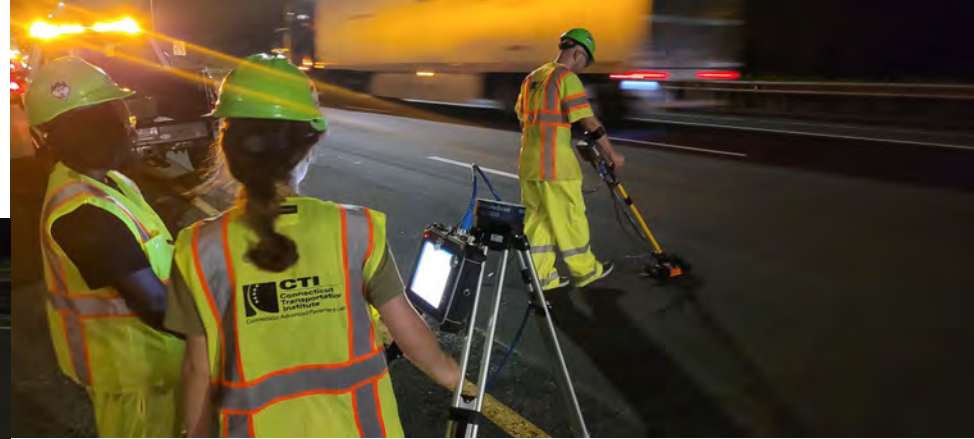
- Laid out a 1-ft grid
- Longitudinal + Transverse

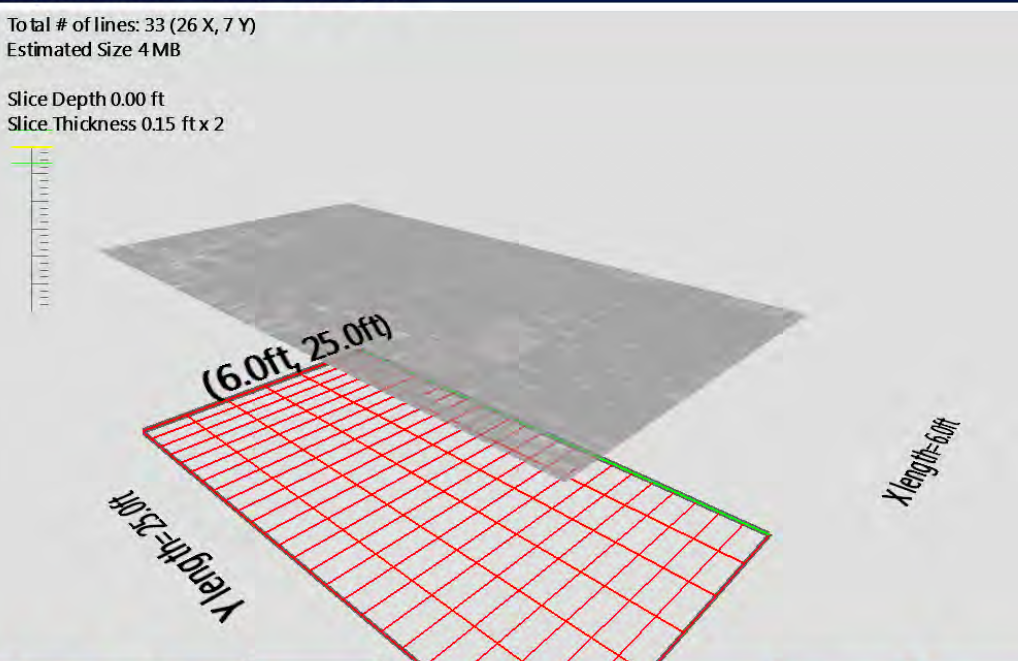
Playback Mode - I91SB - GRID_002

Slice Depth 0.00 ft
Slice Thickness 0.15 ft x 2

The image shows a 3D perspective view of a grid. A red grid is in the foreground, and a grey grid is behind it. The red grid has dimensions labeled as (6.0ft, 25.0ft). The Y-axis is labeled 'Y length=25.0ft' and the X-axis is labeled 'X length=6.0ft'. A vertical scale bar is visible on the left side of the grid.

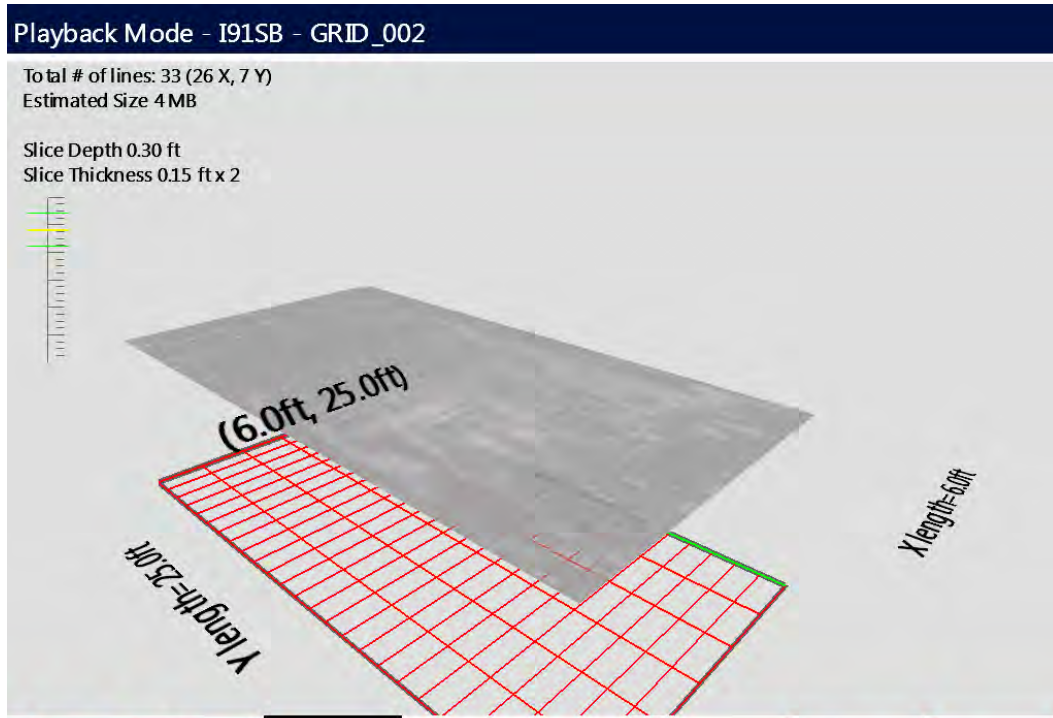
Slice Depth 0.30 ft
Slice Thickness 0.15 ft x 2

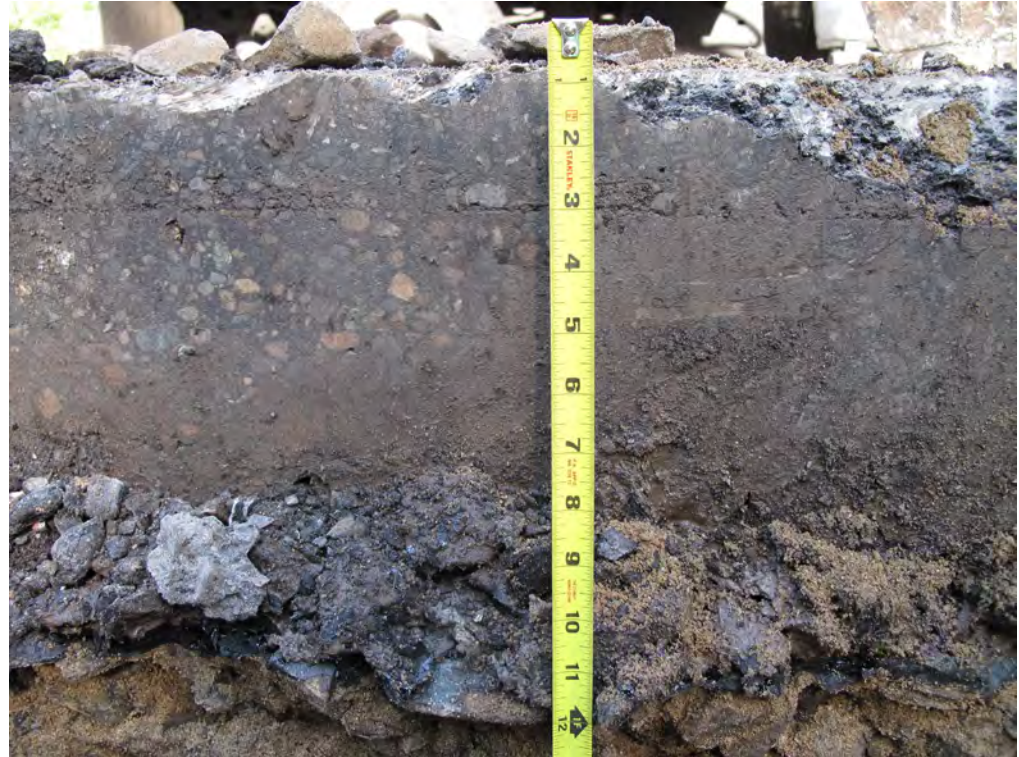
- Can we detect inter-asphalt layer differentials?
- Scans performed in the vicinity of a sand/skim layer
- Cores and test-pits performed as well
- Currently analyzing GPR data for possible identification
- Challenge: Sensitivity of the equipment to detect change in resistivity between different densities of material and accounting for noise of measurement
