ASTM A588 Weathering Steel Guardrail

Routine Maintenance Turns Up Problems in 1993

Condition Survey 1995/1996

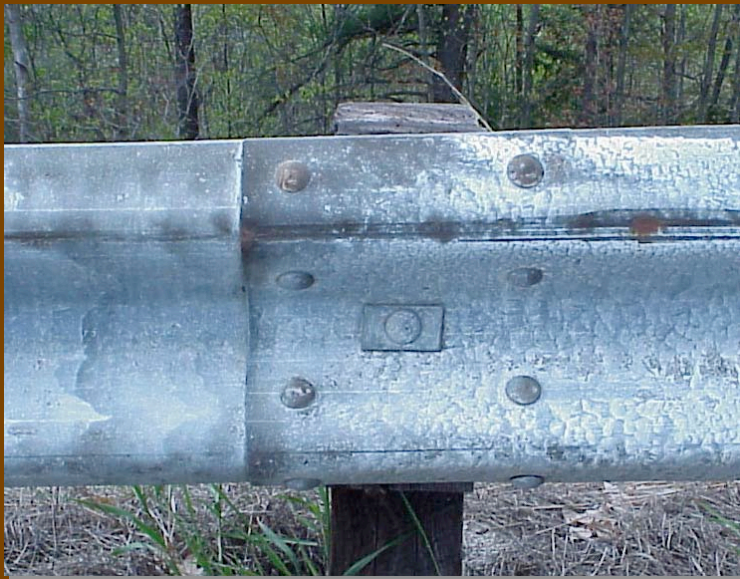
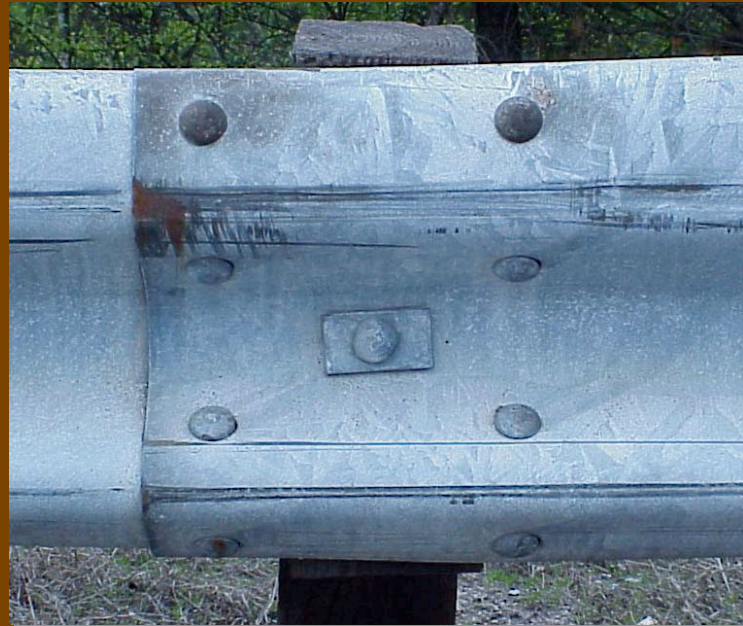
- Galvanized rail exposed to corrosive environments and equal years of service proved to be satisfactory
- Thickness tests showed no decrease from original dimension on all rail sampled
- Over time galvanized rail will become less shiny to a more environmentally blending appearance

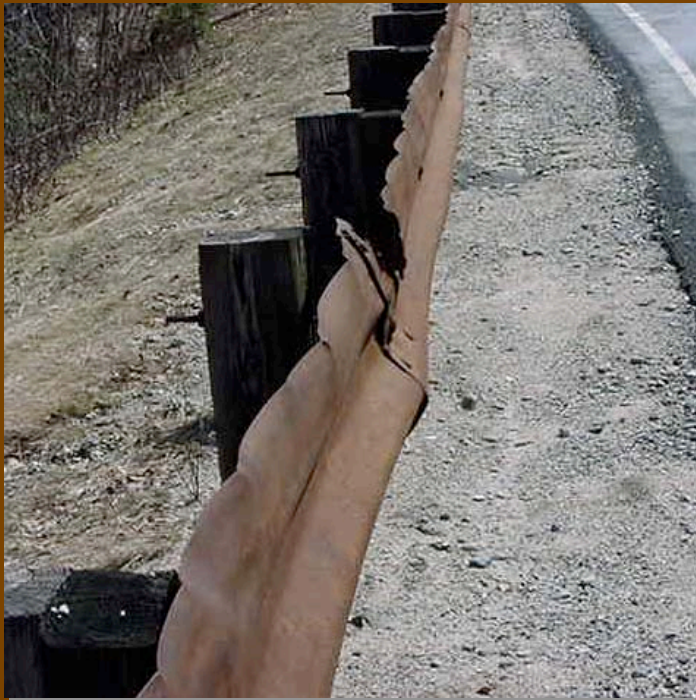
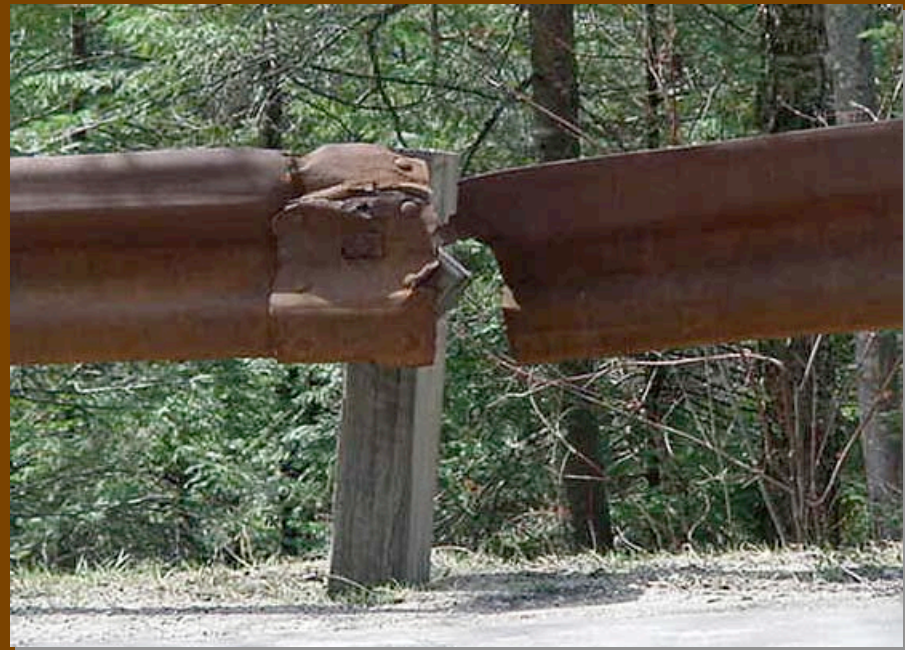
- Weathering Steel is not suited for use in corrosive environments
- In 1997 we had the support of the USFS to discontinue the use of Weathering Steel Guardrail
- Current condition of some rail is a inadequate

- **Discontinue use of Weathering Steel Guardrail**
- **If we are going to continue using Weathering Steel Guardrail...**
 - We should start using zinc inserts
 - Revisit mid-span locations to verify 10% or greater section loss is remaining constant
 - Continue to monitor long term performance of zinc
